**ISLAND PONDS MITIGATION MONITORING
AND REPORTING
YEAR 2- 2007**

Santa Clara Valley Water District
U.S. Fish and Wildlife Service - Don Edwards National Wildlife Refuge
H.T. Harvey & Associates
Philip Williams & Associates, Ltd.

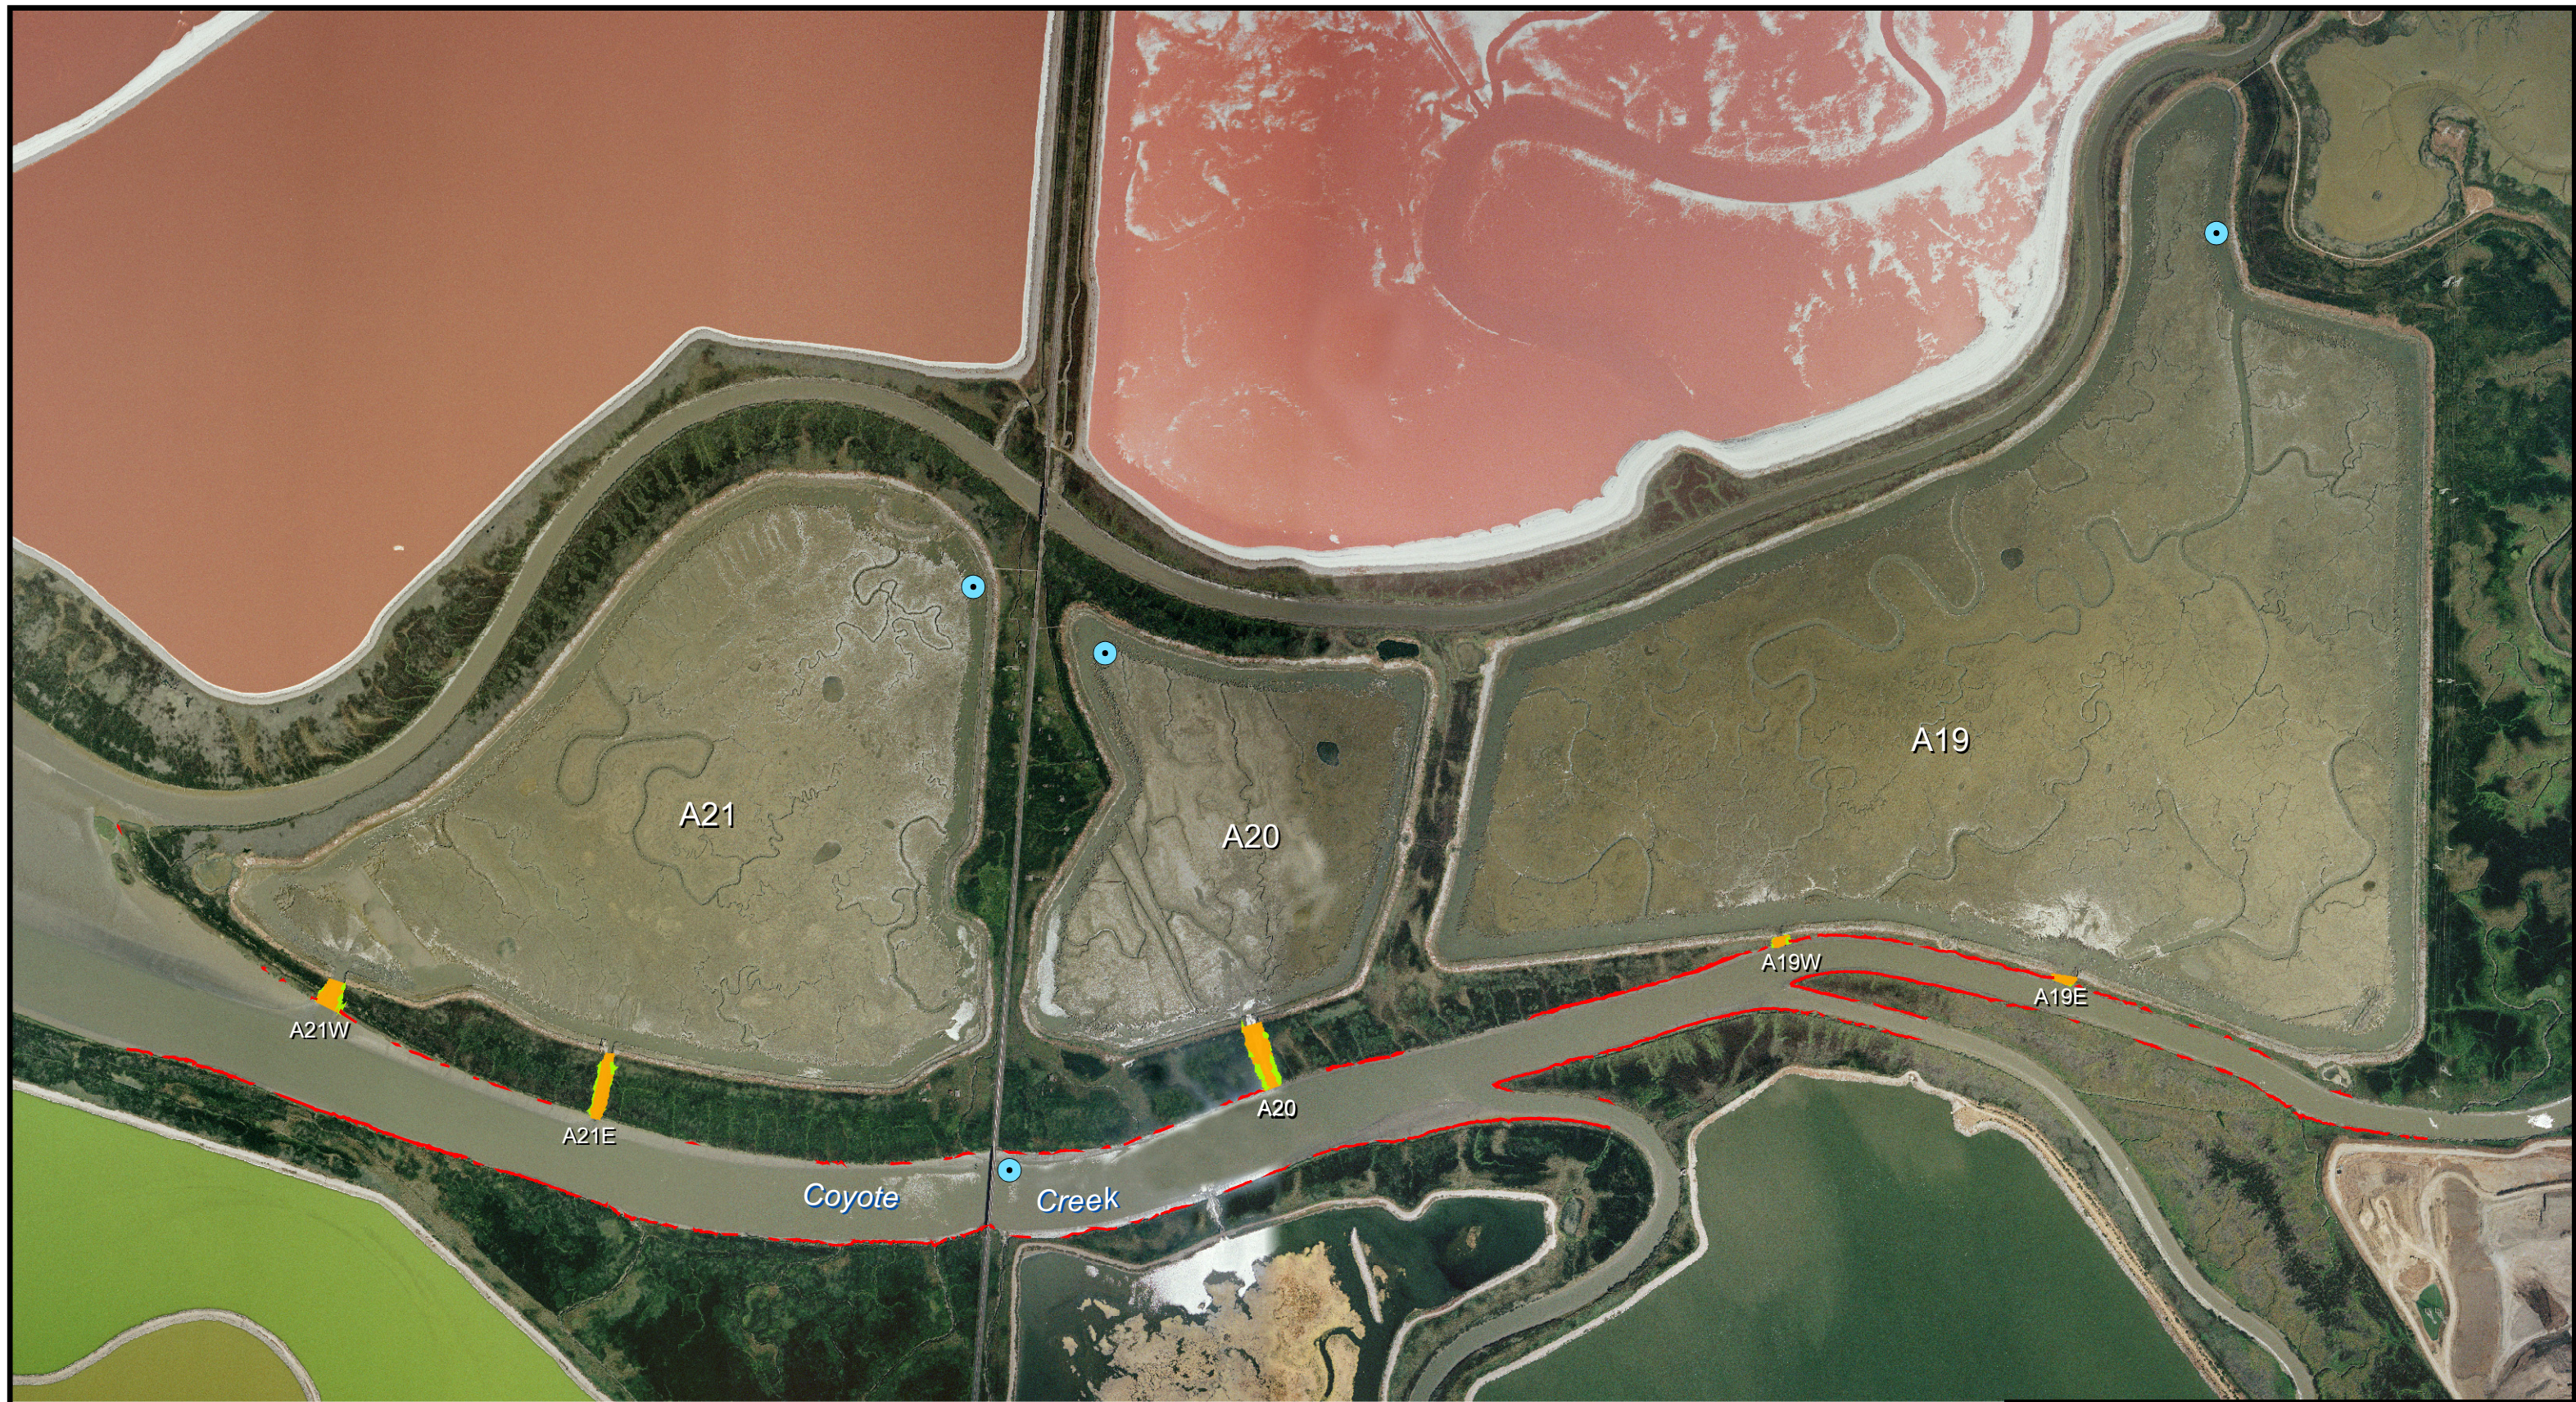
Proj No. 2456-03 Date Jan. 2008 Figure 2

Continued widening of the five levee breaches was observed between 2006 and 2007 (Table 3-1). Marsh loss in 2007 associated with scour of the outboard tidal channels totaled 0.14 acres (Table 3-2). Total marsh loss to date at the five breaches, including marsh loss associated with construction impacts, totaled 1.54 acres (Table 3-2).

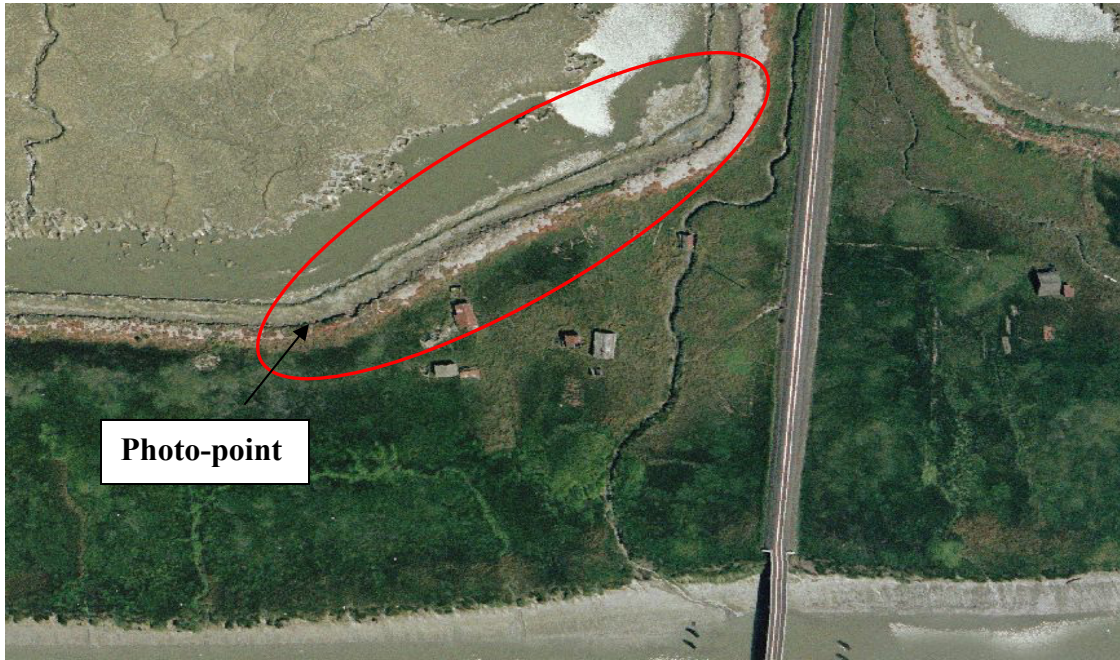
As mentioned above in Section 3.2.3, on May 18, 2007, it was observed that erosion had occurred on the southeast levee of Pond A21 (Appendix B-3). Wave action during high tide is the most likely culprit as this condition has deposited a line of debris atop the southeast corner of the Pond A21 levee. This eroding levee is adjacent to the Town of Drawbridge. However, since the erosion is minimal at this time, no structures appear to be in imminent danger.

Photo 1. Aerial view of railroad and Town of Drawbridge. The red circle (southeast levee of Pond A21) depicts the area which is eroding.

- Year 2 inspections indicate that an erosion scour in the south-southeast corner of the Pond A21 levee is advancing. We recommend installation of measurement devices in this location to more accurately characterize and track the erosion. This should include collecting top of levee elevations and installation of measurement stakes so that future measurements can be easily repeated for comparison purposes. In addition, a meeting between District and Refuge staff should be scheduled to discuss the current threats to the Town of Drawbridge and possible future actions.

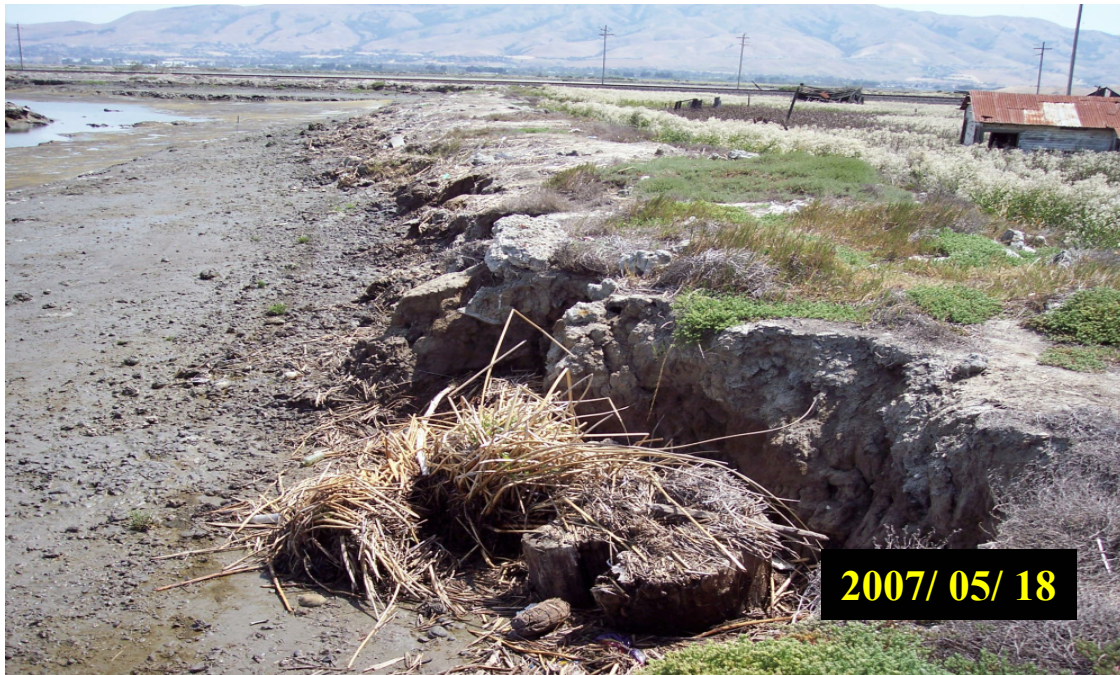
There is evidence of erosion occurring on the southeast levee of Pond A21 near the Town of Drawbridge (Appendix B-3). Wave action during high tides is the most likely culprit as this condition has deposited a line of debris on top of the southeast corner of the Pond A21 levee. For future monitoring, we plan to install measurement stakes in this location to better track the erosion which is occurring.

Photo 2. Levee erosion at Pond A21's southeast levee, view looking east – May 18, 2007.

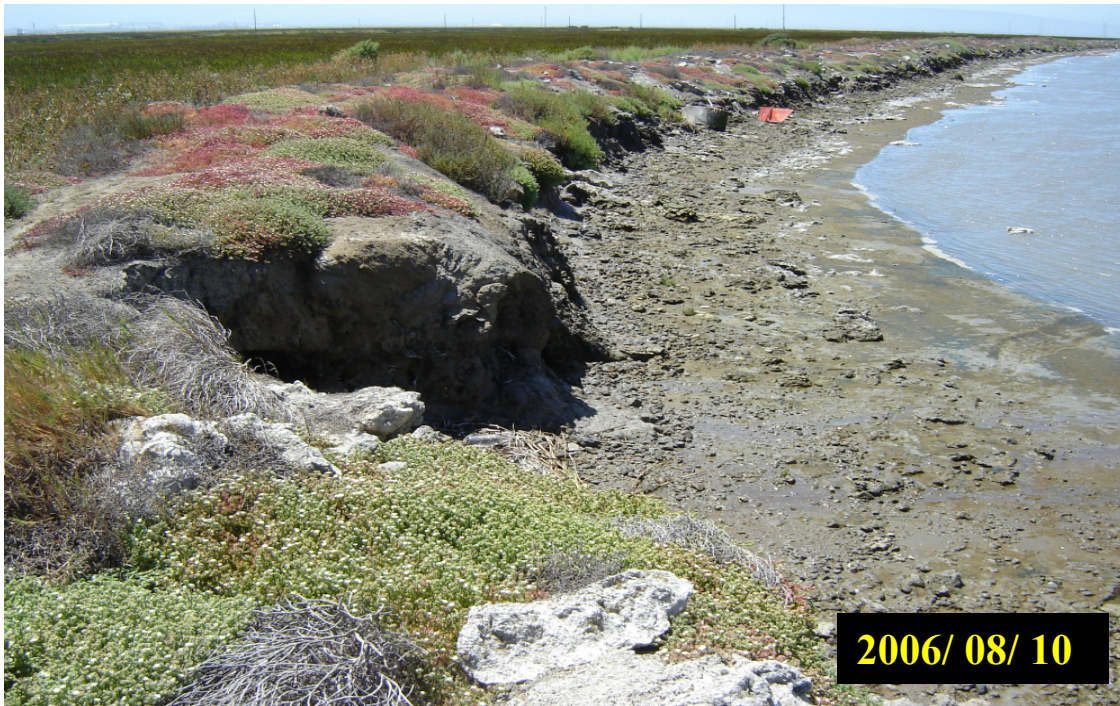
Photo 3. Close up of eroded section of levee in the southeast corner of Pond A21, view looking west – August 10, 2006.

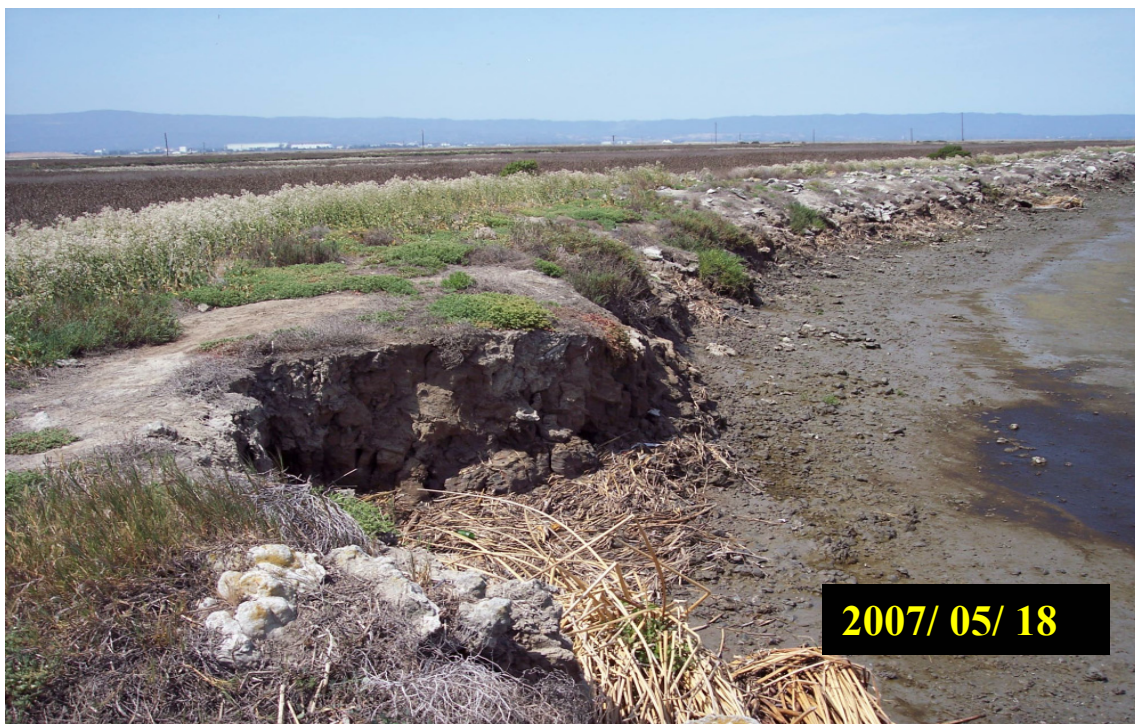
The May 18, 2007 field inspection revealed no apparent signs of rail levee erosion or erosion of the adjacent Pond A20 levee. However, there was evidence of erosion occurring on the adjacent Pond A21 levee. During the site visit, it was apparent that wave action and/or high water conditions had deposited a line of debris on top of the Pond A21 levee located at the southeast corner of the pond. In addition, there were similar piles of debris located outside of the pond, within the marsh area located between the Pond A21 levee and the rail levee. While there was no evidence of scour or erosion of the rail levee, the debris evidence indicates that water may be overtopping the Pond A21 salt pond levee.

Photo 4. Same location as above – May 18, 2007.

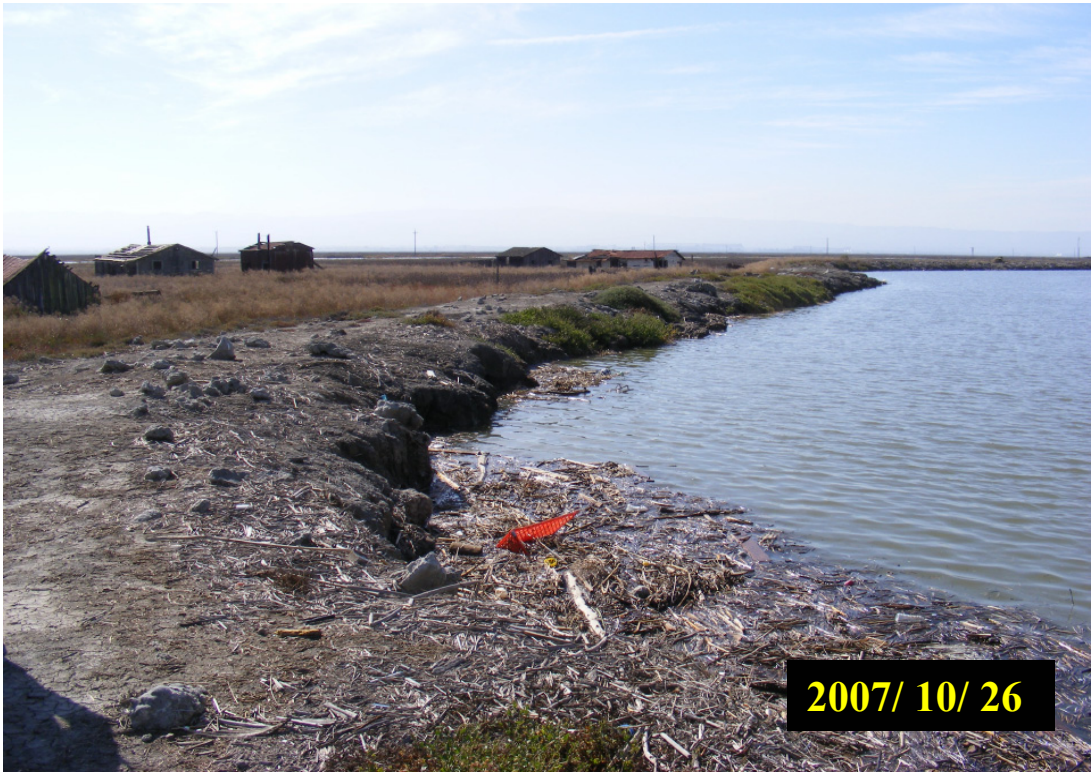
In an attempt to verify whether or not the Pond A21 levee was being overtopped during a high tide event, District staff planned a site visit during an extremely high tide in the Fall on October 26, 2007 (10.7 ft predicted tide height at the Alviso Slough/Coyote Creek tide gage). Since this high tide occurred in the afternoon hours, District staff anticipated normal southerly winds to occur which would help verify whether or not the combination of windy conditions, wave action and high tides cause the water in the pond to overtop the levee. Unfortunately, the site visit occurred on a rare windless day in the South Bay and the only information gathered was that a high tide in and of itself (i.e., without wind or wave action)

Photo 5. Debris accumulated in the southeast corner of Pond A21. Debris is also visible on top of the levee – October 26, 2007.

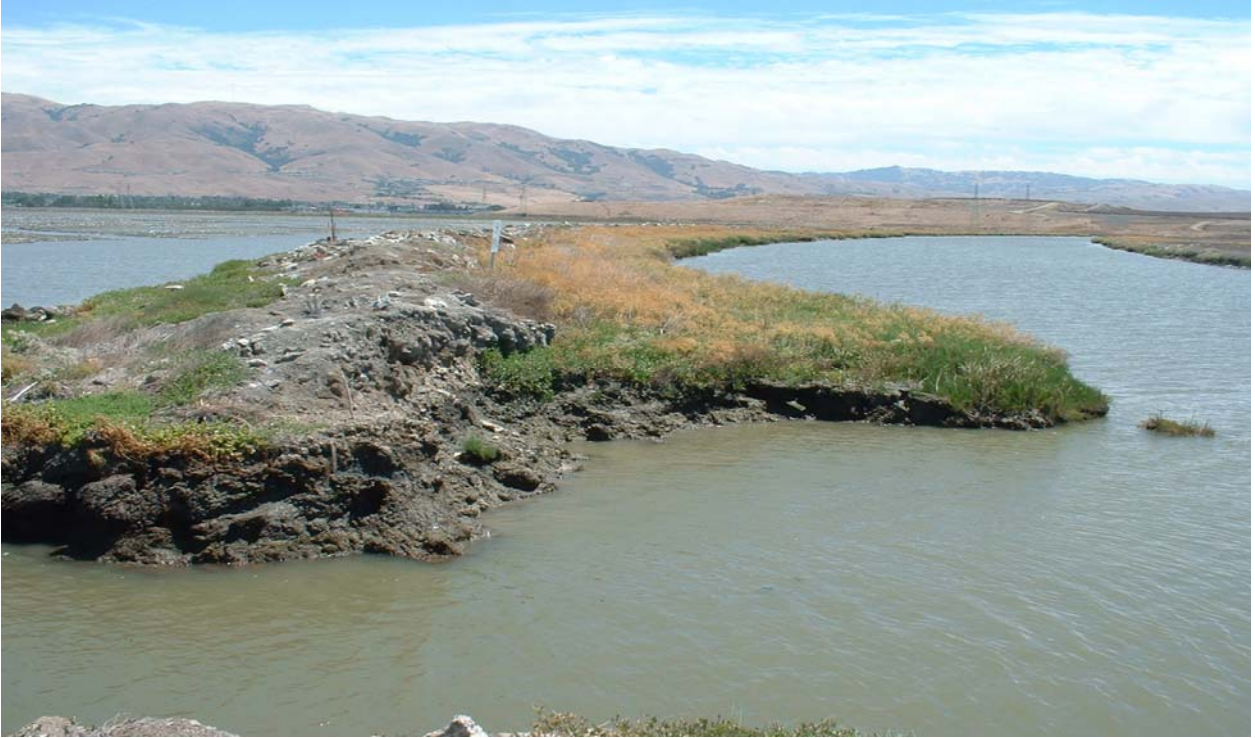
Photo 1. View of A19W Breach. Note evident scour of marsh in foreground - July 24, 2007.

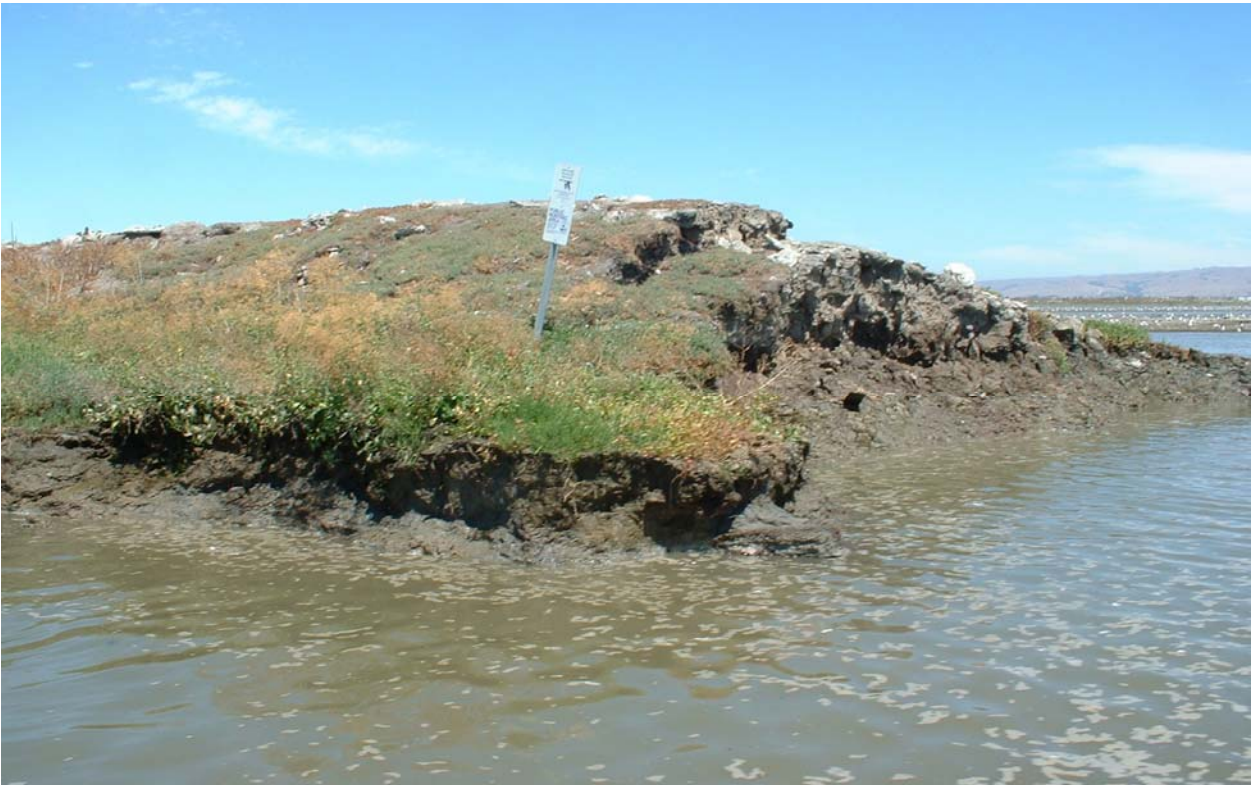
Photo 2. View of A19E Breach. Note evident scour of marsh in foreground – July 24, 2007.

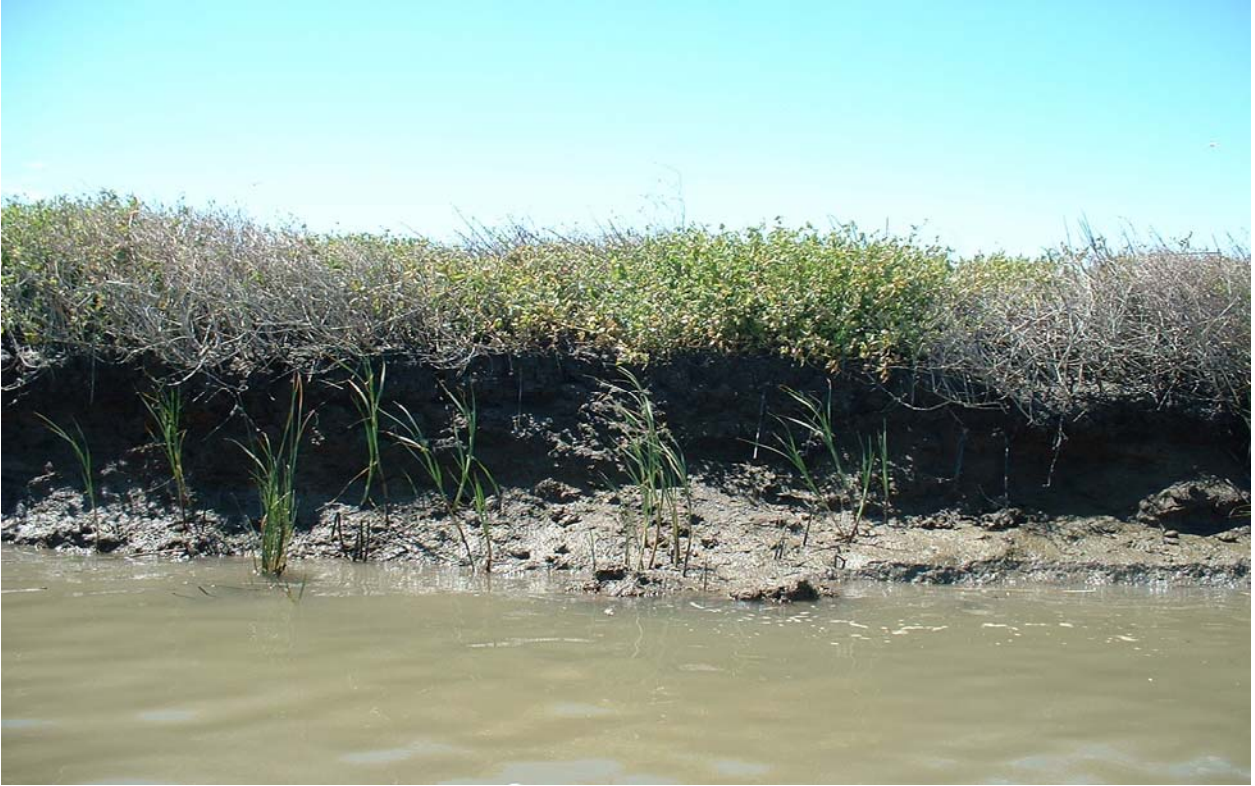
Photo 3. Scour along fringing marsh, northern bank of Coyote Creek – July 24, 2007.

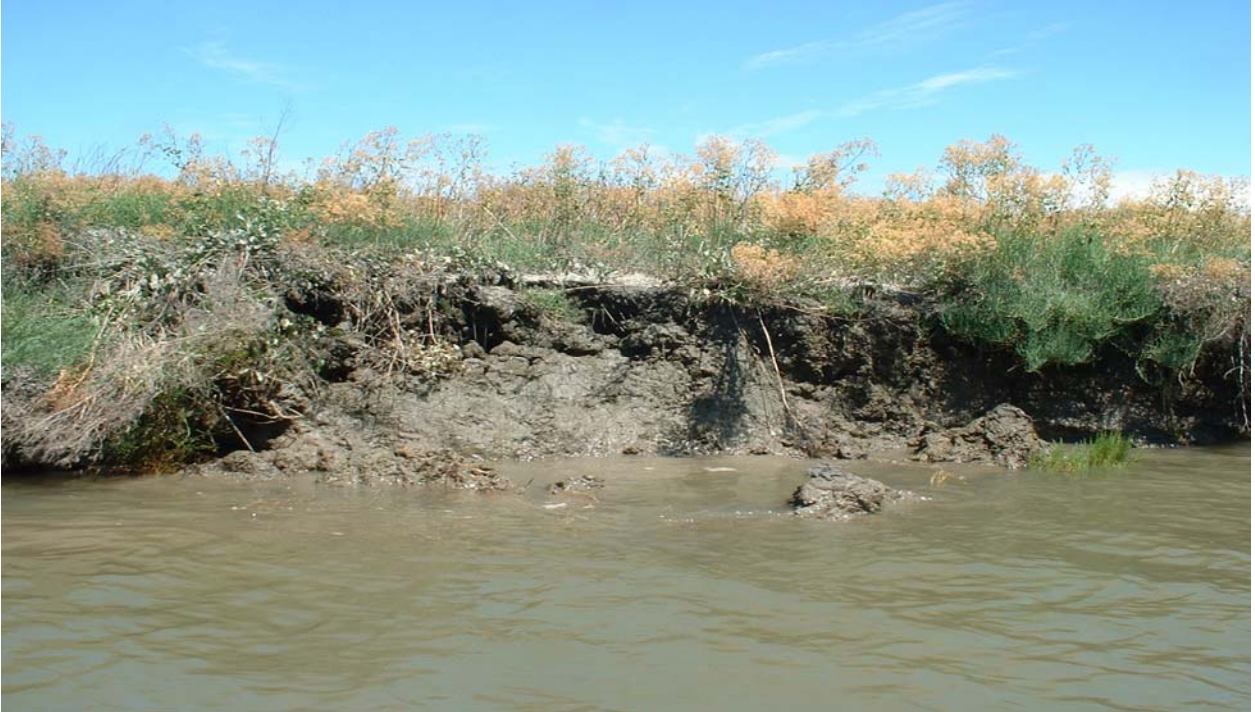
Photo 4. Scour along fringing marsh, southern bank of Coyote Creek – July 24, 2007.

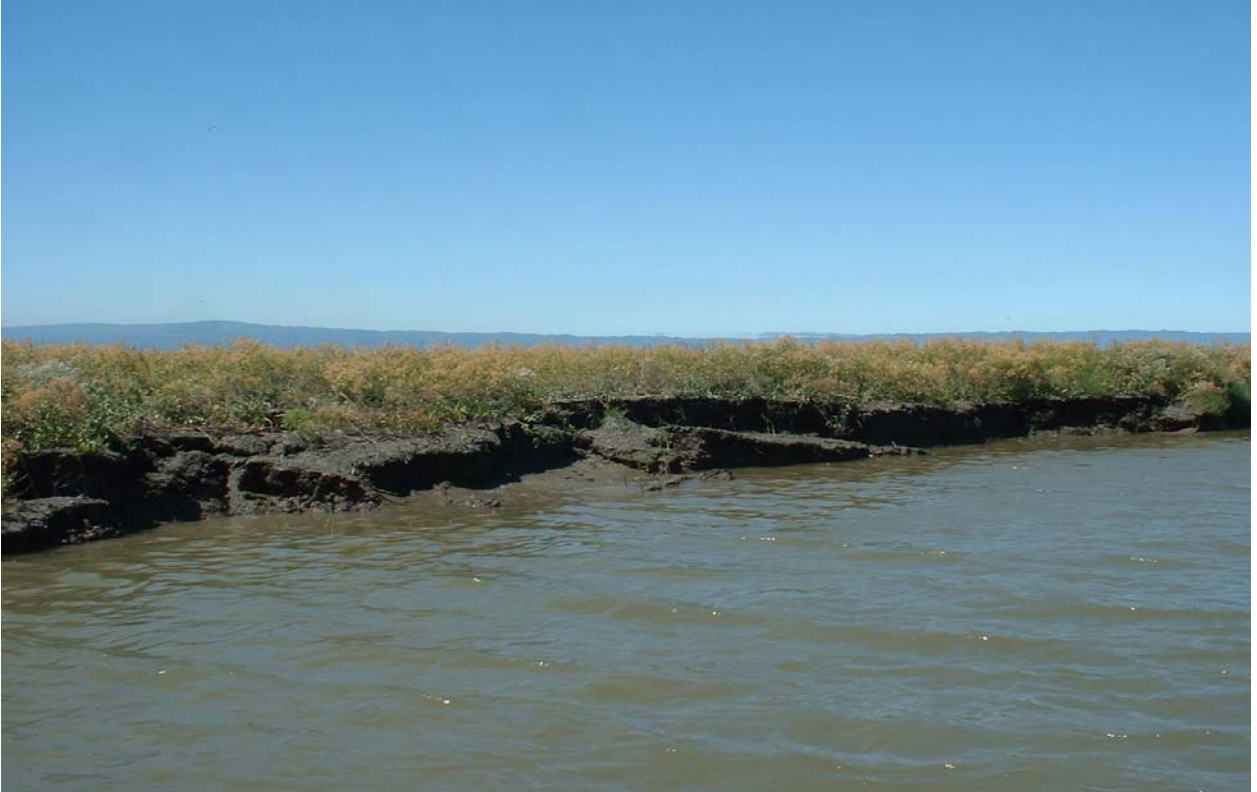
Photo 5: Scour along fringing marsh, southern bank of Coyote Creek – July 24, 2007.
