# PHOTOS

EXISTING AND PROPOSED  
 GEOTECHNICAL EXPLORATIONS  
 Levee Assessment  
 South Bay Salt Ponds Restoration Project  
 San Francisco Bay Area, California

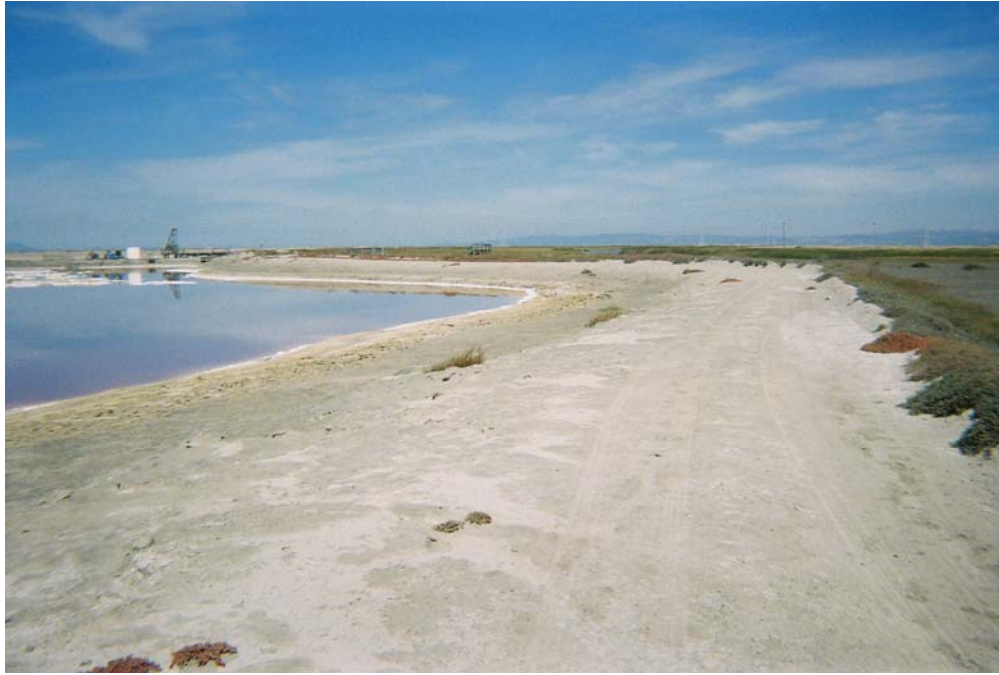
Photograph 1: Example of levee without slope protection (Pond R3 Northeast)

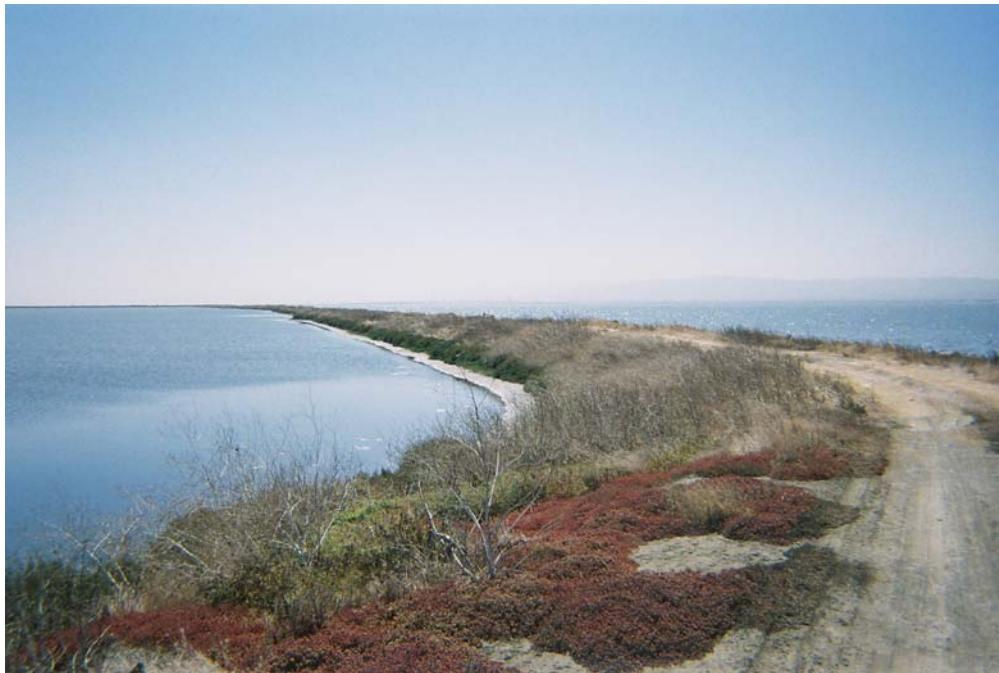
Photograph 2: Example of levee with vegetation slope protection (Pond B2 Northwest)

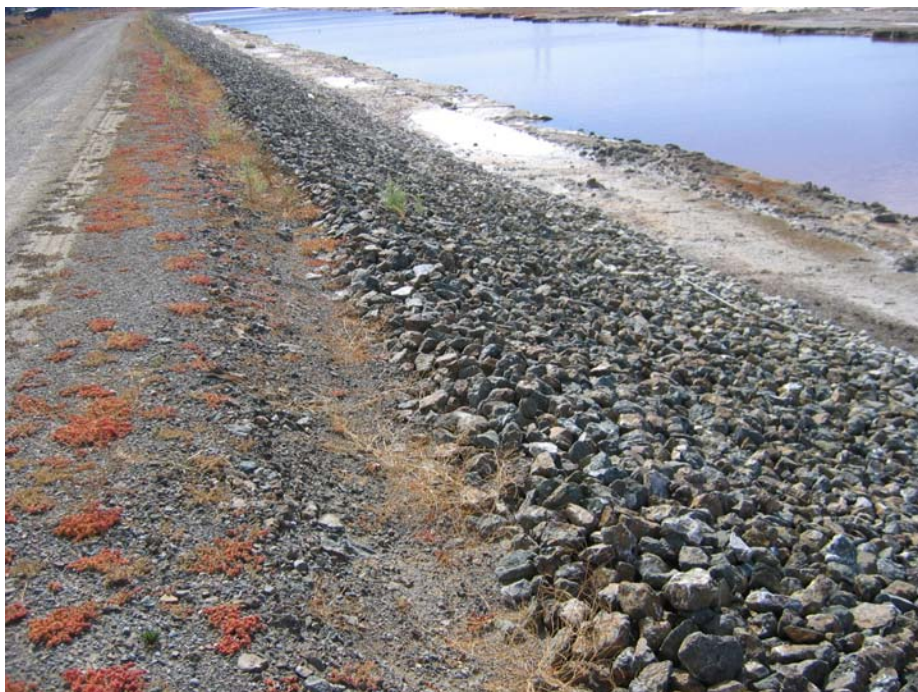
Photograph 4: Example of levee with engineered riprap slope protection (Pond SF2 Southeast)

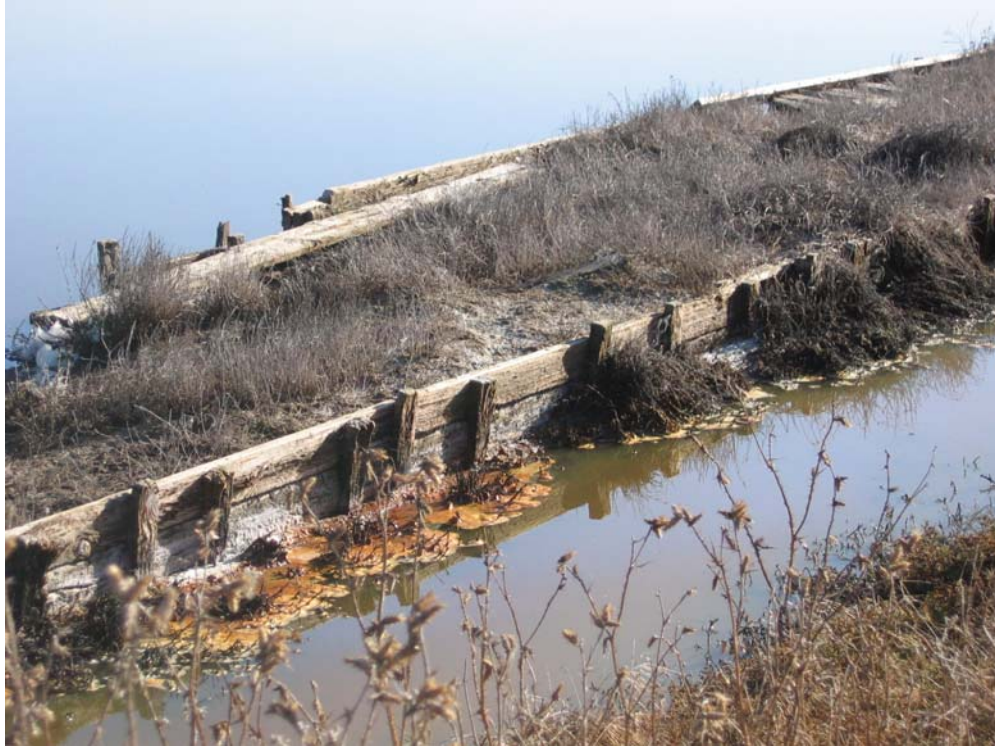
Photograph 5: Example of levee with wood shoring slope protection (Pond B10 North)

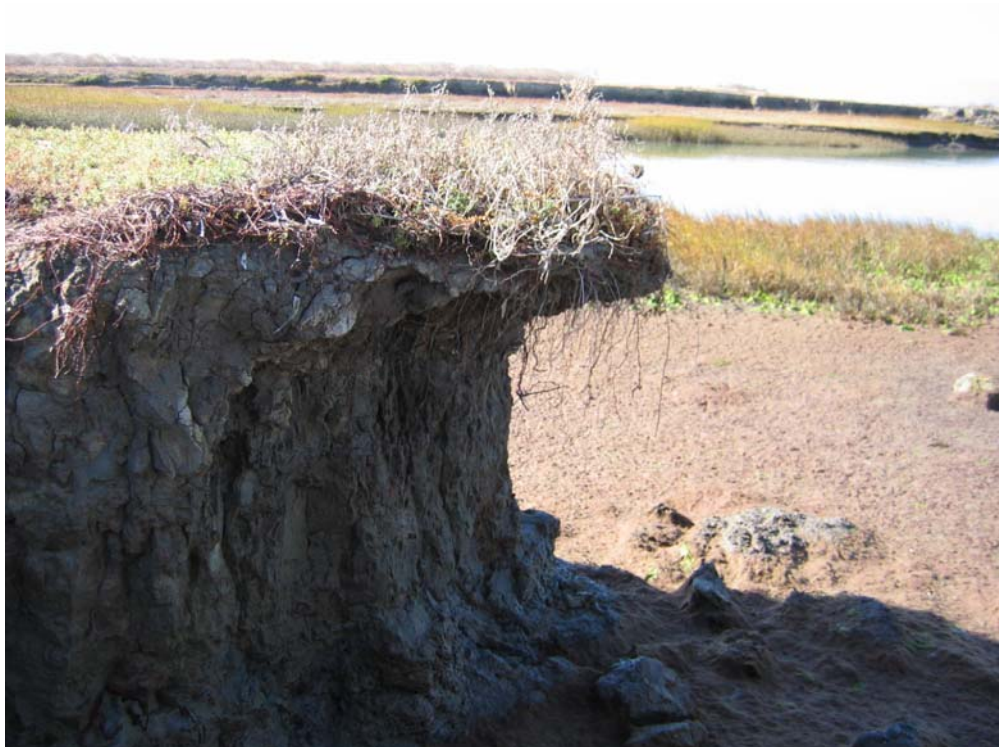
Photograph 8: Example of undercutting and severe erosion distress of levee slope (Pond BT1 Southwestern point)
