South Bay Salt Pond Restoration Project

Levee Assessment

Prepared by:
Geomatrix Consultants

October 2006

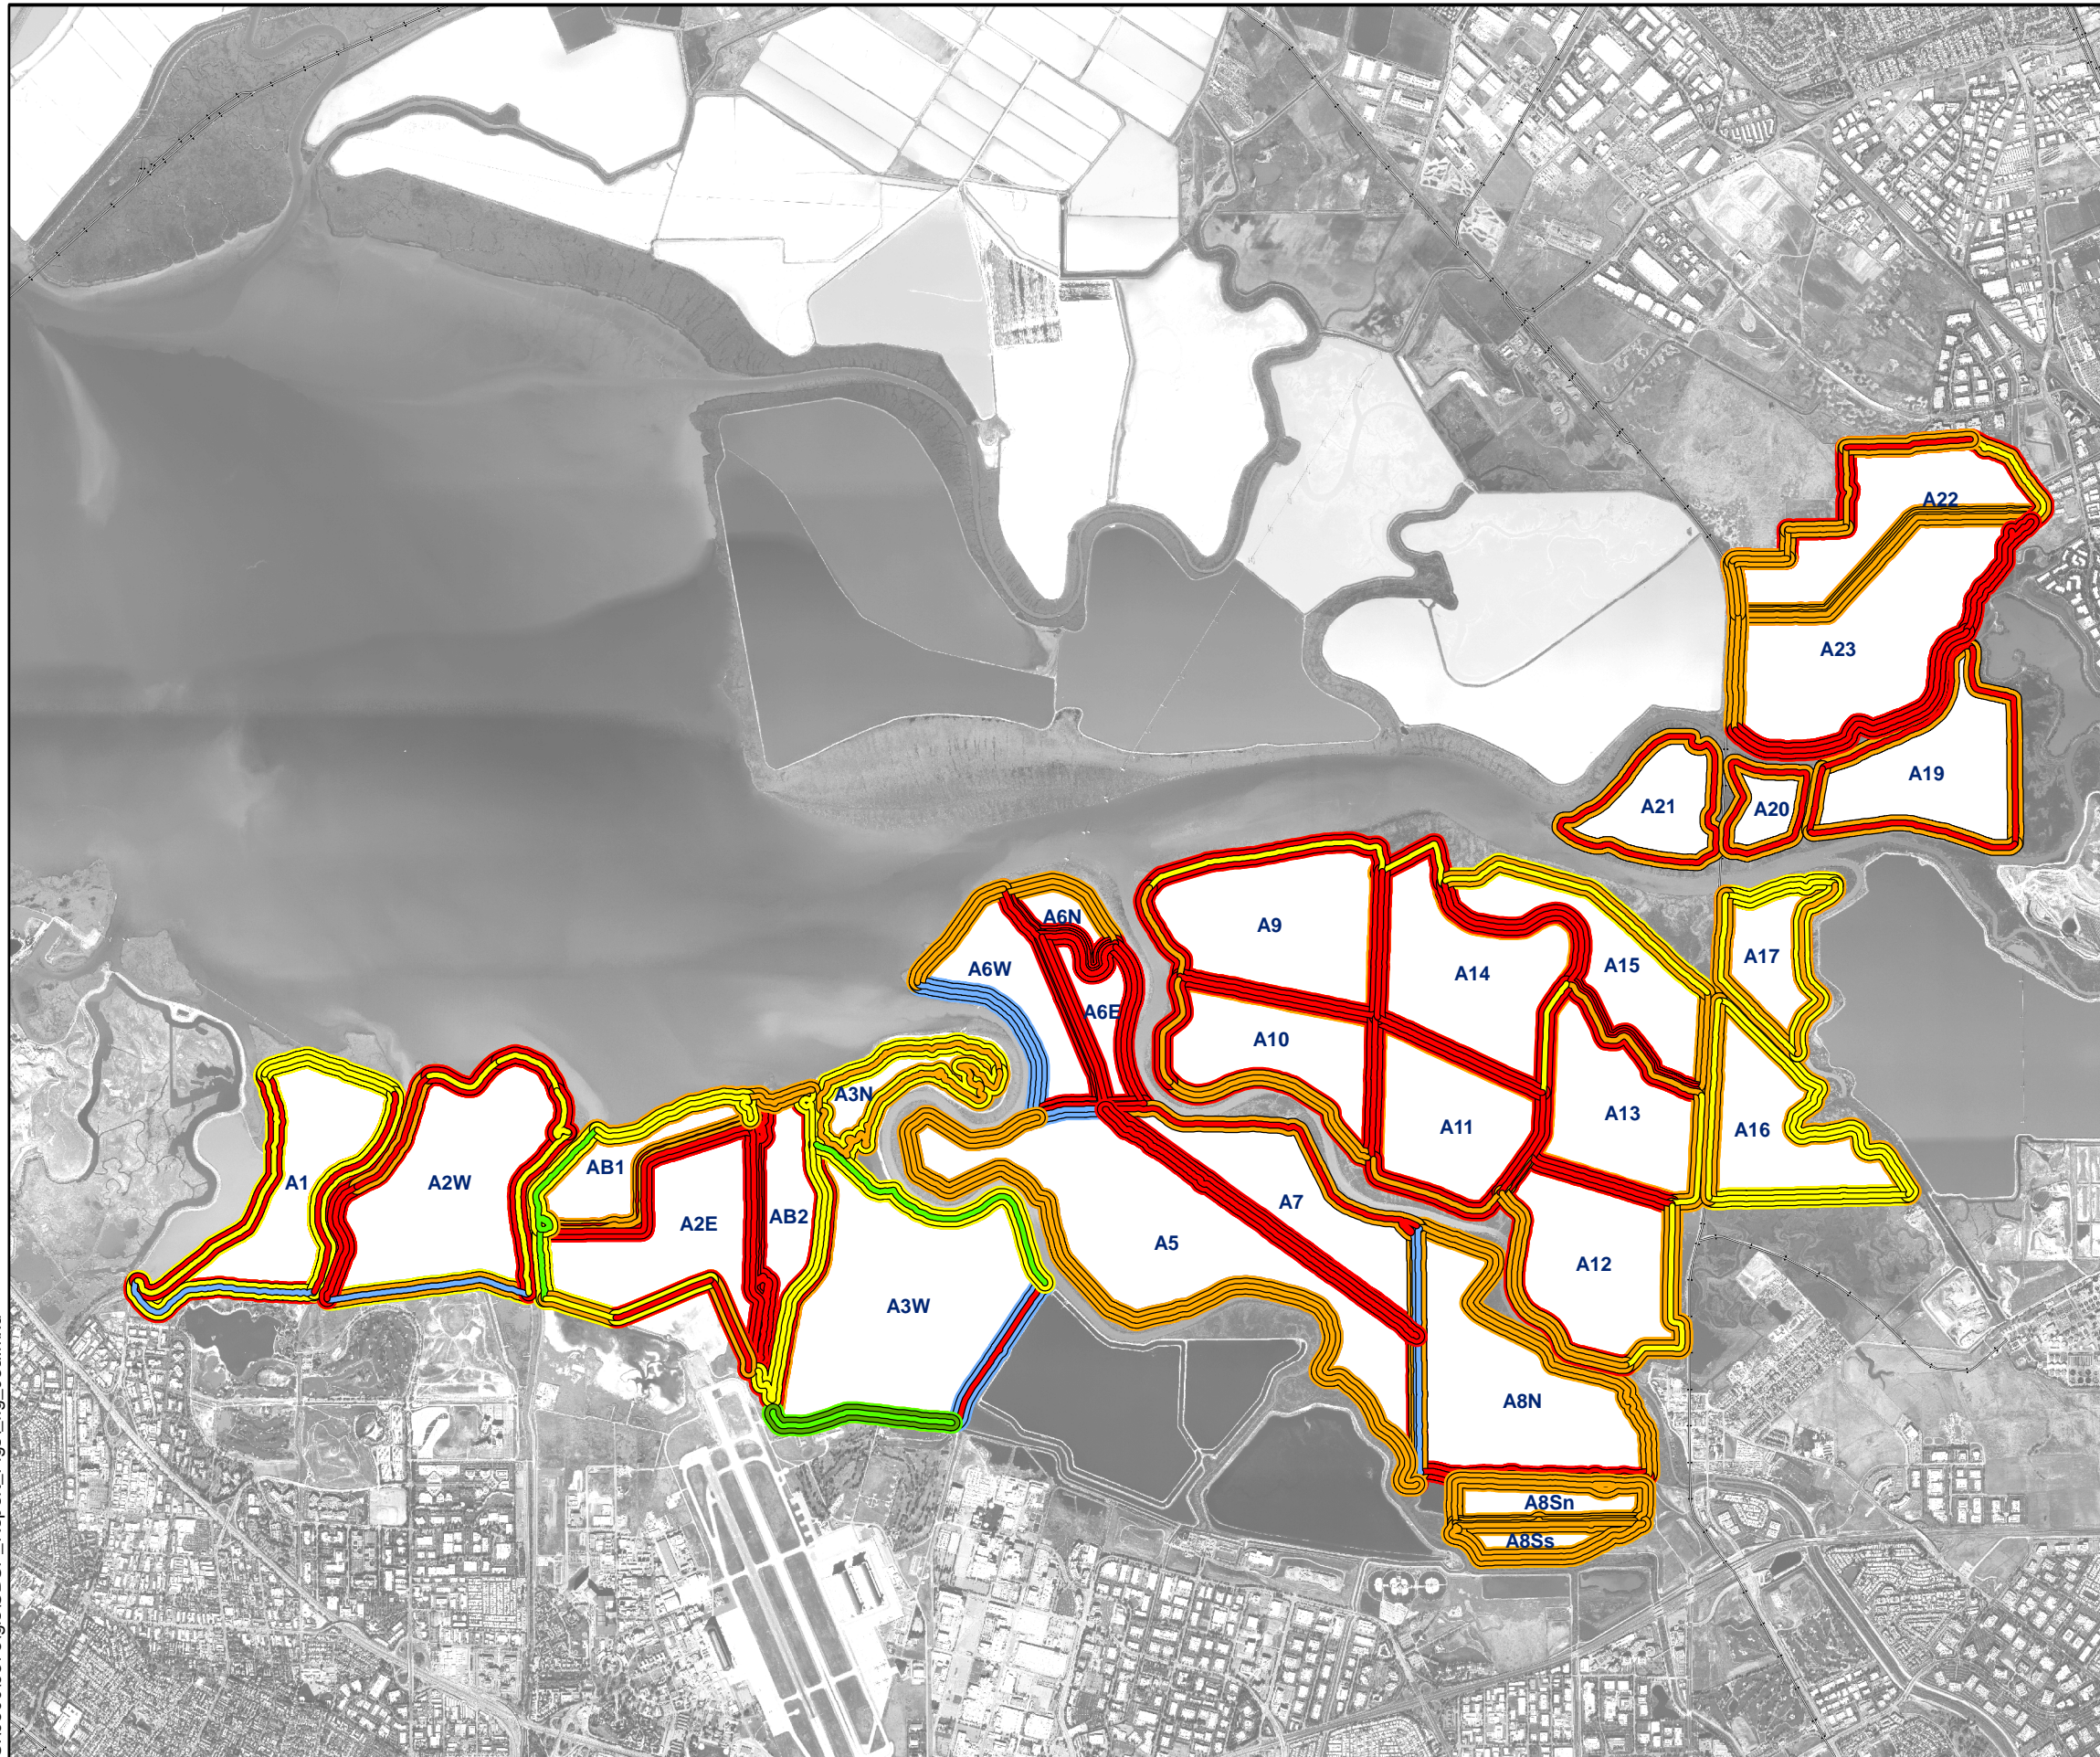
LEVEE ALIGNMENT CONDITION
ALVISO
Levee Assessment
South Bay Salt Ponds Restoration Project
San Francisco Bay Area, California

Figures 3a, 3e, and 3r are a series of maps for each respective pond complex (Alviso (a), Eden Landing (e), Ravenswood (r)) showing summarized levee alignment conditions for the crest, slope and toe. These figures include data compiled from multiple sources. Where overlapping data exists, that from the most recent source is presented. Levee conditions in Figures 3a, 3e, and 3r are labeled and color coded good (blue), fair (yellow) and poor (red).

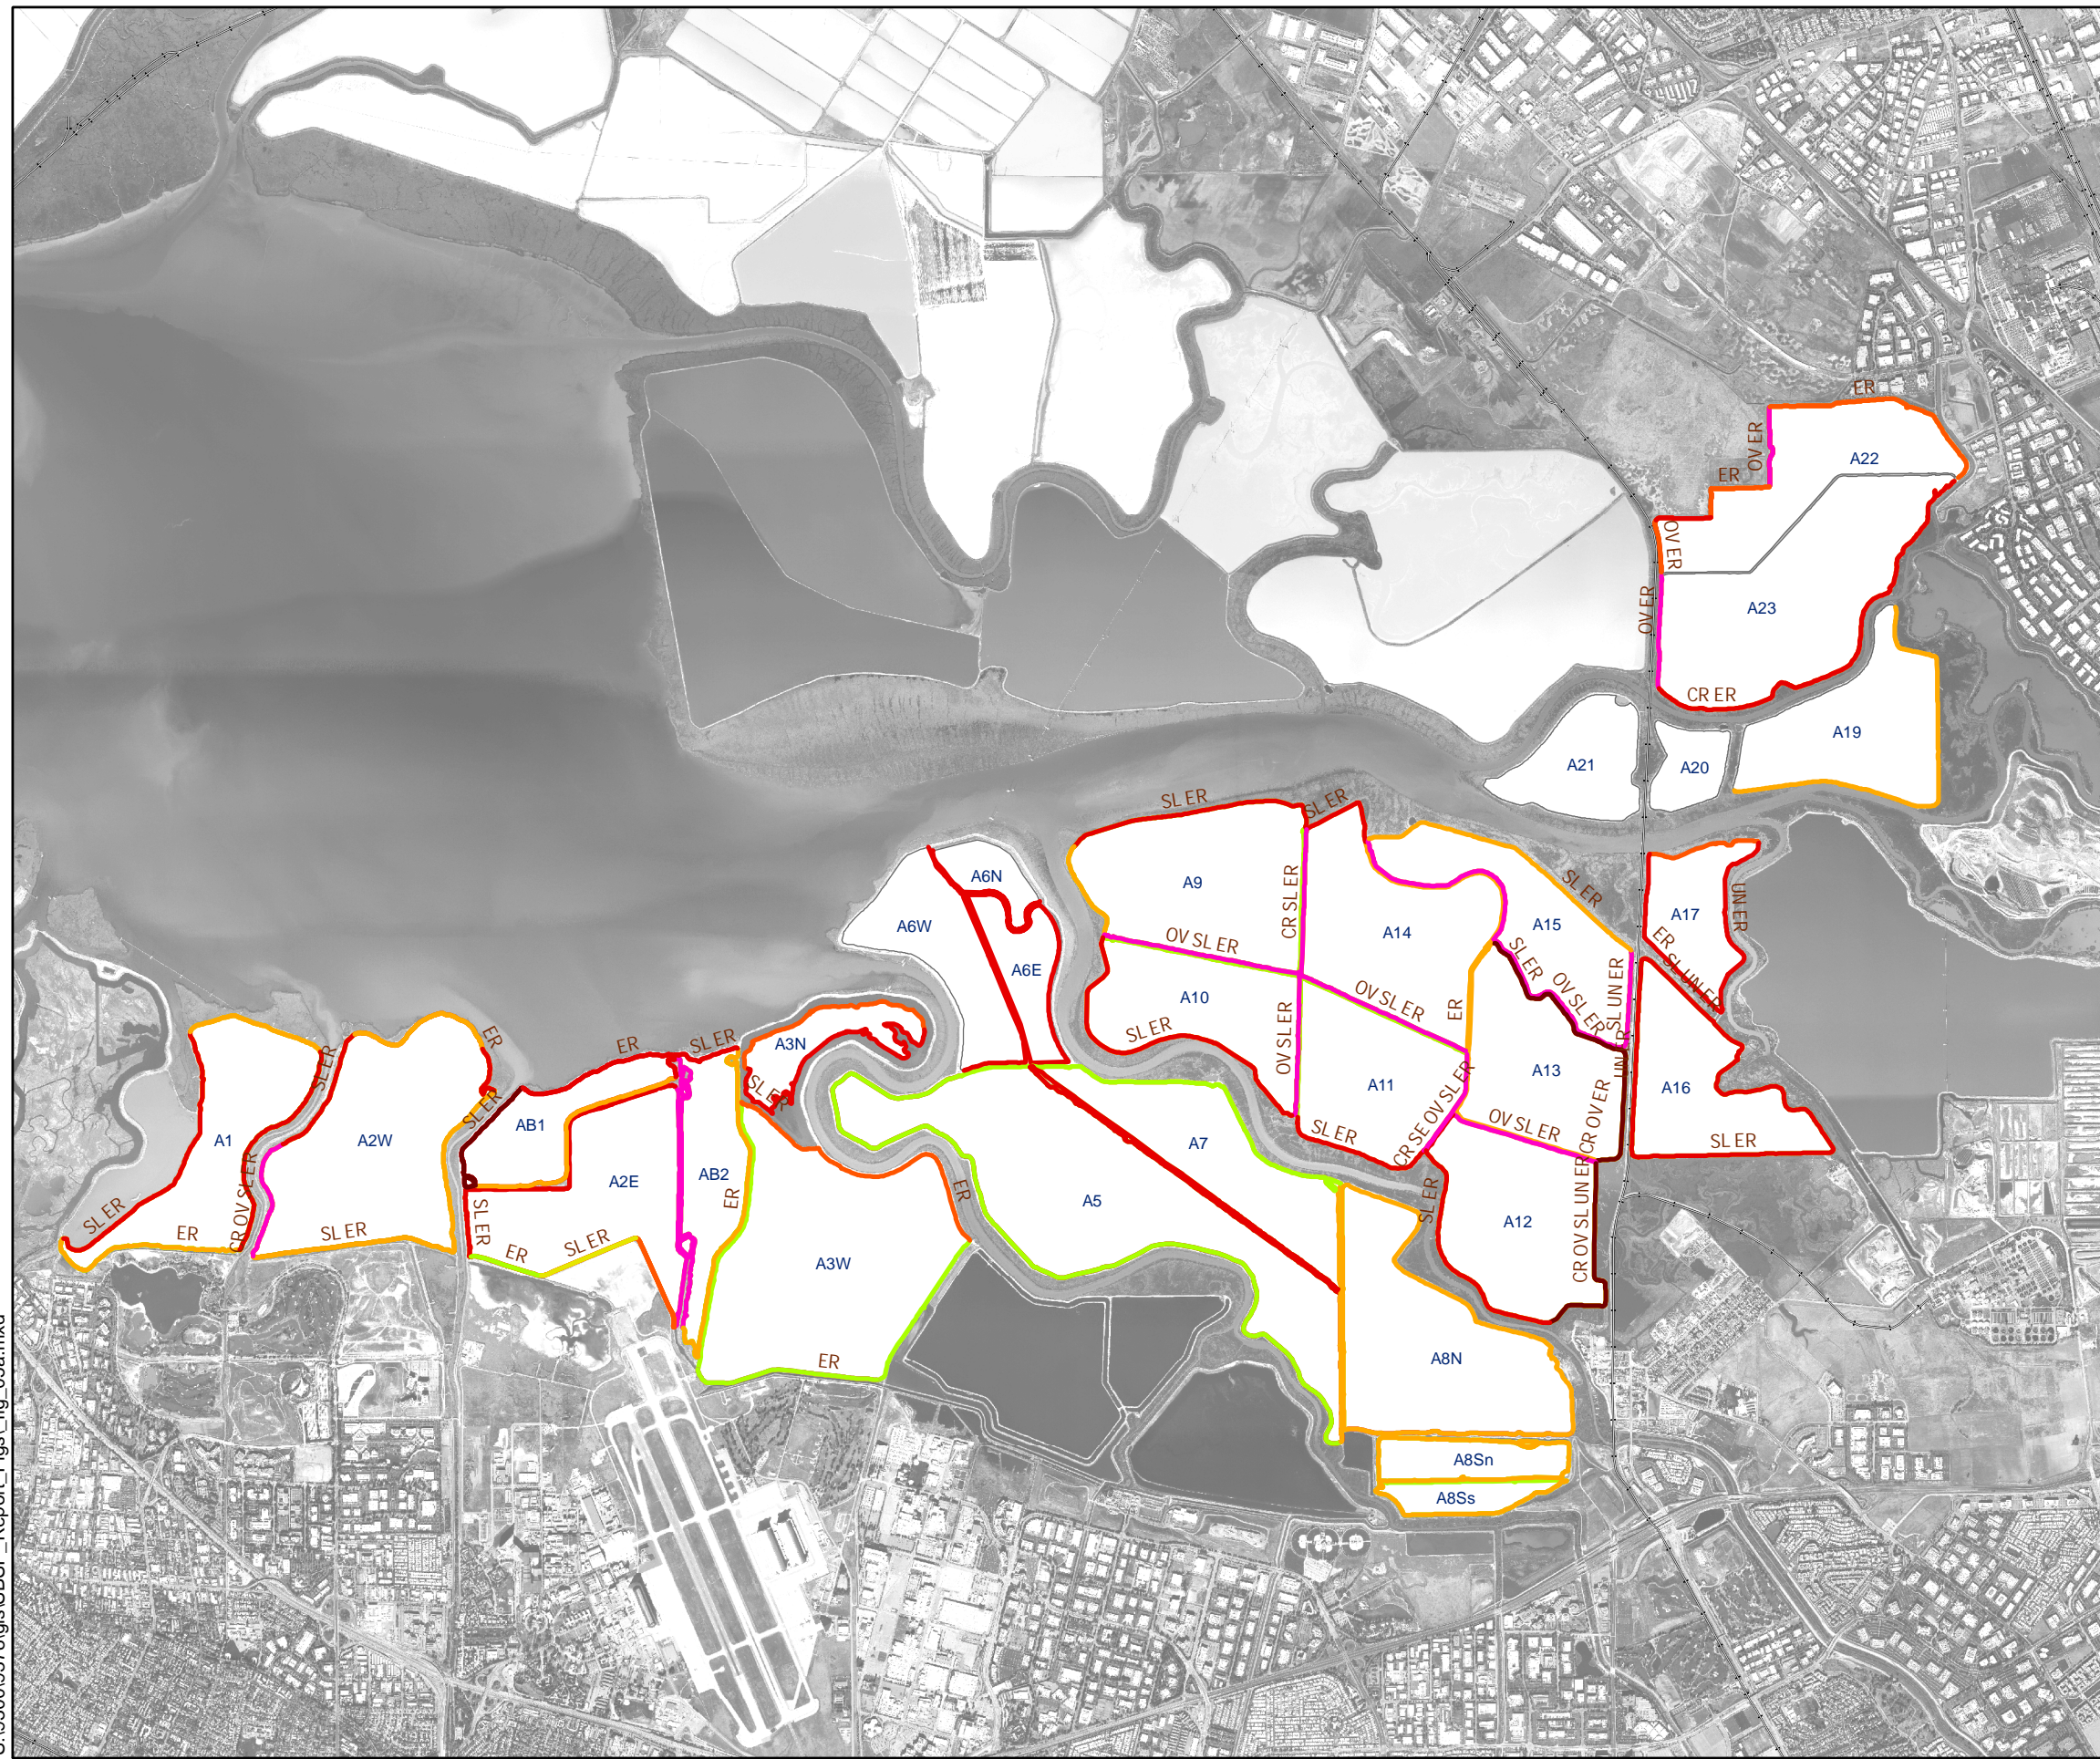
OBSERVED LEVEE DISTRESS
ALVISO
Levee Assessment
South Bay Salt Ponds Restoration Project
San Francisco Bay Area, California

Figures 5a, 5e, and 5r are a series of maps for each respective pond complex summarizing observed levee distresses. These figures include data compiled from multiple sources. Where overlapping data exists, that from the most recent source is presented. The types of observed levee distress are labeled on Figures 5a, 5e, and 5r. Examples of the various levee distress

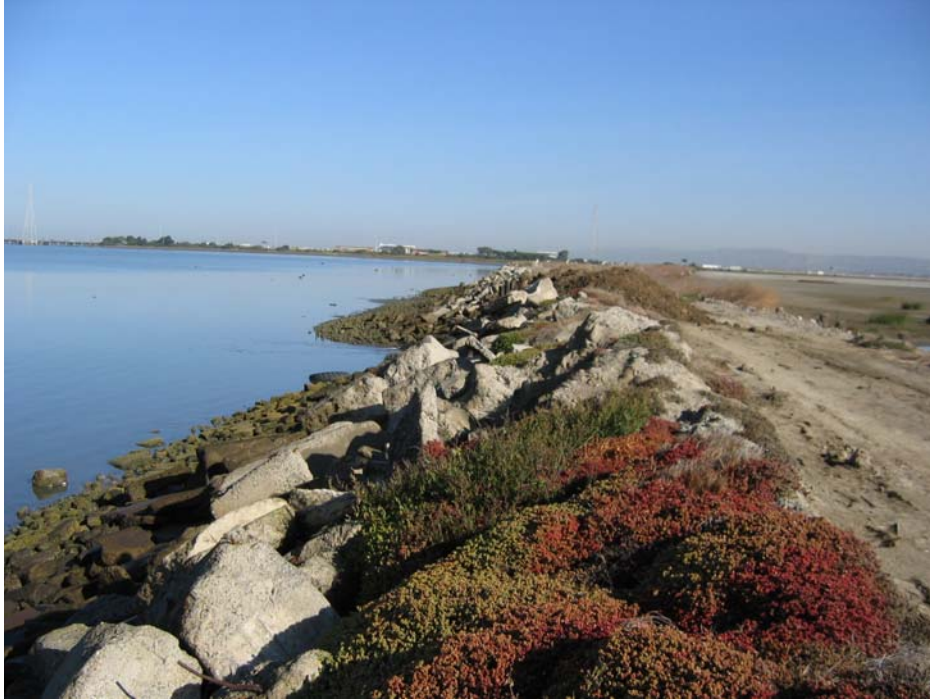
Photograph 3: Example of levee with broken concrete slope protection (Pond B10 West)

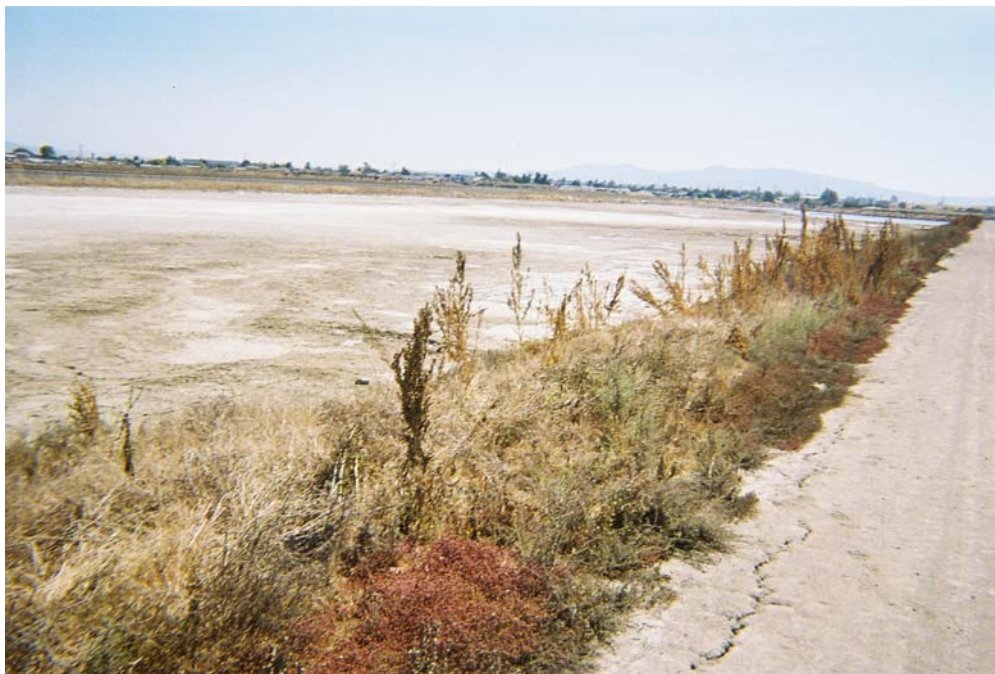
Photograph 6: Example of cracking distress of levee crest (Pond A12 East)

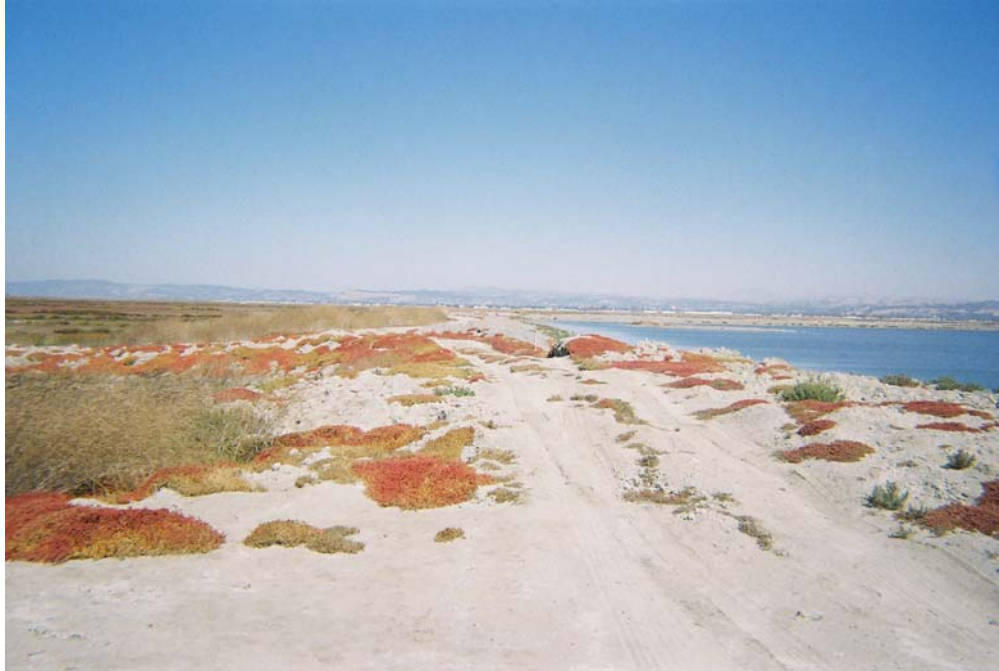
Photograph 7: Example of previous breach and overtopping distress of levee with subsequent poor repair (Pond B2 West)

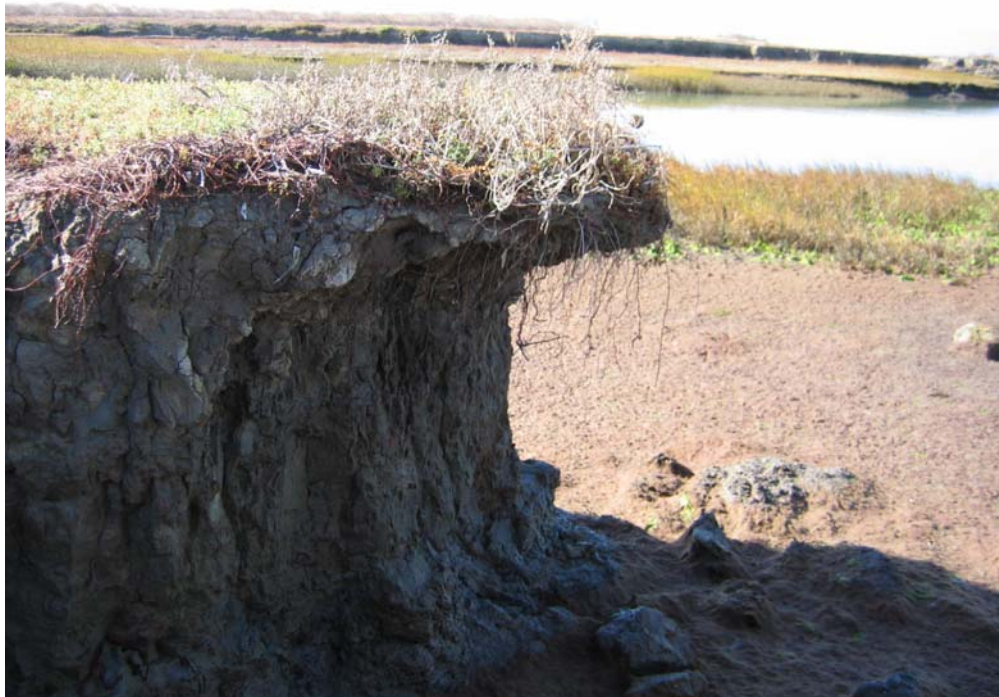
Photograph 8: Example of undercutting and severe erosion distress of levee slope (Pond BT1 Southwestern point)

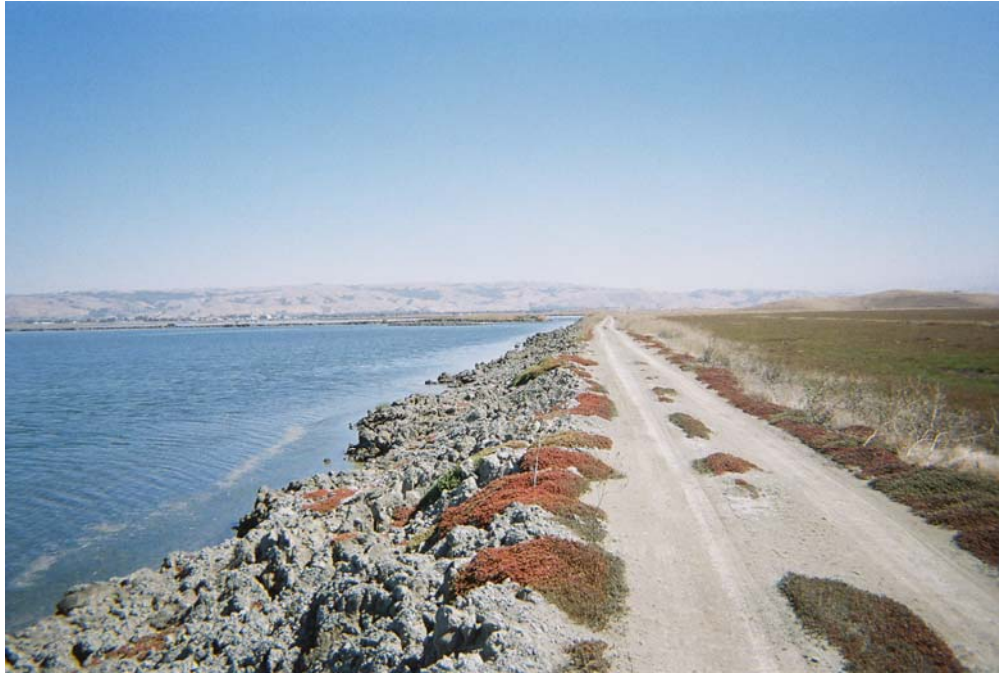
Photograph 9: Example of gullying and severe erosion distress of unprotected levee slope (Pond B2 South)

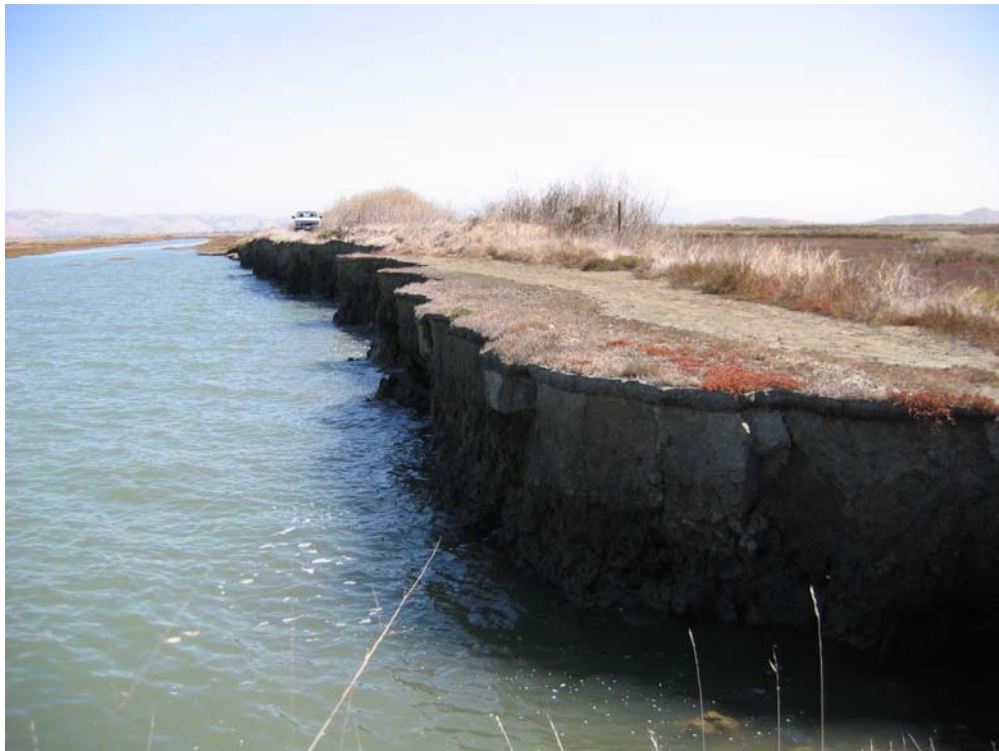
Photograph 10: Example of severe erosion distress of levee slope and crest (Pond BT2 North)
