**BAIR ISLAND RESTORATION
AND MANAGEMENT PLAN:
EXISTING HYDROLOGIC
CONDITIONS ASSESSMENT**

H.T. Harvey & Associates

Philip Williams & Associates, Ltd.

Revised June 30, 2000

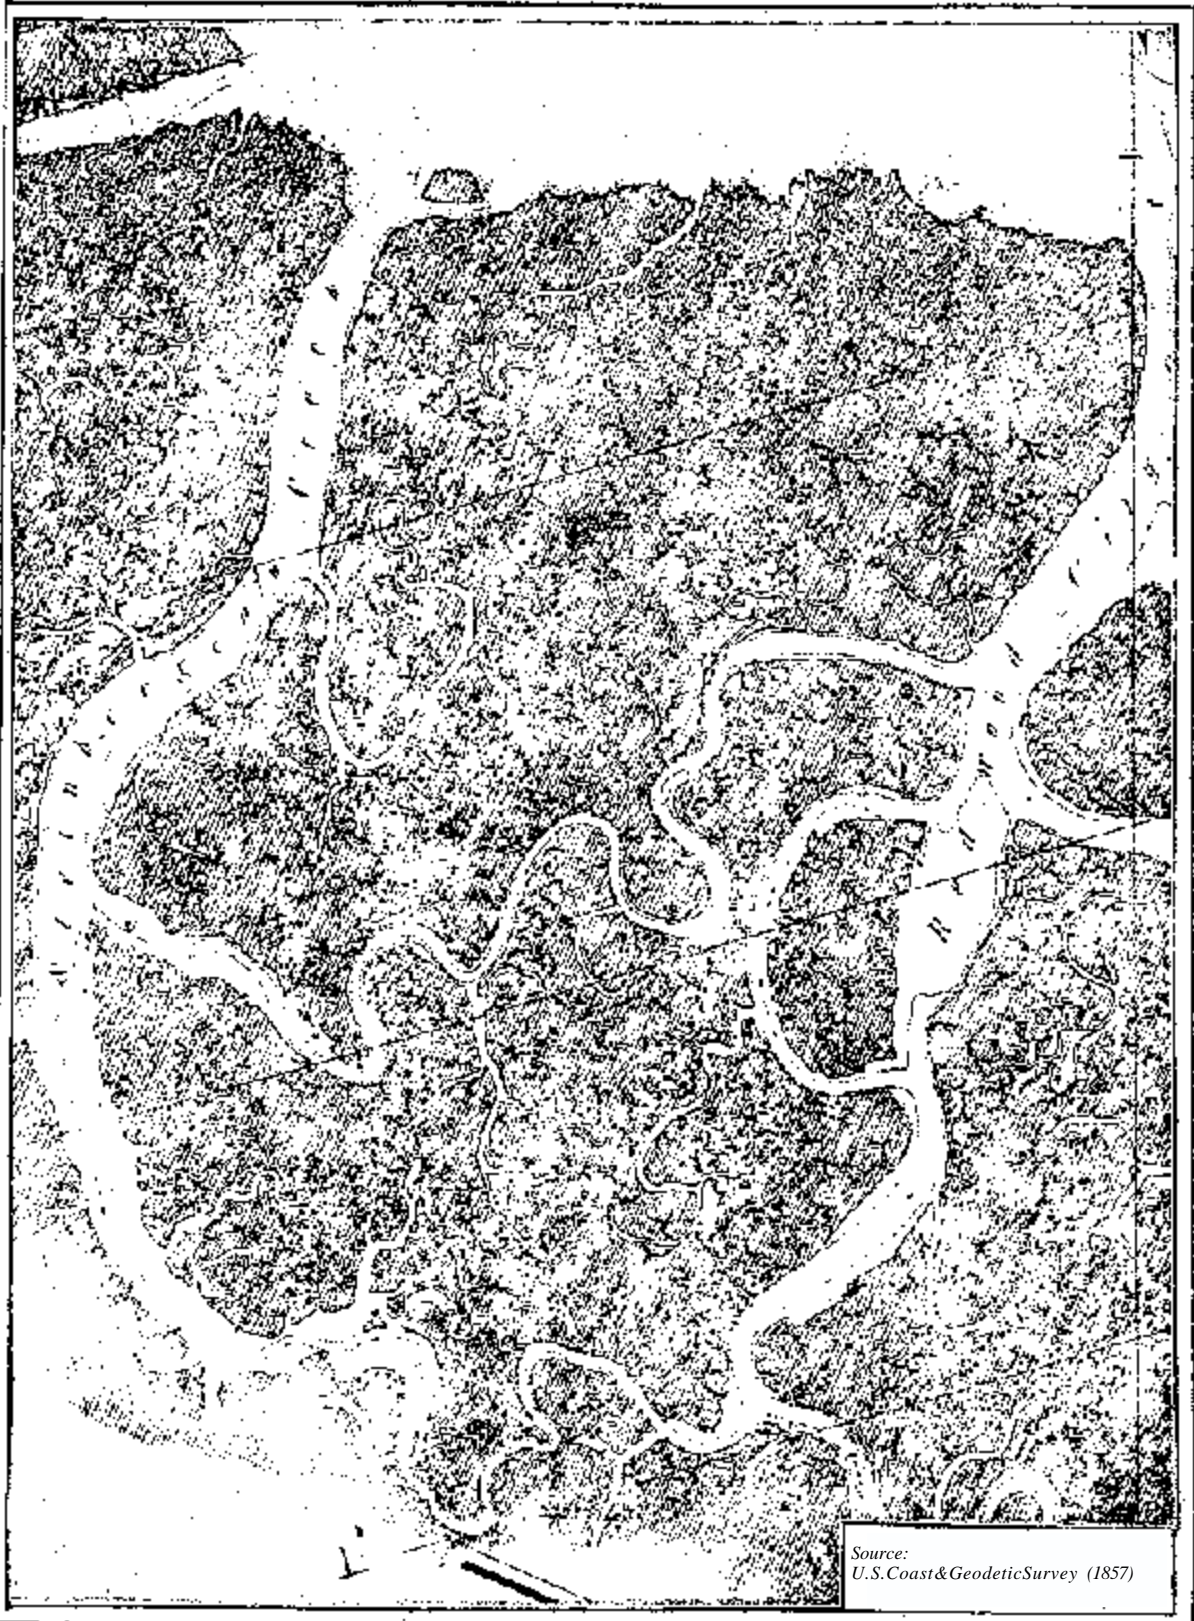
figure 3

Bair Island
Historic Conditions, 1857

Source:
U.S. Coast & Geodetic Survey (1857)

A review of historic and recent topographic maps of the area illustrates the changes that have occurred from the 1850s through the present. In 1857, only the bayward two of the three islands that now comprise Bair Island existed as islands; the area that is now Inner Bair was part of the mainland (Figure 3). There were no structures or levees and the entire Bair Island was tidal salt marsh. There were no significant changes between 1857 and 1897, except for a 10-acre area at the confluence of Corkscrew Slough and Redwood Creek, which was diked for use as a fishing village in 1869 (SLC 1977). The 1897 map shows what appears to be Cordilleras Creek discharging to Smith Slough through a small tidal channel on what

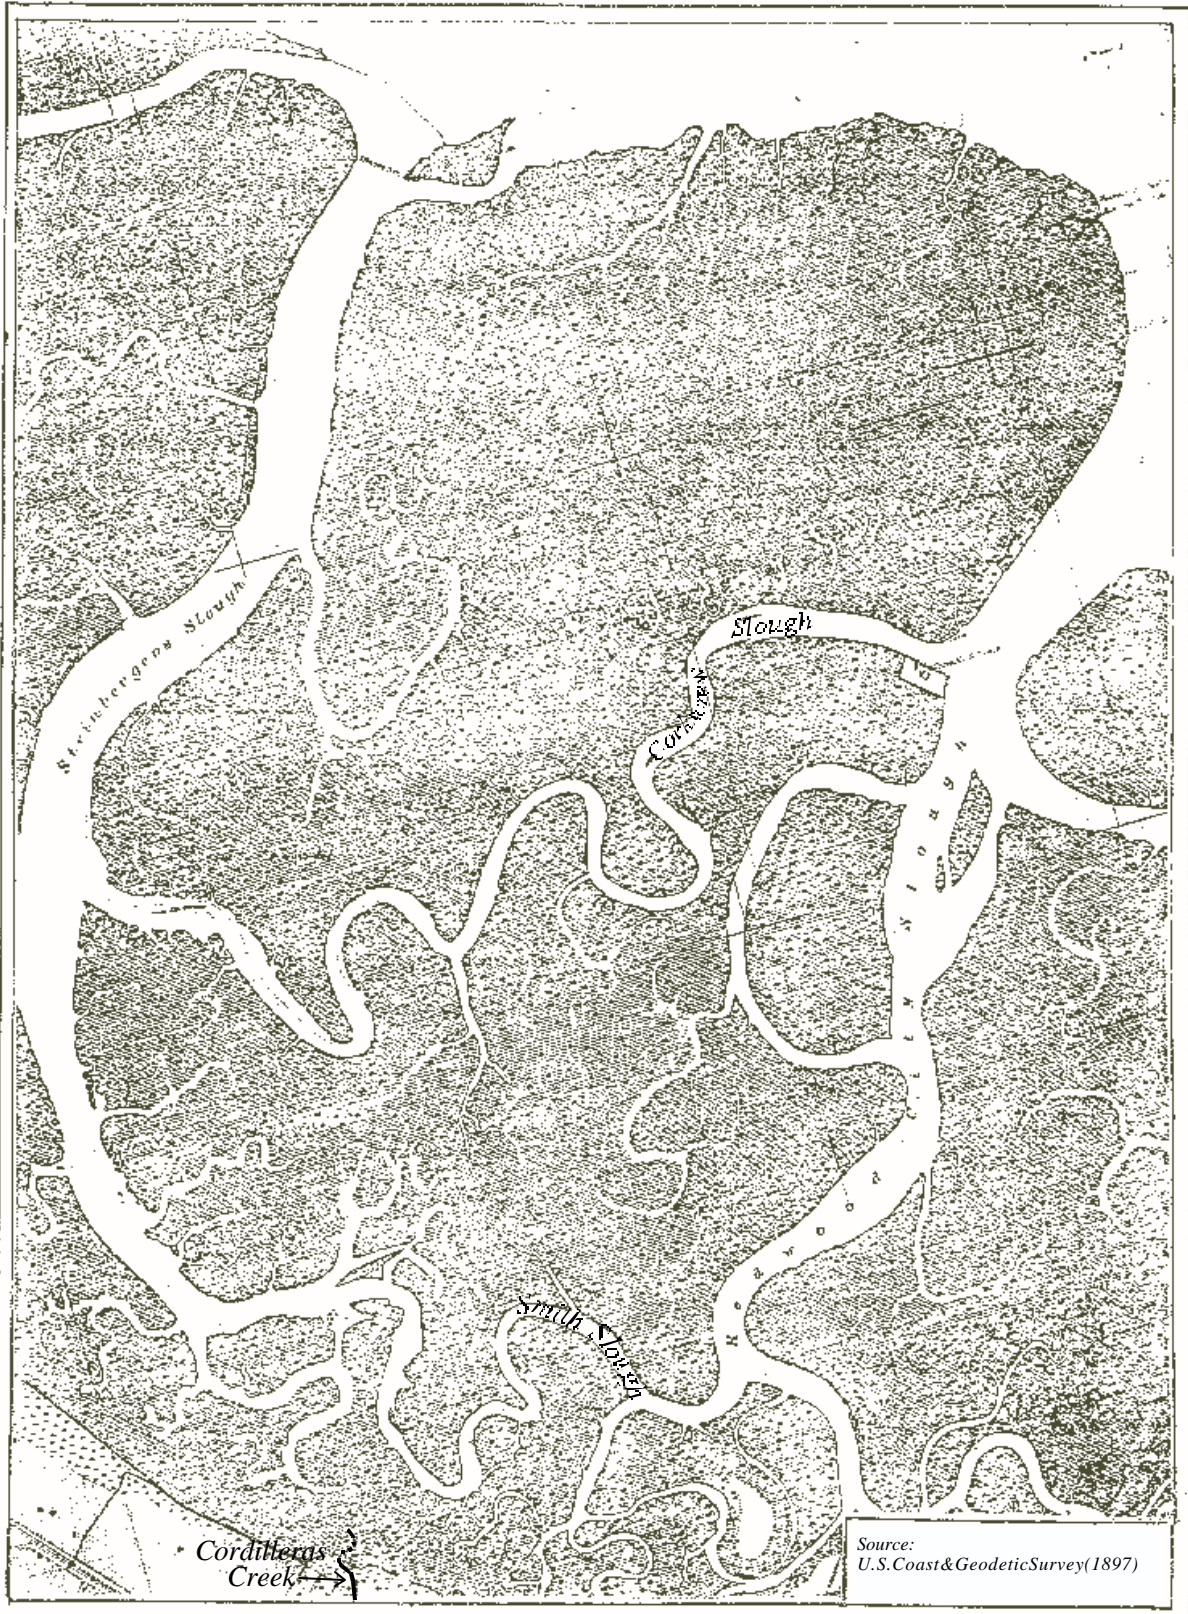
figure 4

**Bair Island
Historic Conditions, 1897**

Source:
U.S. Coast & Geodetic Survey (1897)

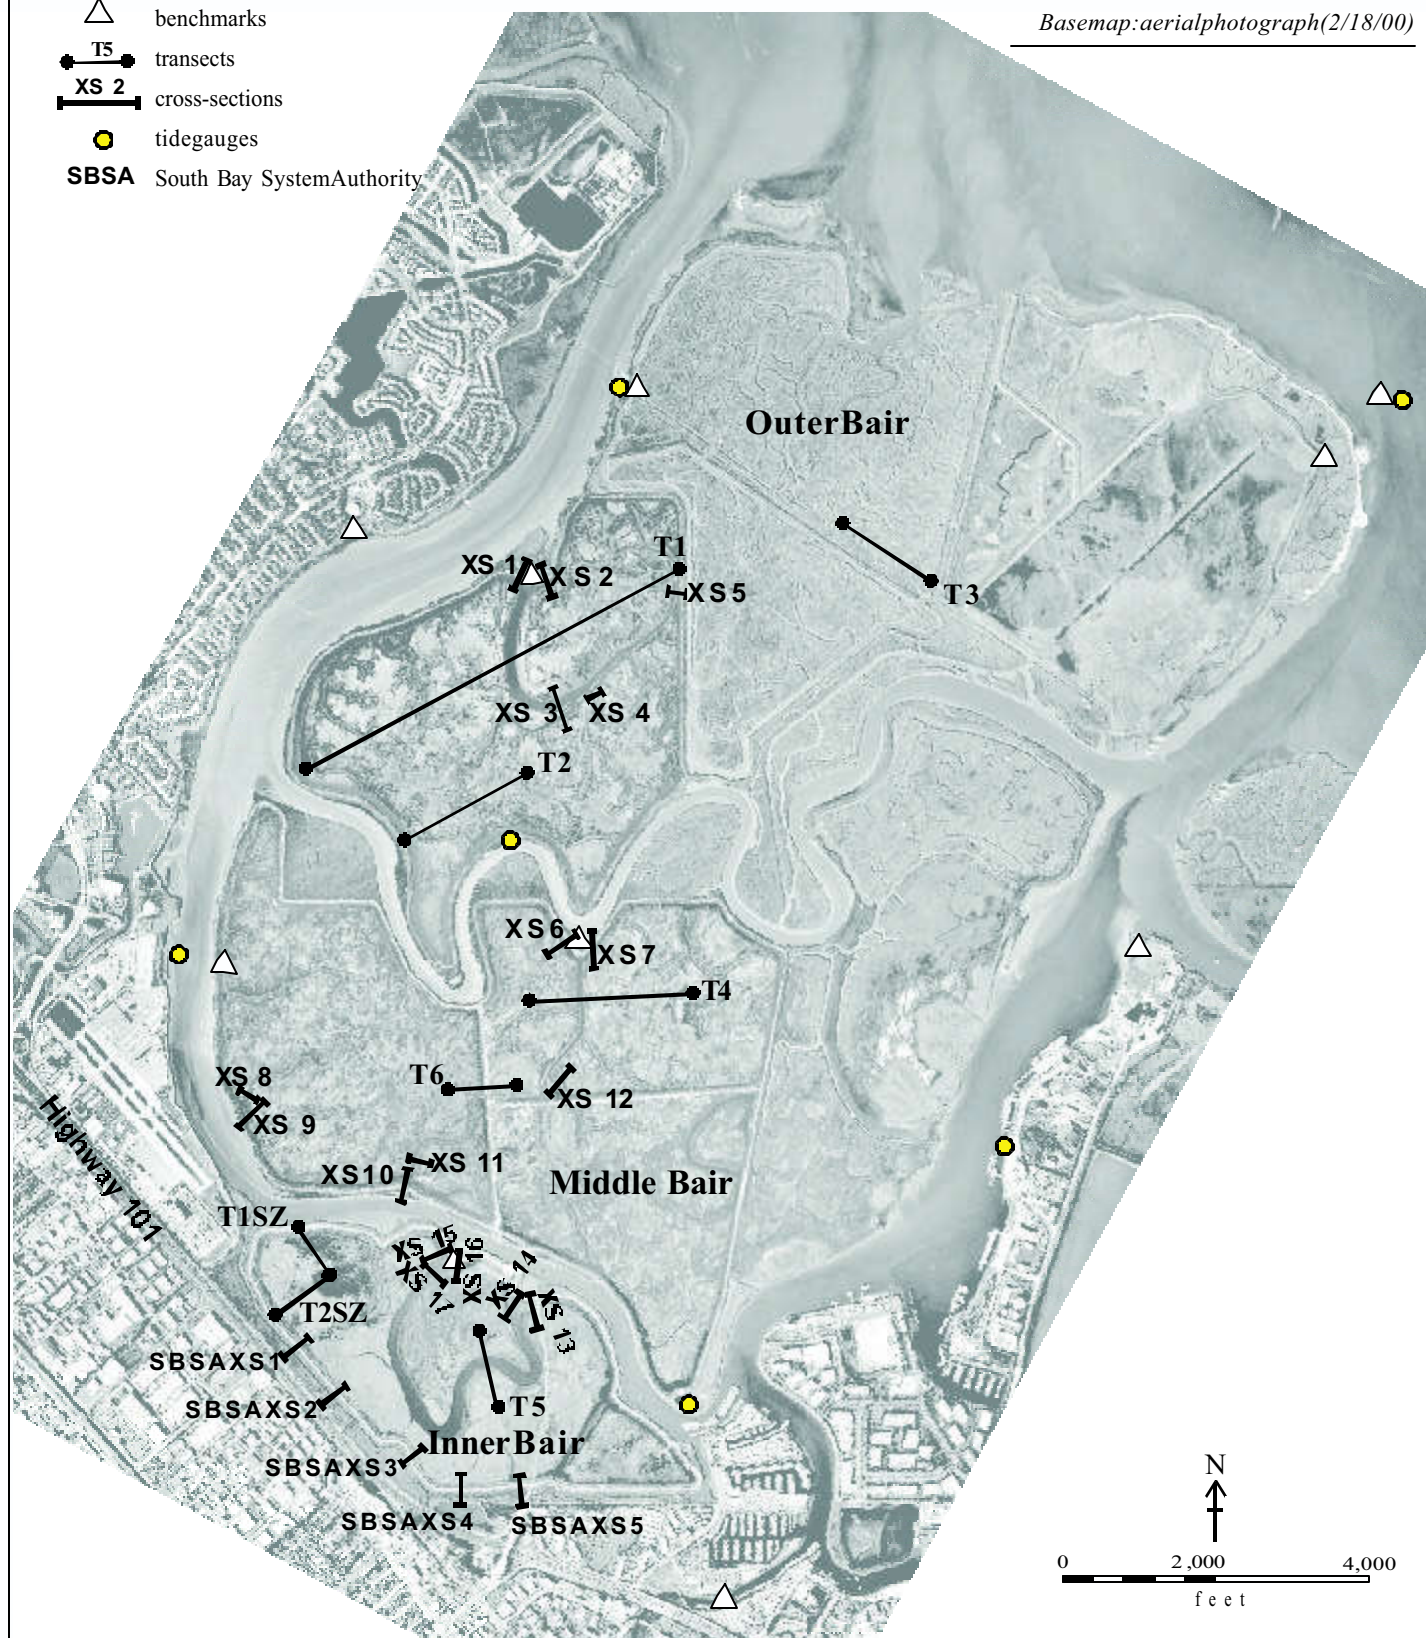
Bair Island Field Survey Locations

Basemap: aerial photograph (2/18/00)

Existing topographic information for the site consists of 1981 topographic maps of Inner and Middle Bair Islands (BKFA 1981), 1993 surveys of levee crest elevations on Inner Bair (Bohley Maley Associates, 1993), and field surveys conducted for this study. PWA surveyed elevations of marshplain transects and levee/borrow ditch cross-sections in the inactive salt pond areas of Inner, Middle, and Outer Bair Islands in February through April, 2000 (locations shown in Figure 8).

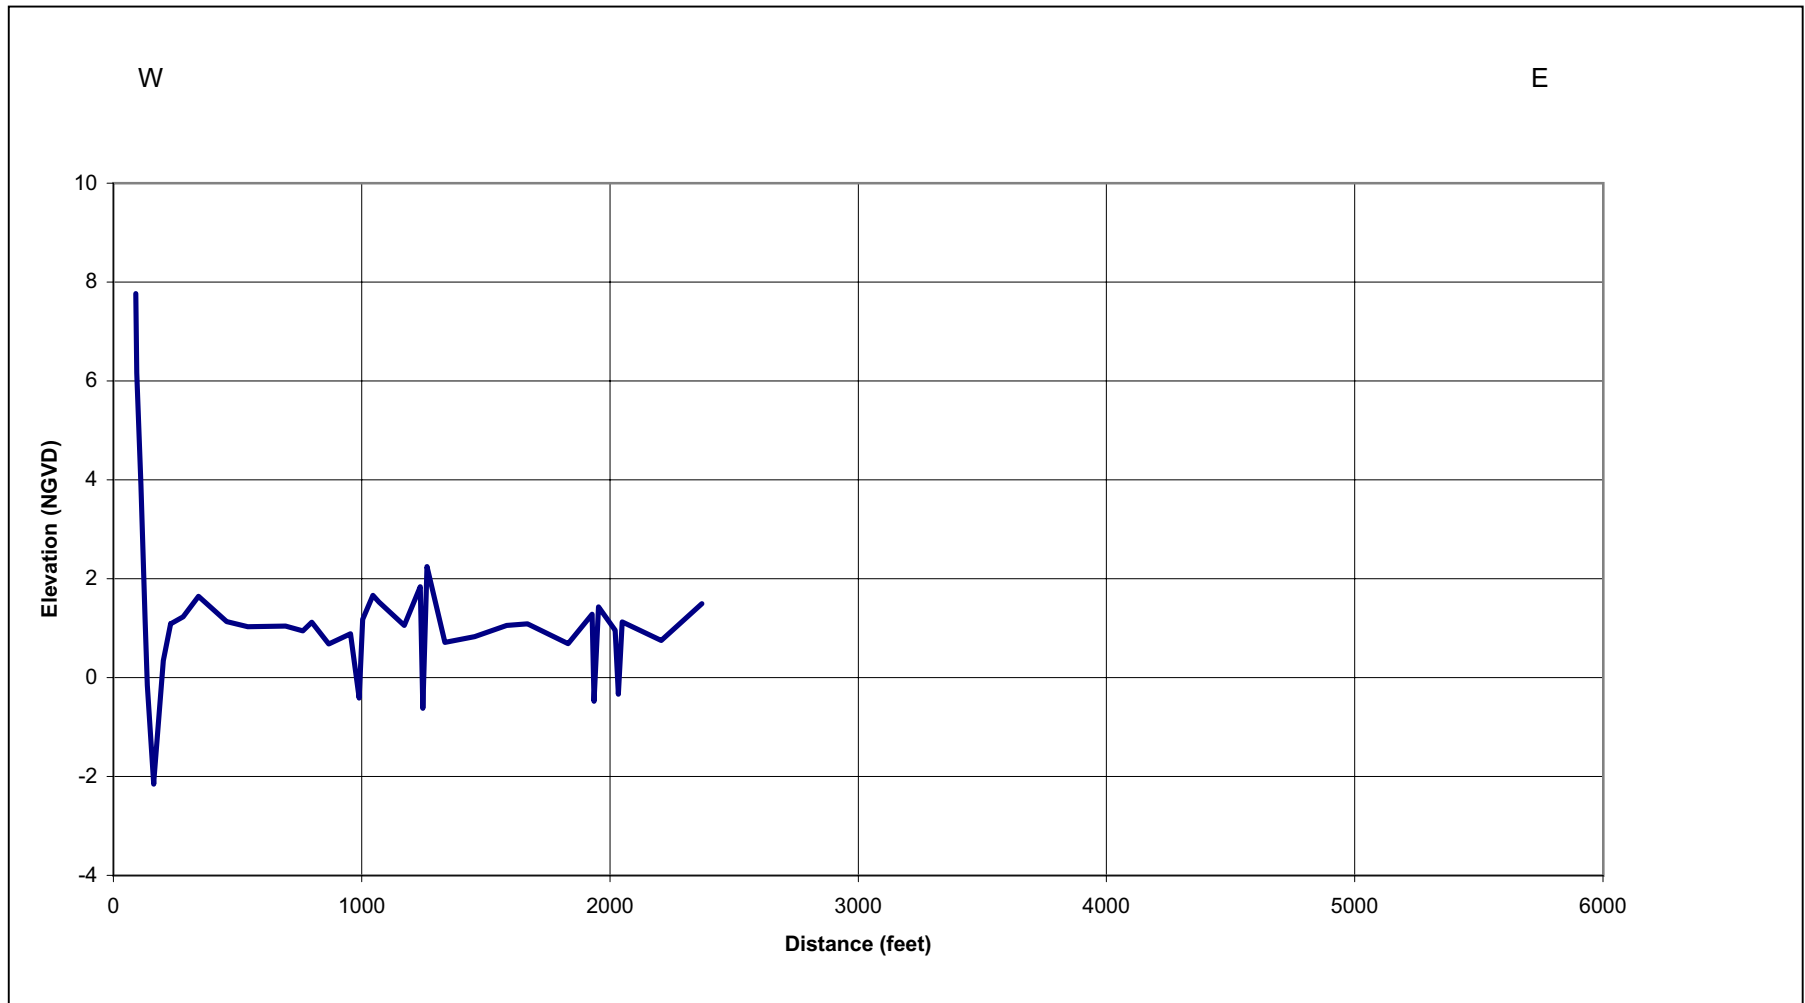
A-1 Topographic transects T1 through T6 and Safety Zone transect

Source: PWA field surveys (July 2000).

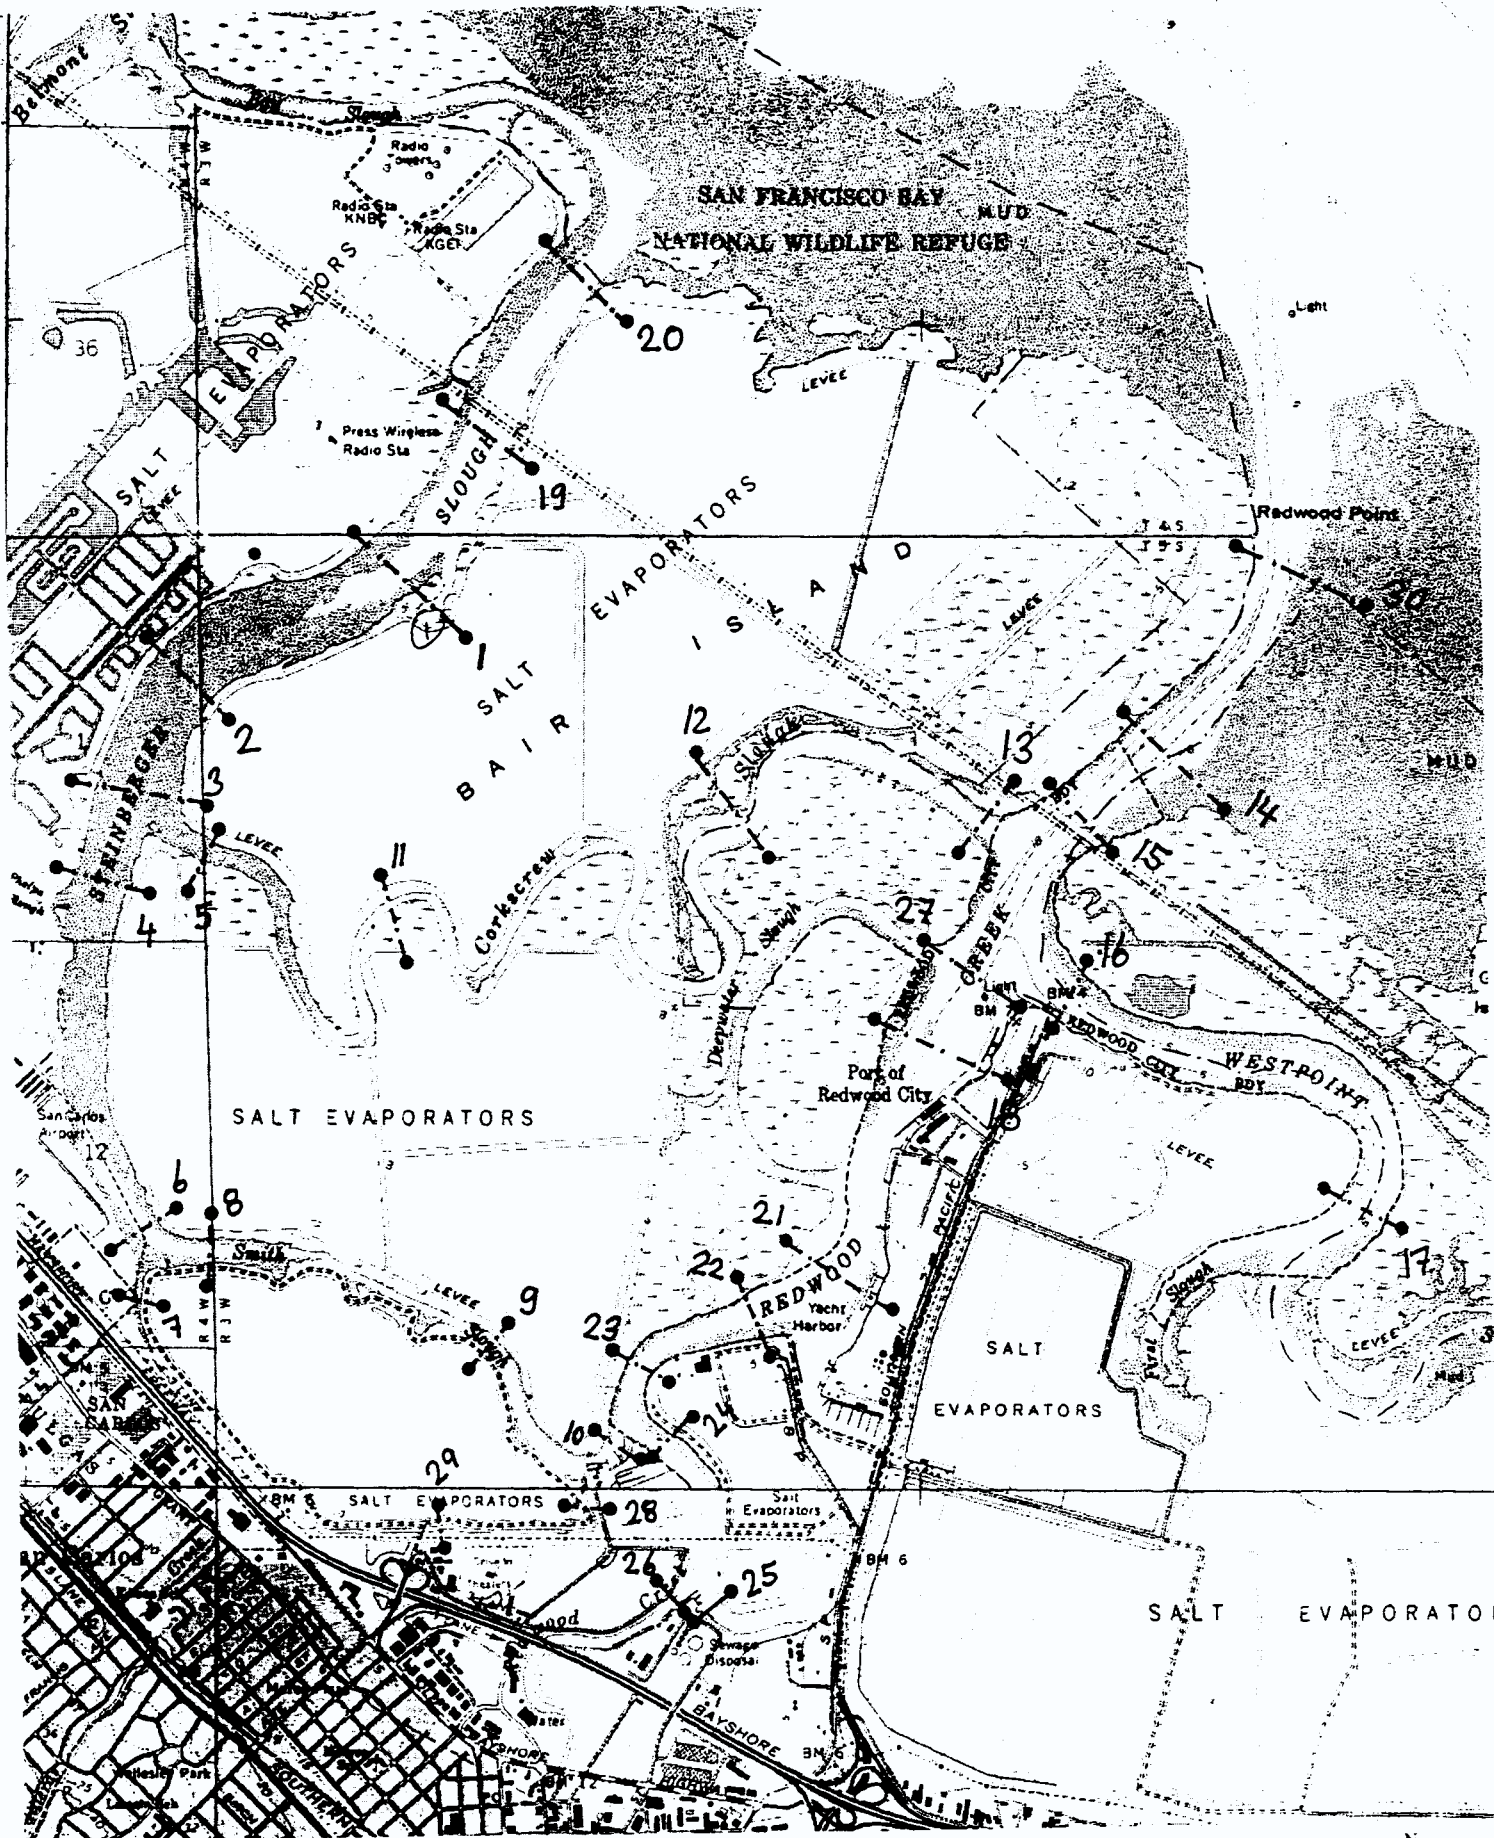
A-4 Hydrographic cross-sections in the major slough channels: location map and cross-sections 1 through 30
