Existing Biological Conditions Report

**BAIR ISLAND RESTORATION
AND MANAGEMENT PLAN:
EXISTING BIOLOGICAL CONDITIONS**

July 05, 2000

Project Number 1697-01

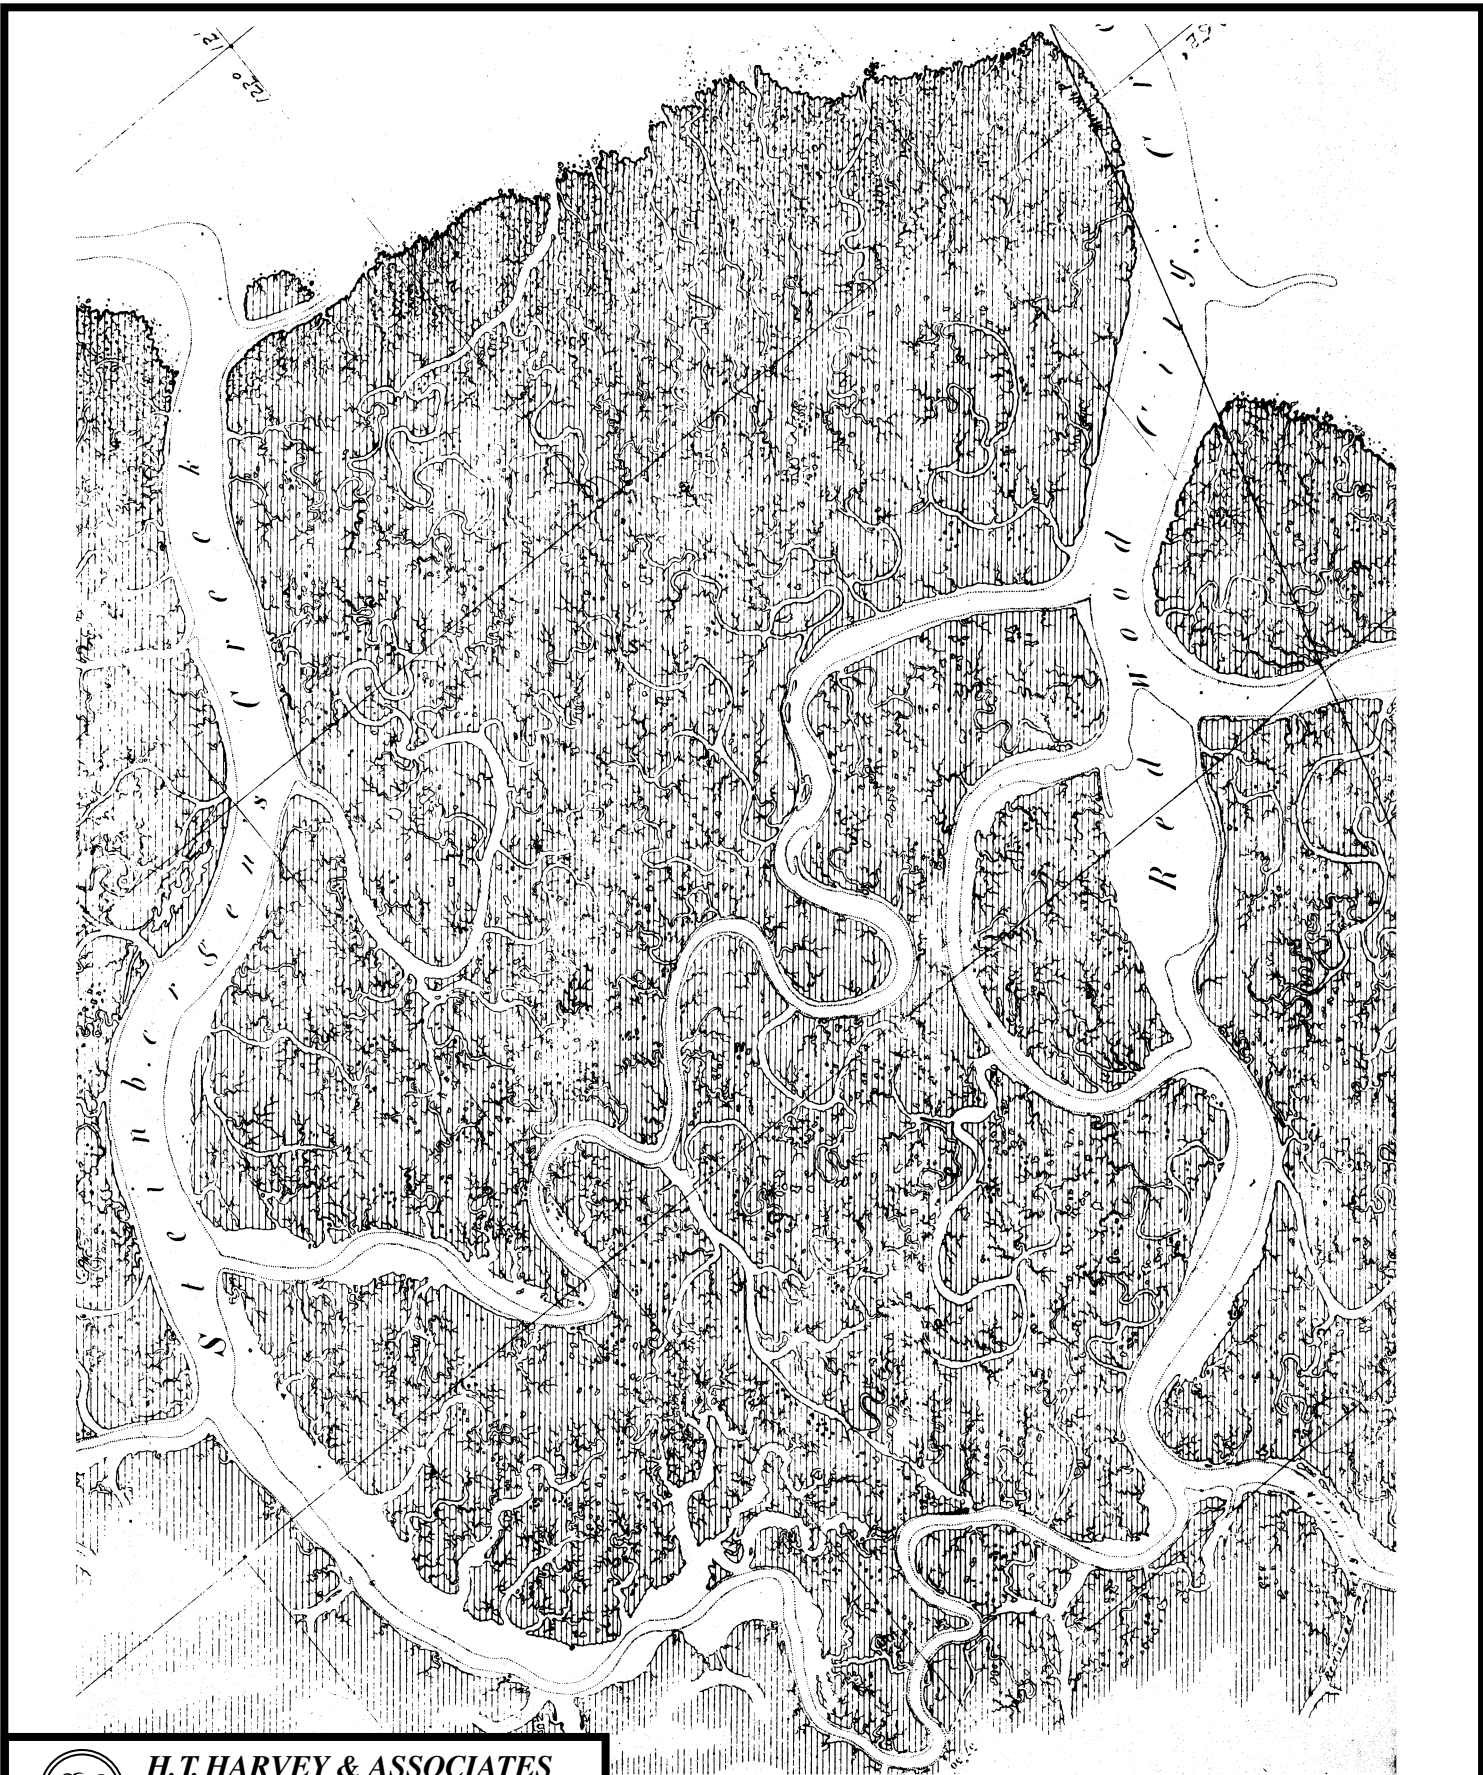
File No. 1697-01	Date 6/30/00	Figure 1
------------------	--------------	----------

**Bair Island Existing Biological Conditions:
 Vicinity Map**

Bair Island is a former tidal salt marsh that is located adjacent to the San Francisco Bay in Redwood City, San Mateo County, California (Figure 1). Due to considerable natural and anthropogenic changes, the Bair Island complex consists of a mosaic of habitats, including tidal salt marsh, mud flats, seasonal wetlands, former diked salt ponds and uplands created from the disposal of dredged material. Bair Island is divided into three distinct areas separated by slough channels: Inner, Middle and Outer Bair (Figure 1). Inner Bair Island is connected to the mainland and can be directly accessed via Whipple Avenue. It is separated from Middle Bair by Smith Slough, which in turn is separated from Outer Bair by Corkscrew Slough (Figure 1). The project boundary for the purposes of the Restoration and Management Plan encompass the majority of Bair Island, with the exception of a portion of Middle Bair Island in the vicinity of Deepwater Slough (Figure 1). The habitats (and acreages) discussed in this document pertain only to those areas within the specified project boundaries.

Bair Island consists of three sub-areas: Inner, Middle and Outer Bair. These areas are separated by slough channels, with only Inner Bair accessible without the use of a boat (Figure 1).

Bair Island is largely surrounded by water, with the exception of Inner Bair, which is accessible to pedestrians from Whipple Avenue. Bair Island is bordered to the west by Steinberger Slough, to the north by San Francisco Bay, to the east by Redwood Creek, and to the south by Highway 101 (Figure 1). Inner Bair is separated from Middle Bair by Smith Slough and Middle Bair is separated from Outer Bair by Corkscrew Slough (Figure 1). The project site is characterized by tidal, muted and diked salt marsh, mud flats and salt pannes, levees and borrow ditches, as well as historic slough channels.

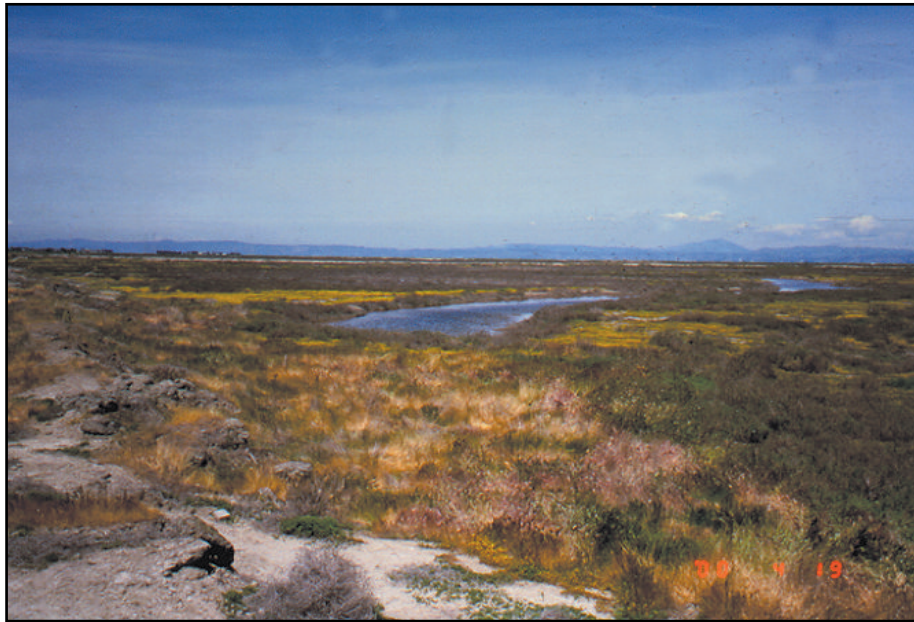
A: Degraded diked salt marsh in former salt pond A11.

- The vast majority of the project site consists of former salt ponds (Photograph A; Appendix C).
- The outboard side of the levees support bands of tidal salt marsh most of which are dominated by pickleweed (*Salicornia virginica*; Photograph B; Appendix C). All of the dominant plant species observed on site (and their wetland indicator status) can be found in the text of the report.

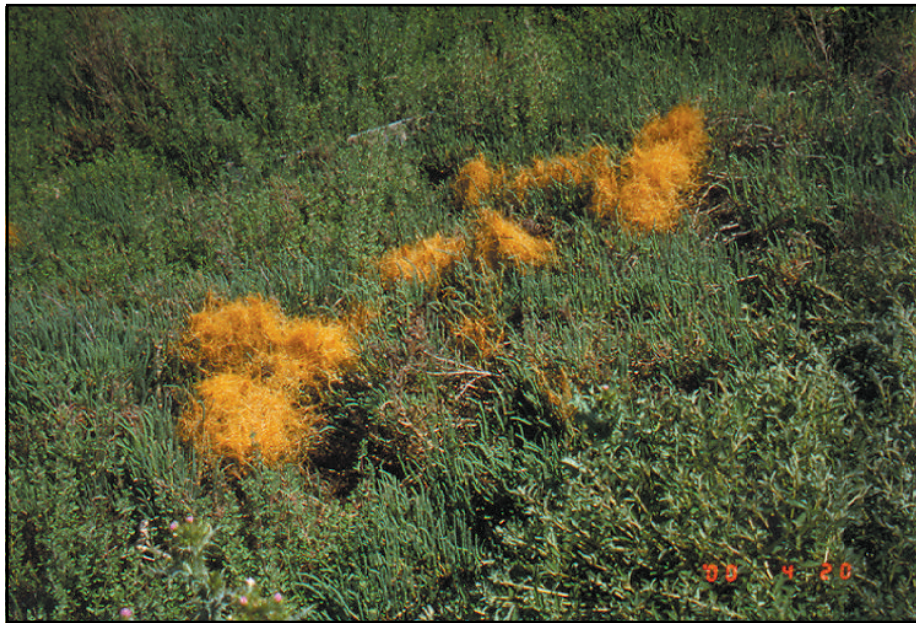
C: Salt marsh dodder.

- Much of the area within the levees appears as a degraded marsh with substantial subsidence; existing salt marsh vegetation in these areas, such as pickleweed, generally appear to have a lower vigor and are sometimes covered with salt marsh dodder (*Cuscuta salina*; Photograph C, Appendix C).
