**Island Ponds and Vicinity
Island Ponds Restoration Project**
Alameda County, California

Site Map
Island Ponds Restoration Project
 Alameda County, California

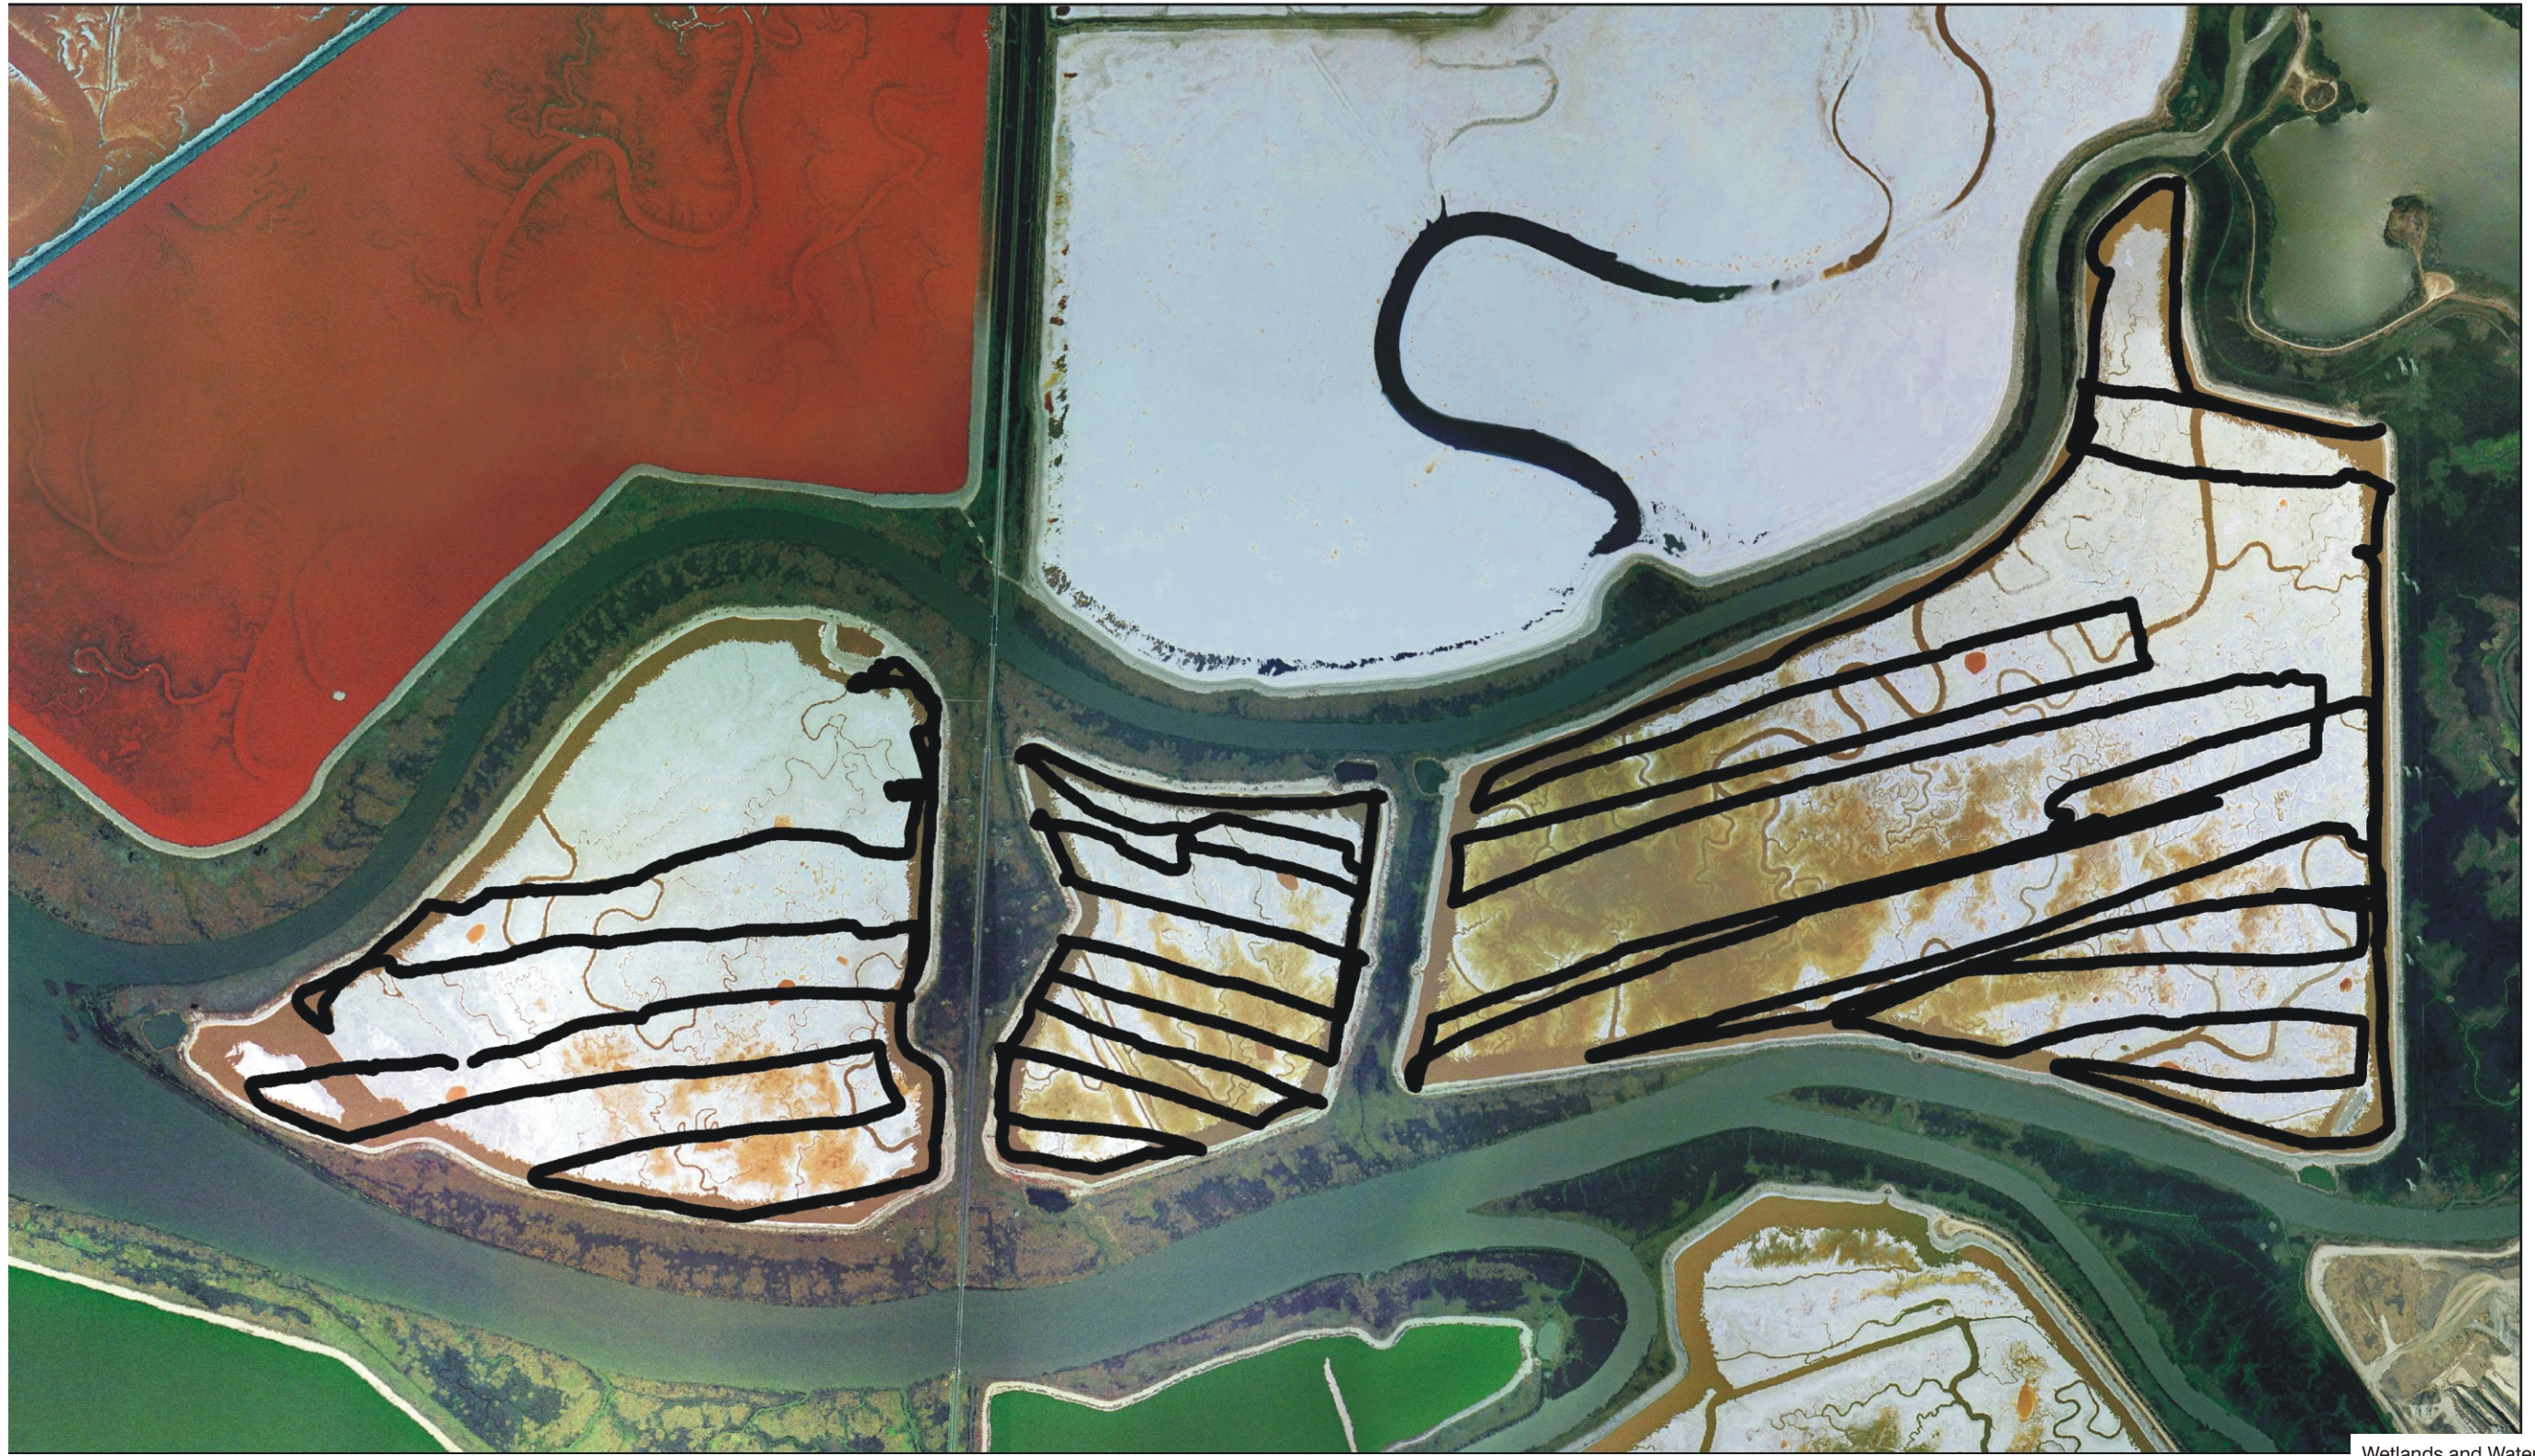
2004 USGS Island Pond Bathymetry Sampling Transects Locations
Island Ponds Restoration Project
 Alameda County, California

- Bathymetric Survey Points

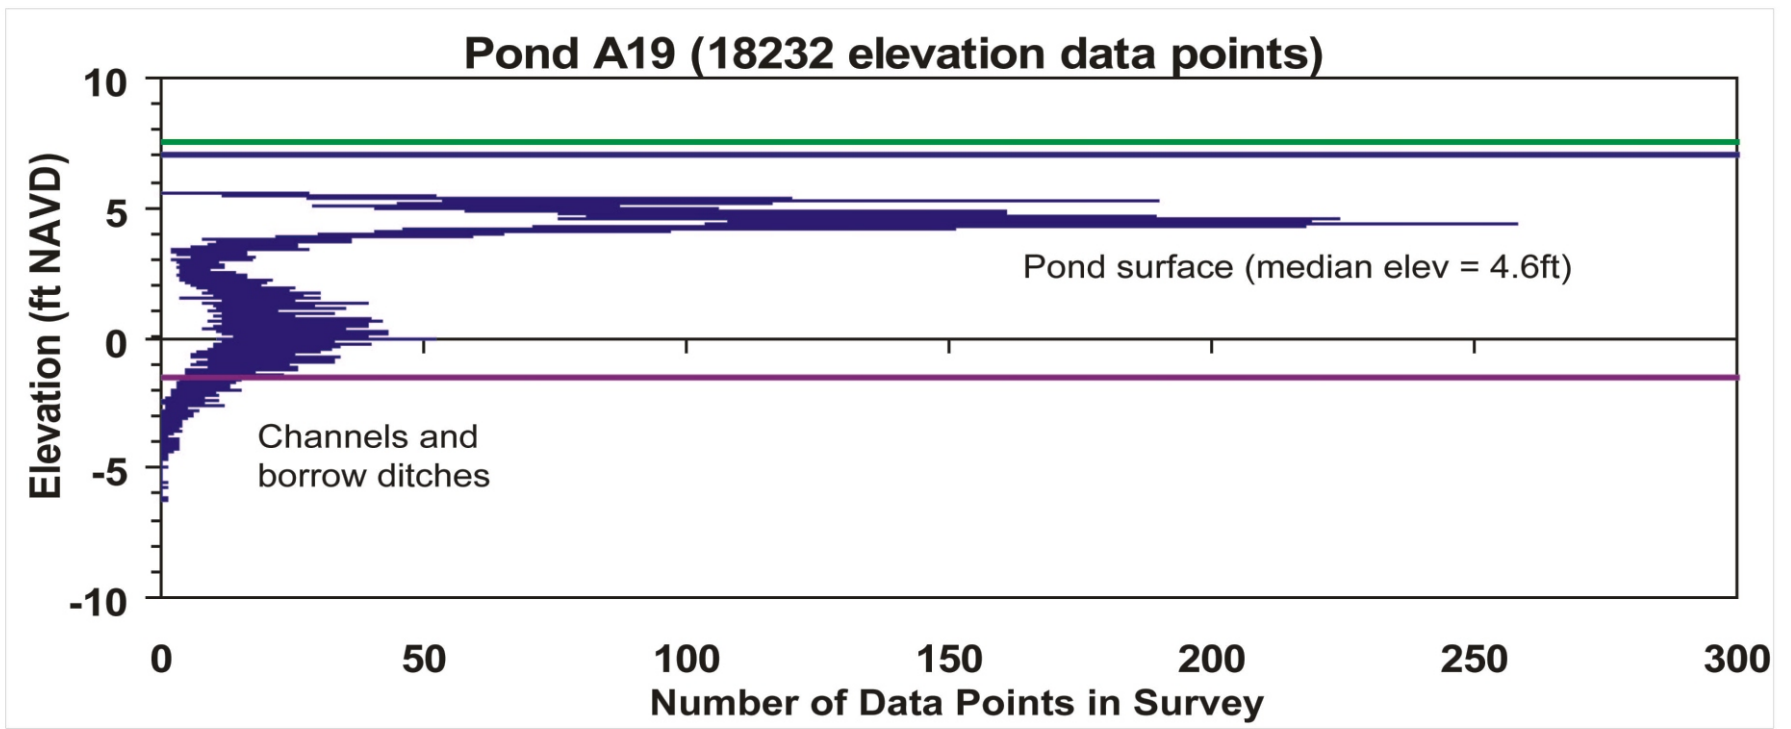
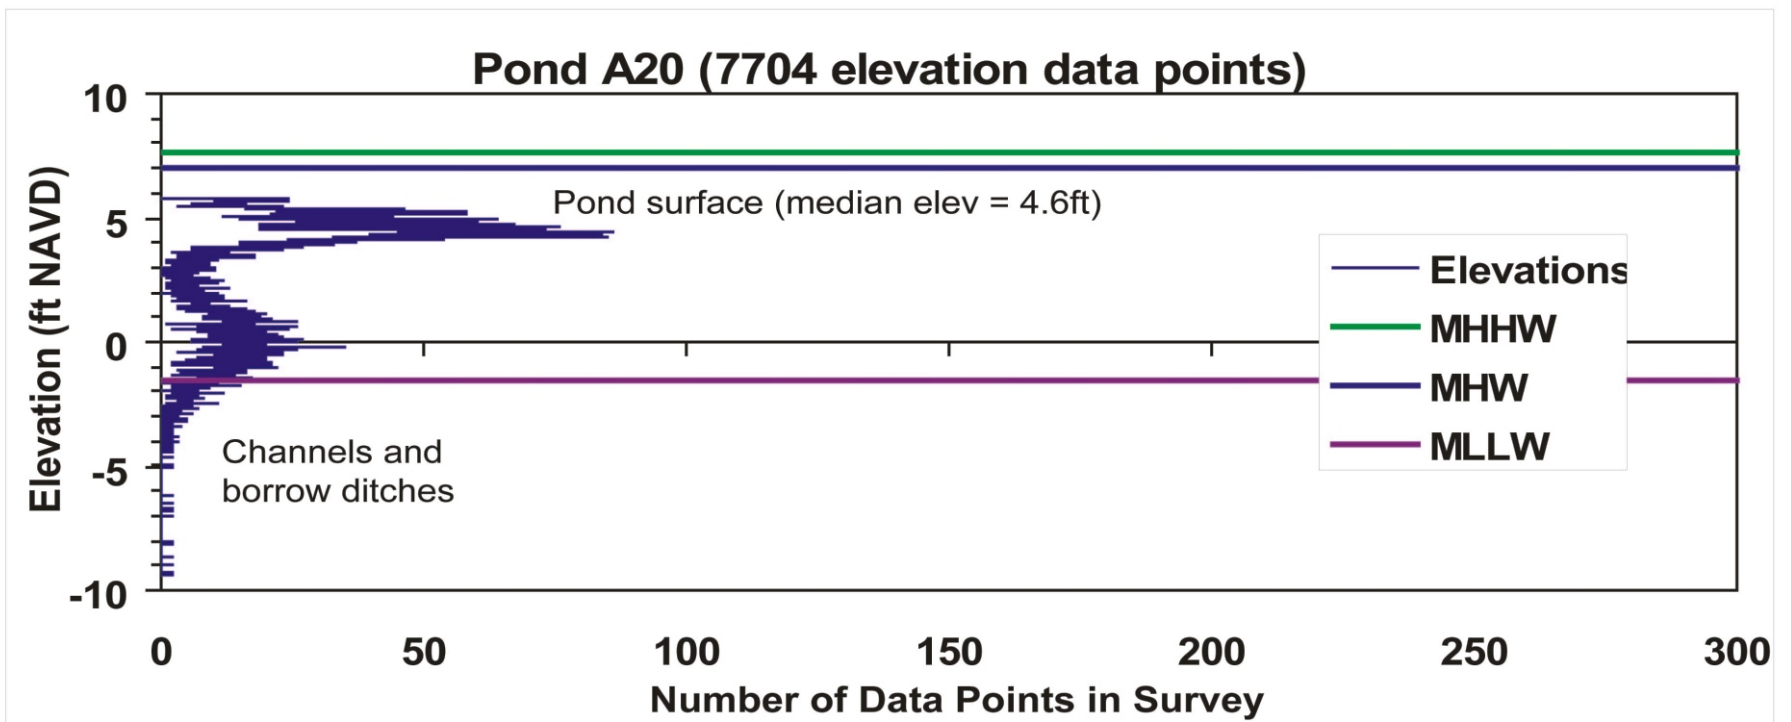
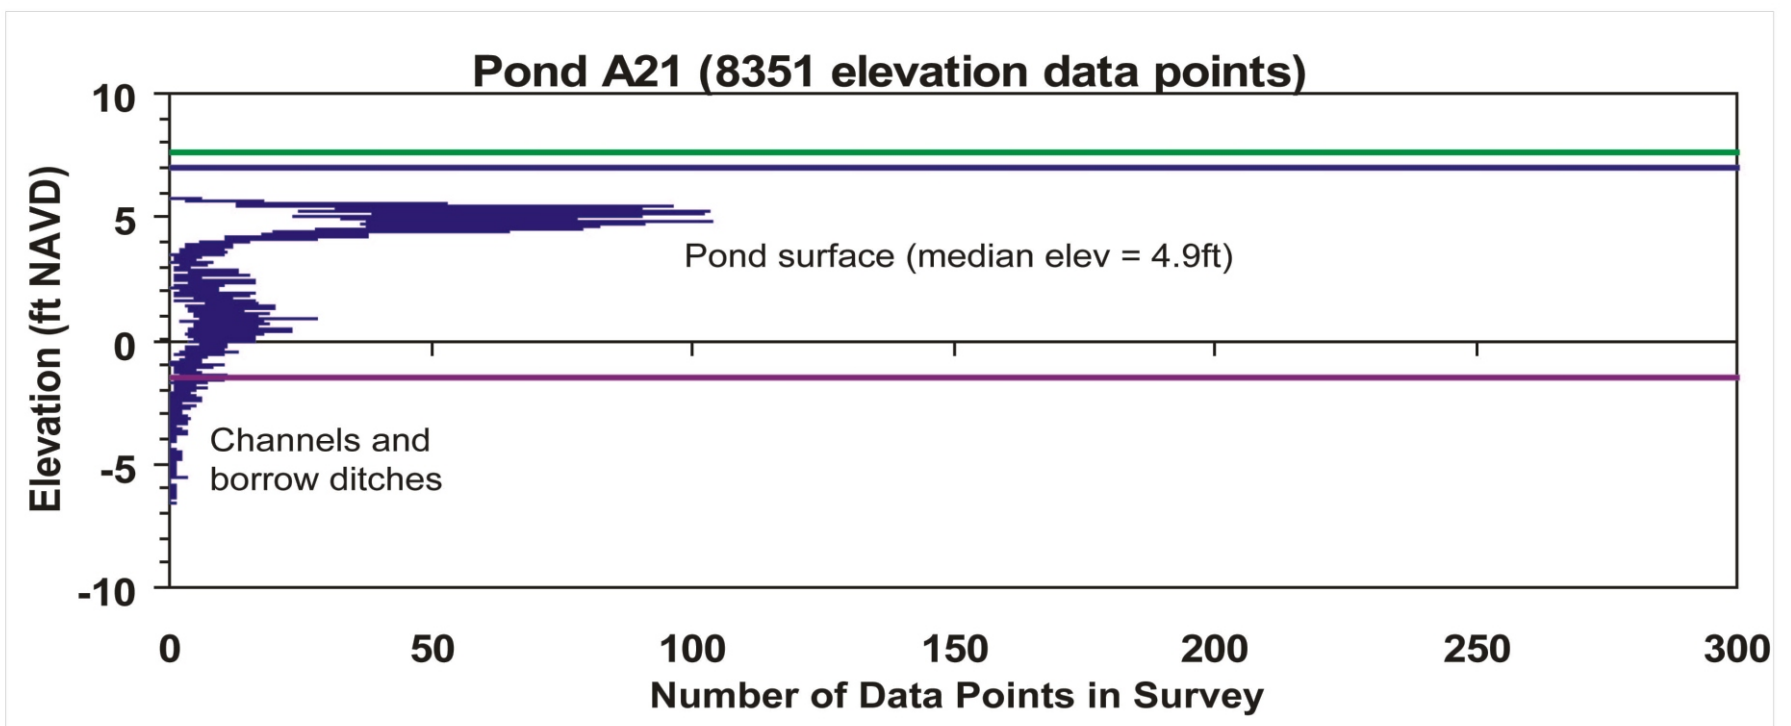
- 1) These histograms show the number of data points by elevation, which describes the elevation distribution of the pond surfaces (upper mode of each plot) and the channels and borrow ditches (lower mode of each plot). A higher number of data points at a given elevation means that a larger percent of the pond surface or channels are at the indicated elevation
- 2) Tidal datum values shown are preliminary, based on Jan-Apr 2004 Coyote Creek at UPRR crossing tide stage data from South Bay Salt Pond Restoration Project
- 3) USGS pond elevation data updated May 2005; pending reference elevation update December 2005
- 4) All data converted from NGVD29 to NAVD88 with VertCon

**Pond Elevation Data Histogram
USGS 2004 Bythemetric Surveys
Island Ponds Restoration Project**

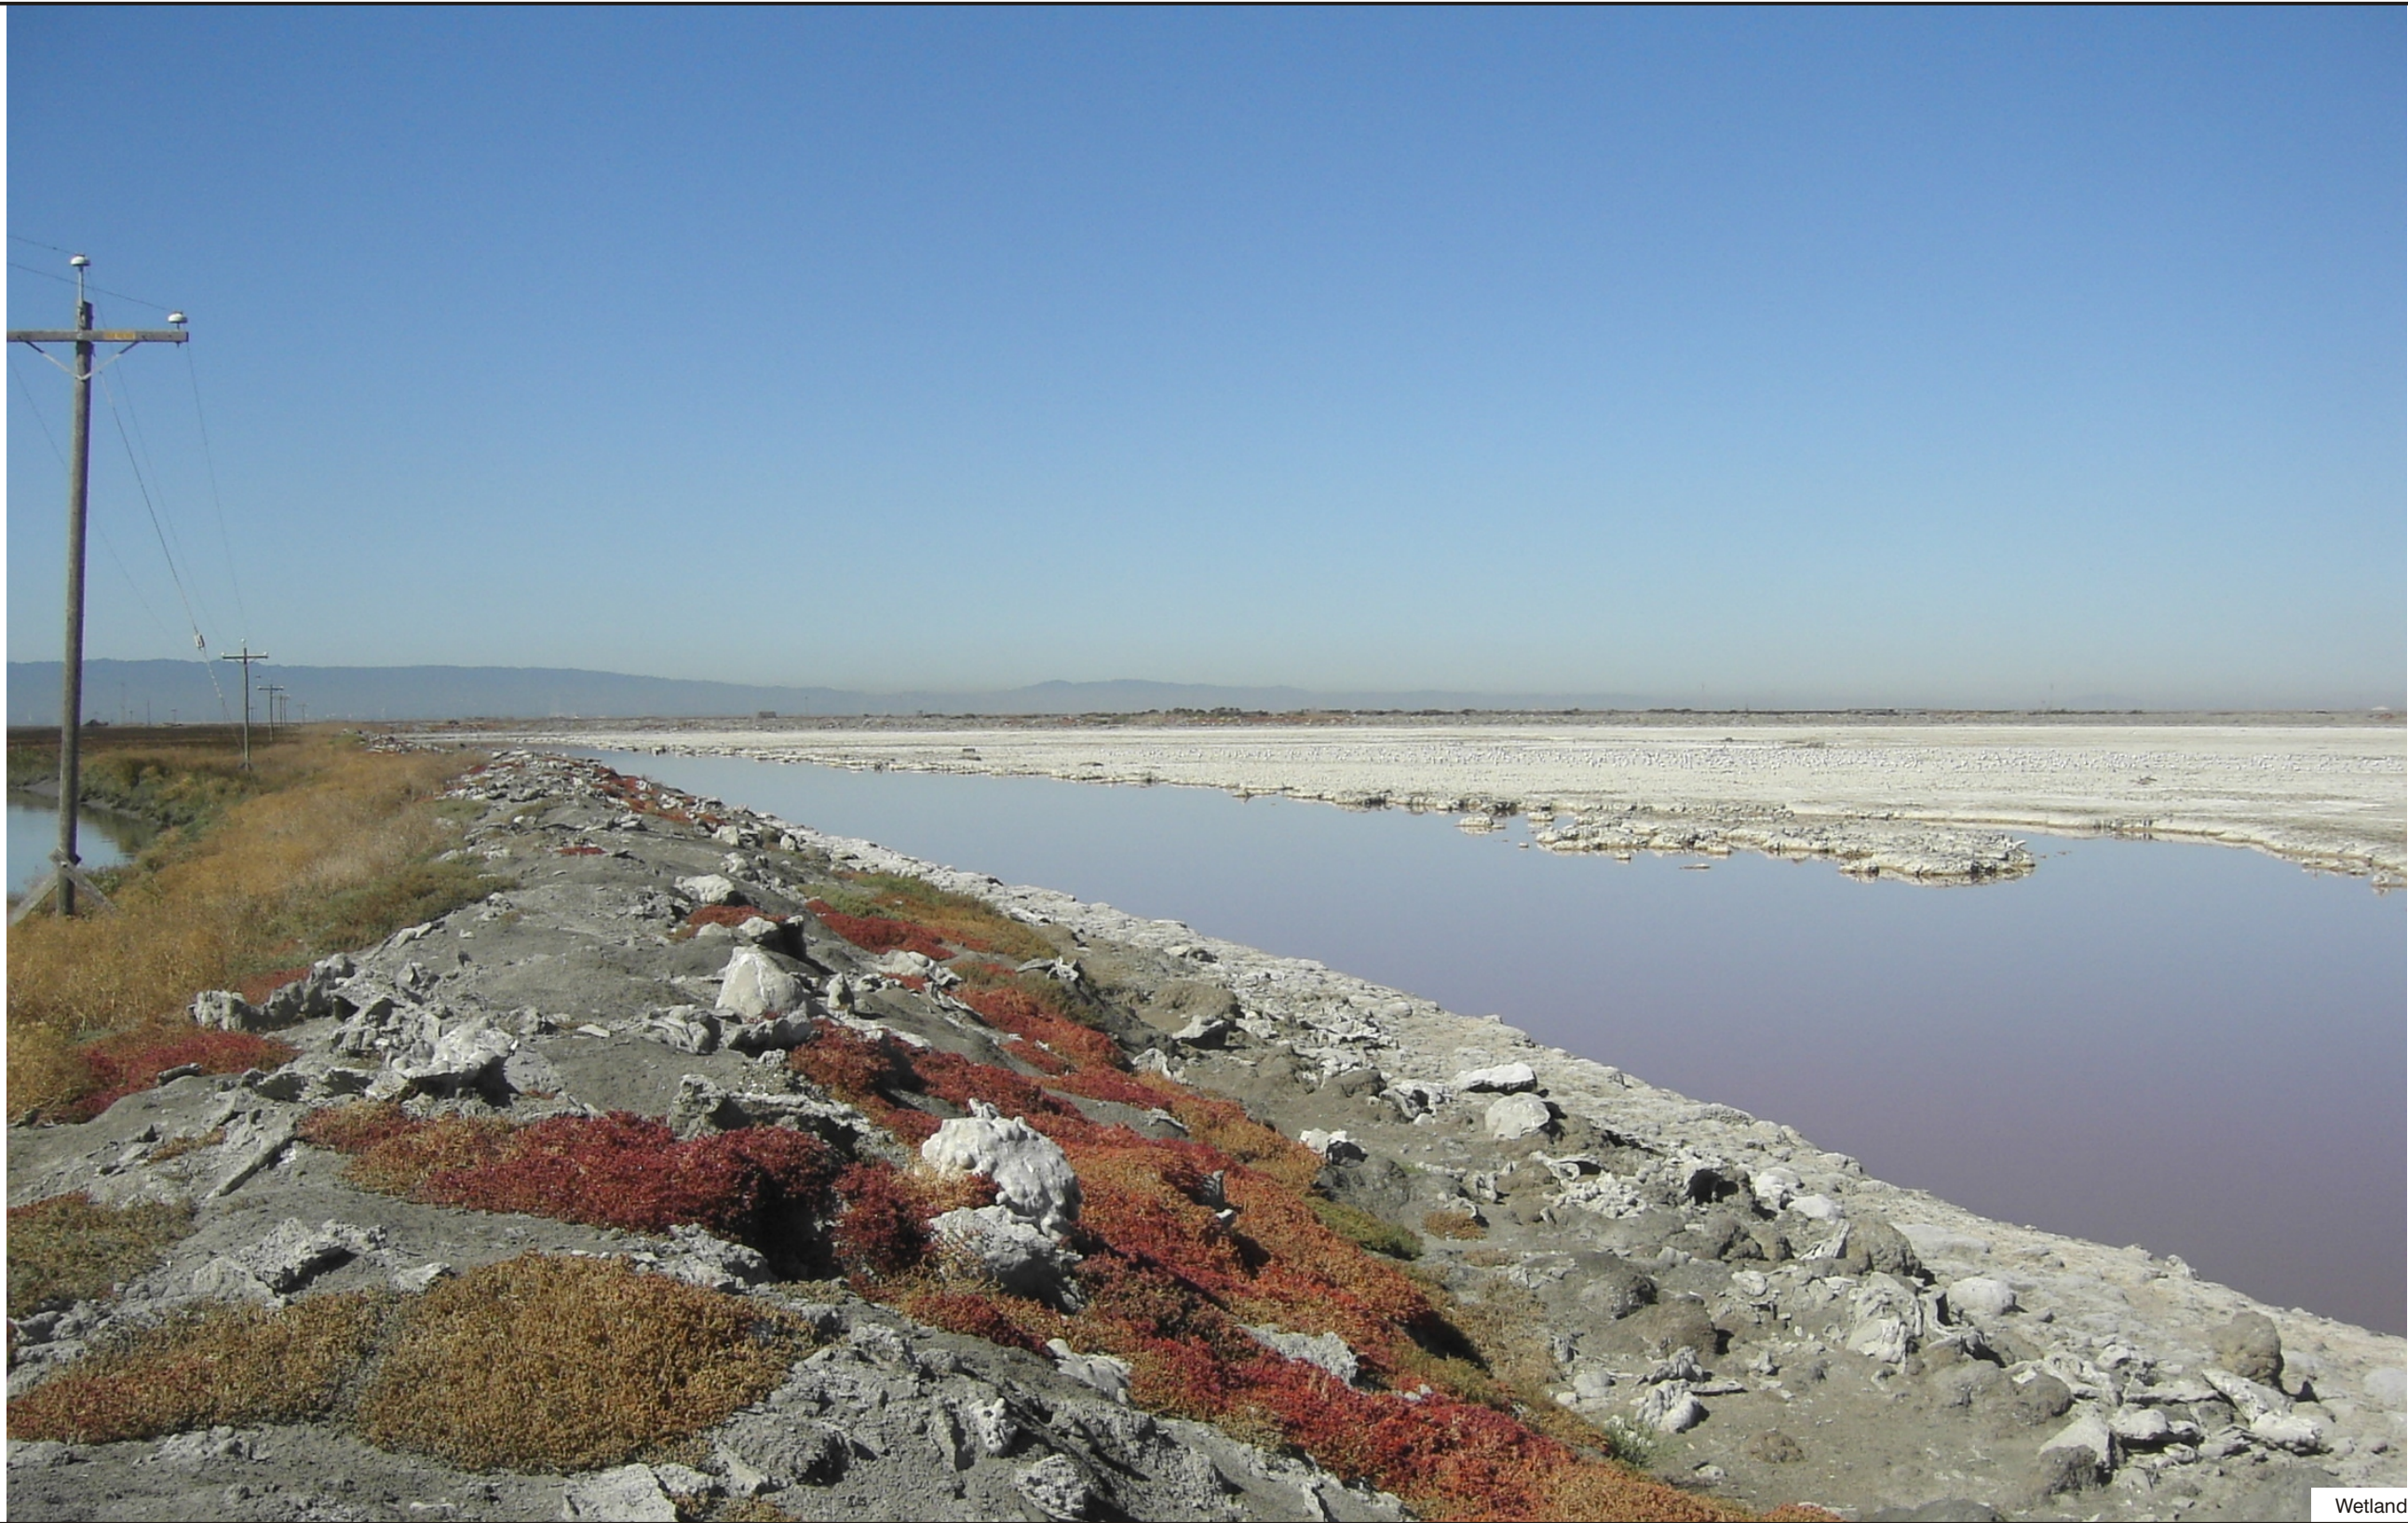
Photo from atop Pond A19 levee, October 10, 2005.
Note gypsum blocks on levee surface, from excavating borrow ditch materials during levee maintenance.
Note gypsum-covered pond surface.
Note borrow ditch between levee and pond surface. Coyote Creek on left.

Gypsum on Levee and Pond Surface
Island Ponds Restoration Project
Alameda County, California
