**ISLAND PONDS MITIGATION MONITORING
AND REPORTING
YEAR 2- 2007**

Santa Clara Valley Water District
U.S. Fish and Wildlife Service - Don Edwards National Wildlife Refuge
H.T. Harvey & Associates
Philip Williams & Associates, Ltd.

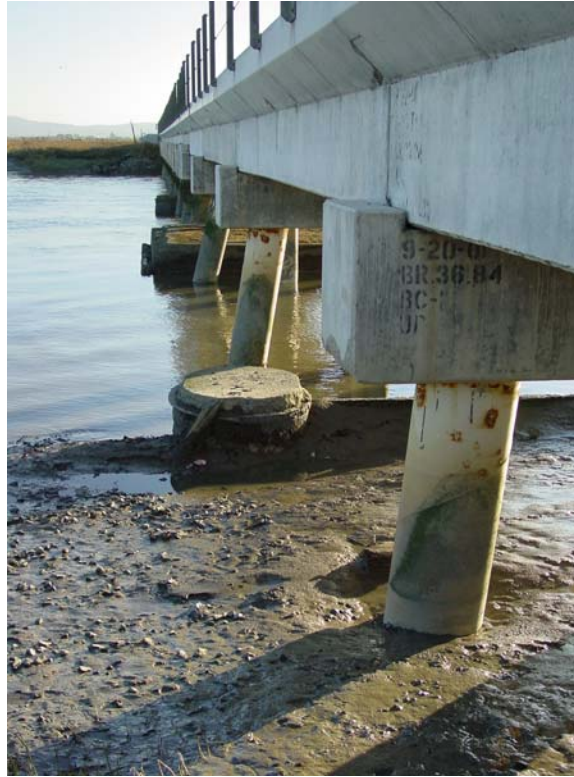
Photo 1. East Side of Bridge Looking South. Pile 1N-C in foreground – November 29, 2006

- The rail bridge scour photographs document only the piles located at the highest intertidal edges of Coyote Creek. Since the largest increase in tidal velocity, due to an increase in upstream tidal prism, would likely take place through the deepest part of the channel, the current method of collecting photographs above the waterline is inadequate to assess the condition of the subtidal piles. Therefore, we recommend that a meeting with railroad staff be scheduled to discuss whether or not there is a need for subtidal data collection. If it is determined that additional data is necessary, a subsequent meeting will be scheduled between the District and Refuge staff to determine appropriate actions and responsibilities.

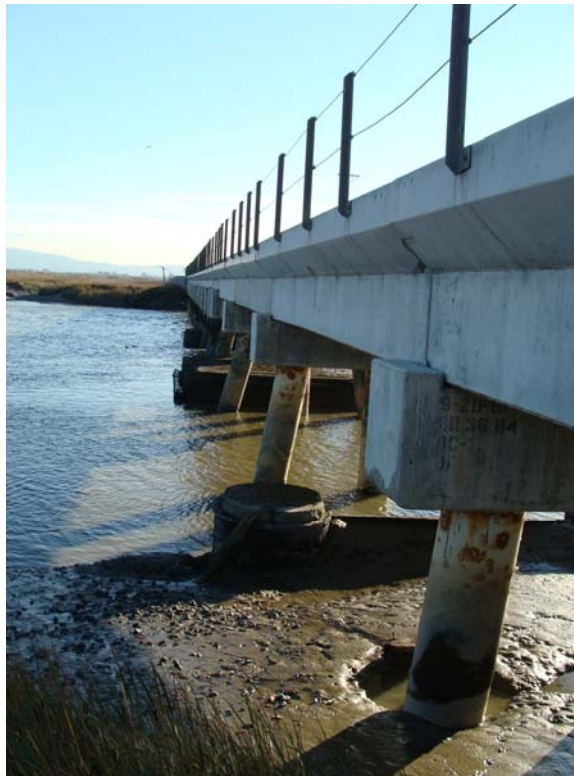
Photo 2. East Side of Bridge Looking South. Pile 1N-C in foreground – November 21, 2007

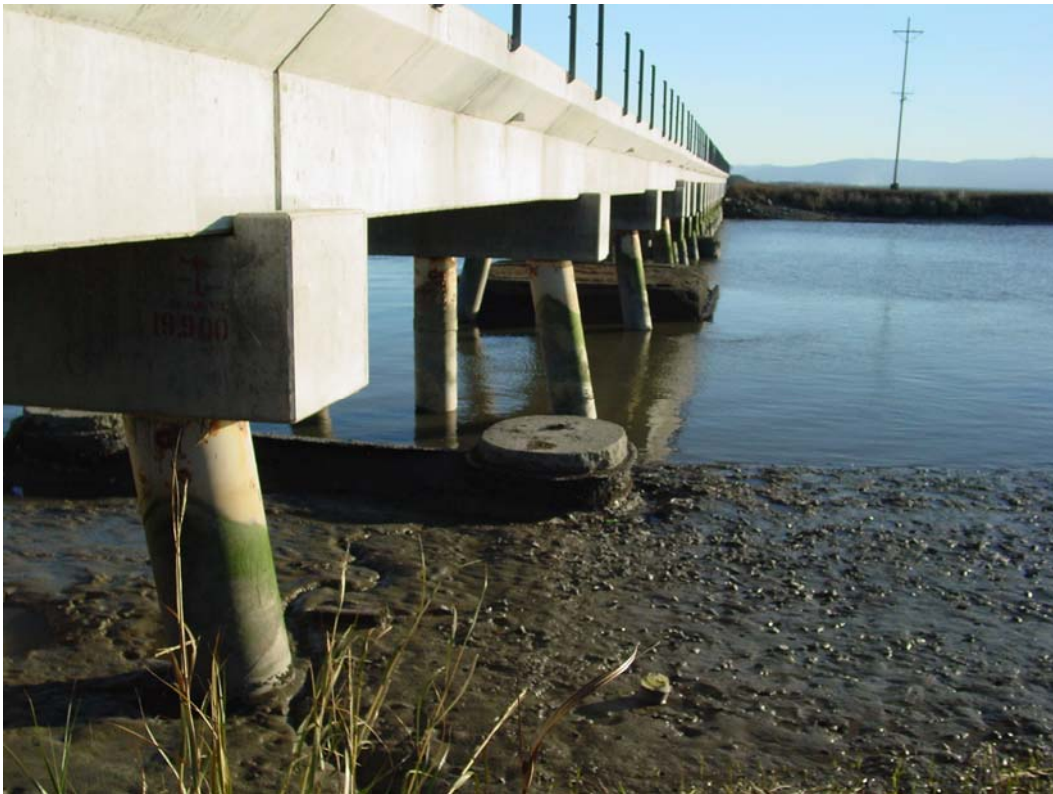
Photo 3. West Side of Bridge Looking South. Pile 1N-A in foreground – November 29, 2006

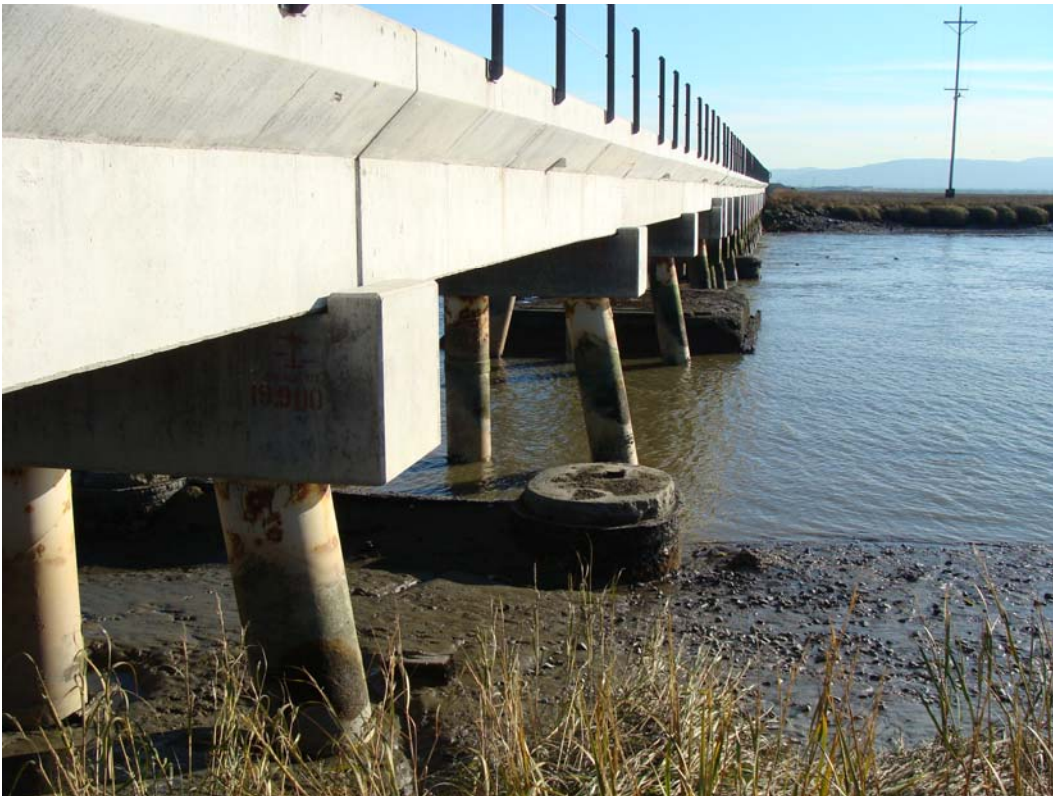
Photo 4. West Side of Bridge Looking South. Pile 1N-A in foreground – November 21, 2007

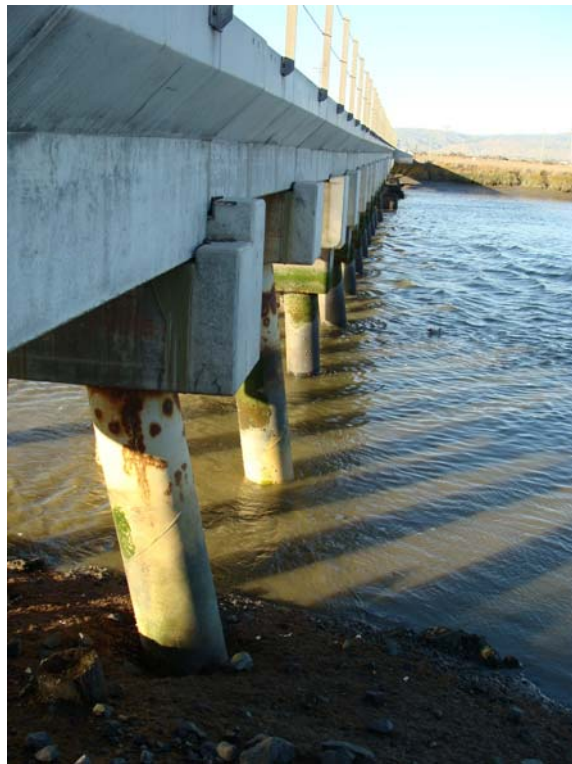
Photo 8. East Side of Bridge Looking North. Pile 1S-C in foreground – November 21, 2007

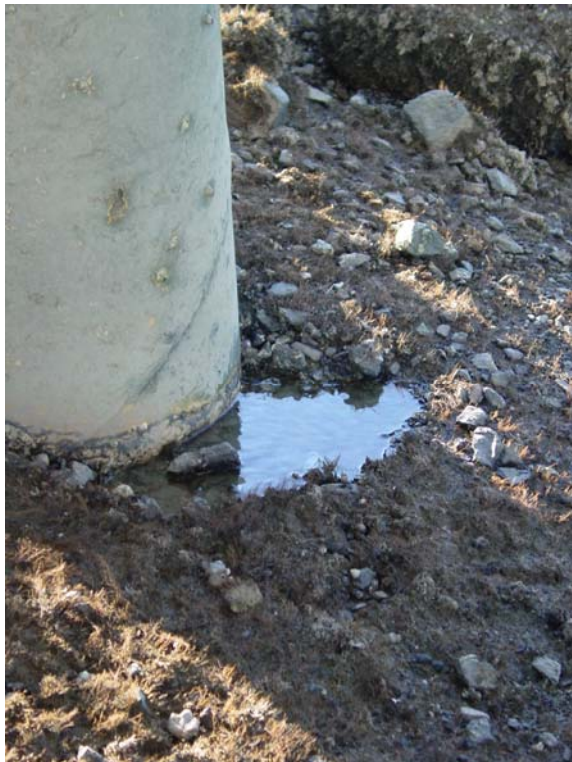
Photo 9. Close-up of pile 1S-A – November 29, 2006

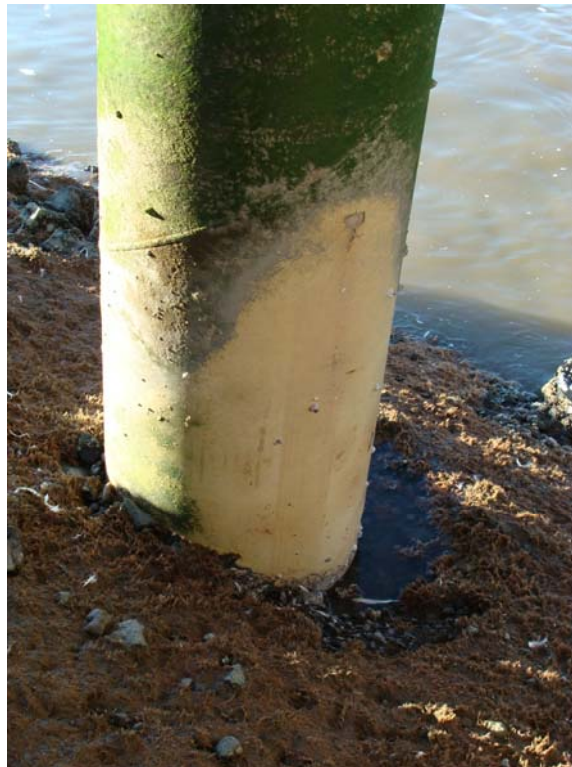
Photo 10. Close-up of pile 1S-A – November 21, 2007

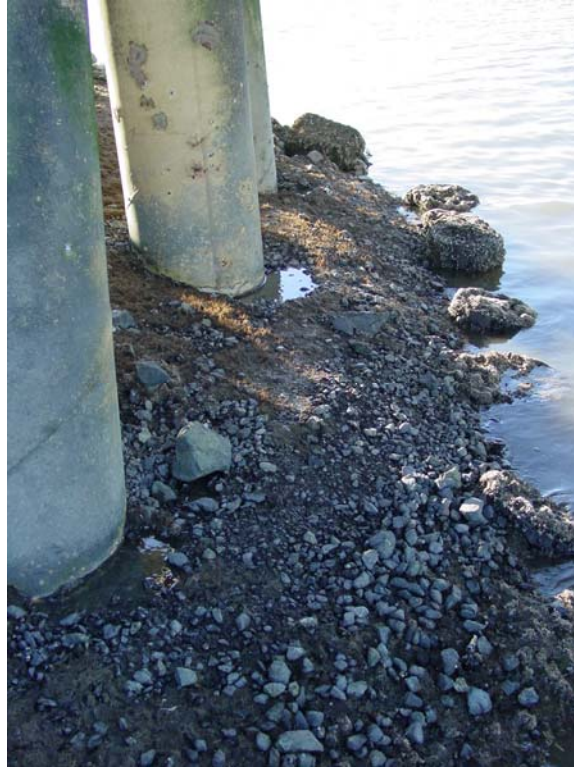
Photo 11. Close-up of piles 1S-C (foreground), 1S-B (centre), and 1S-A – November 29, 2006

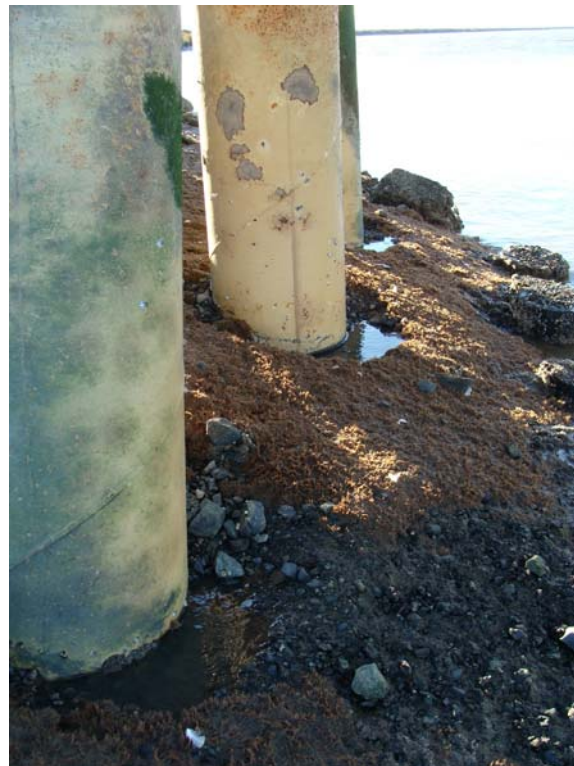
Photo 12. Close-up of piles 1S-C (foreground), 1S-B (centre), and 1S-A – November 21, 2007

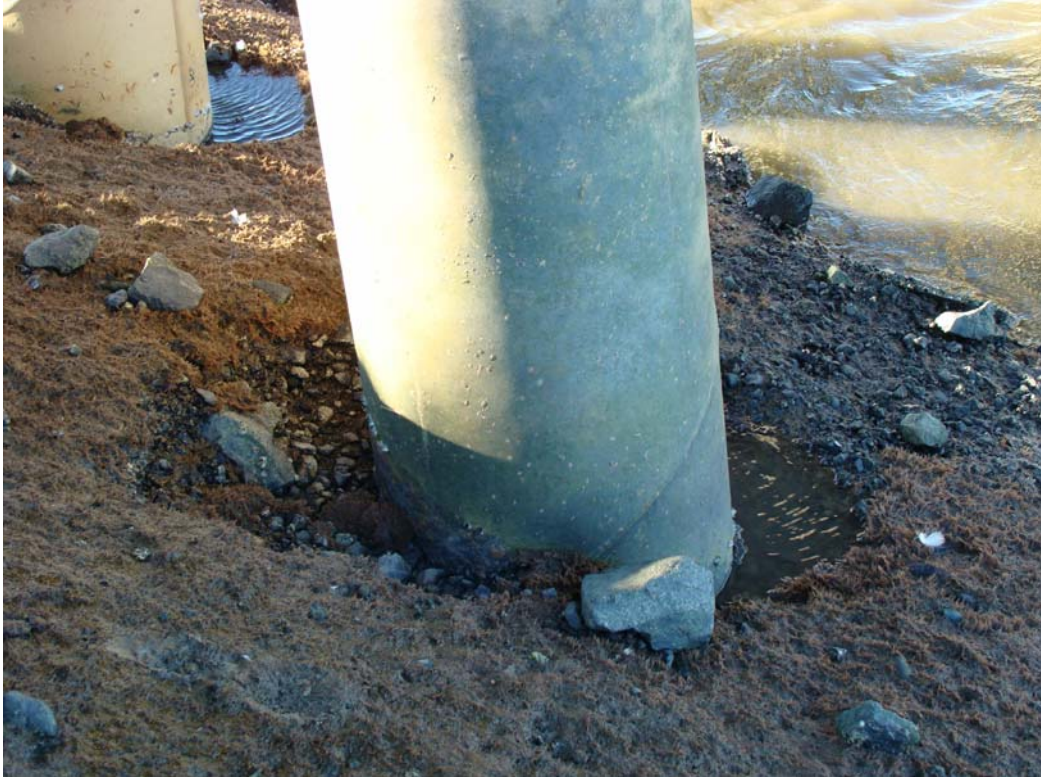
Photo 13. Close-up of pile 1S-C – November 21, 2007

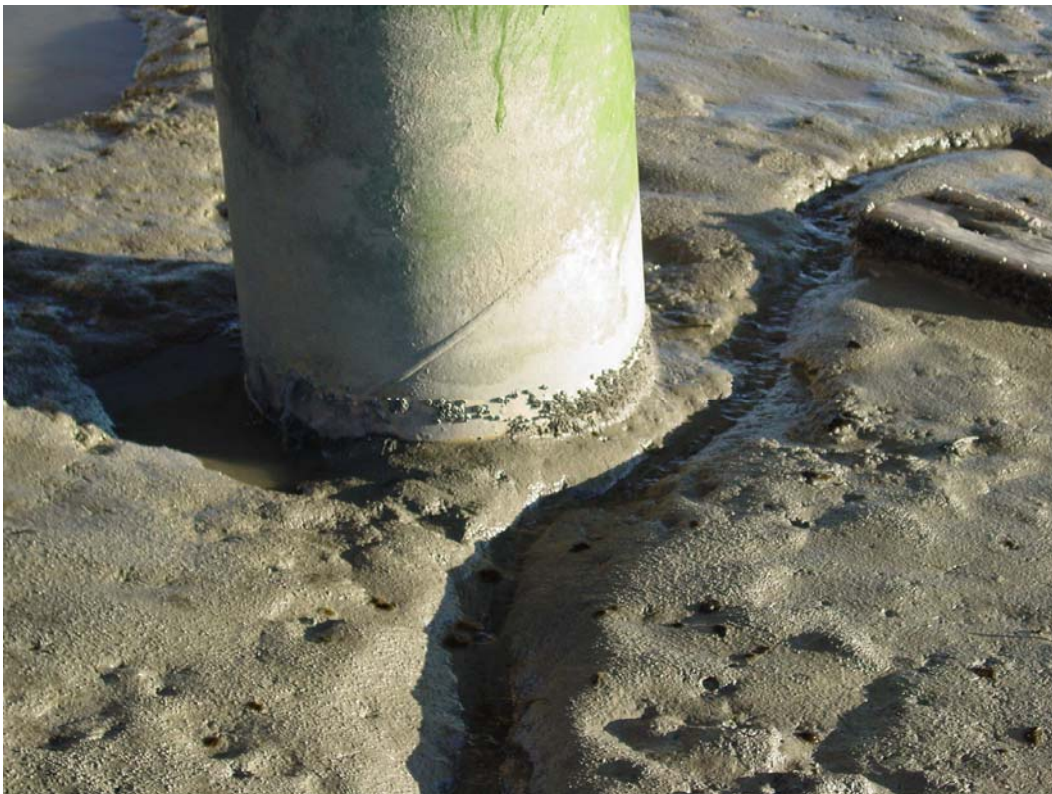
Photo 14. Close-up of pile 1N-A (looking west) – November 29, 2006

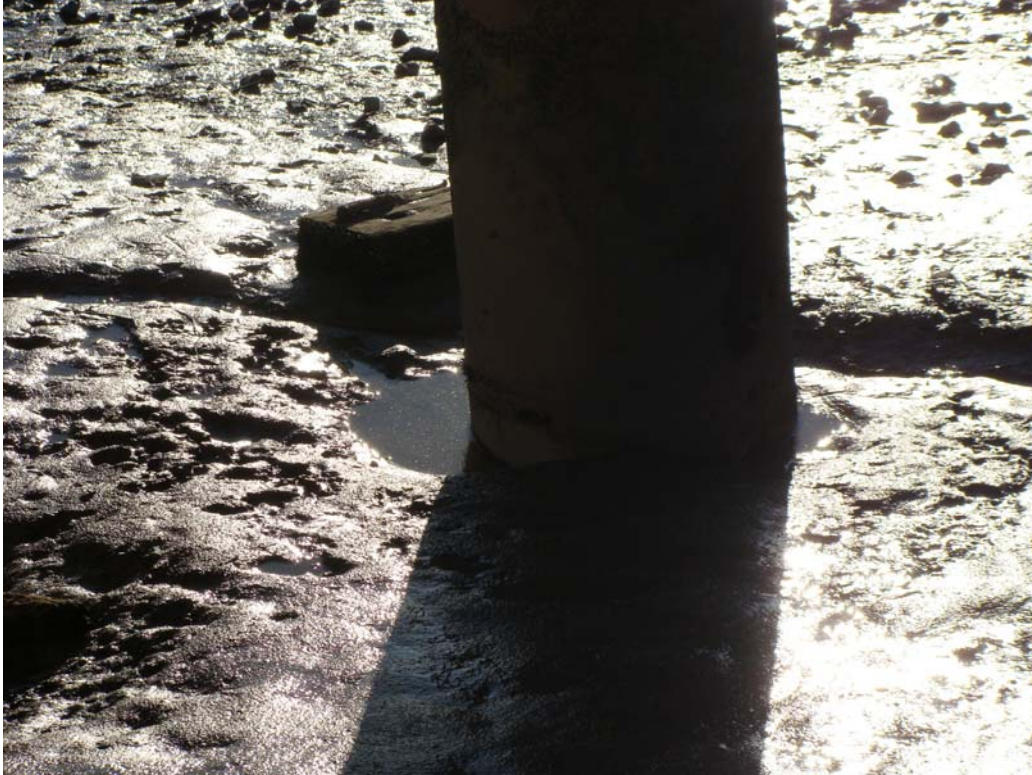
Photo 15. Close-up of pile 1N-A (looking east) – November 21, 2007

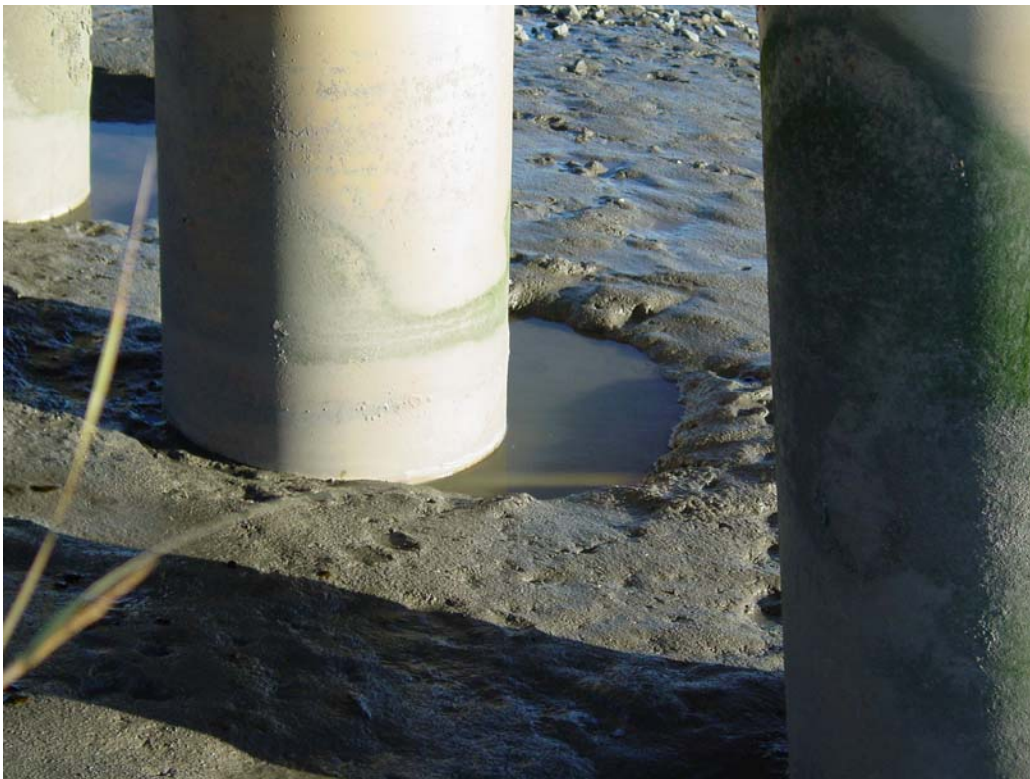
Photo 16. Close-up of pile 1N-B (looking east) – November 29, 2006

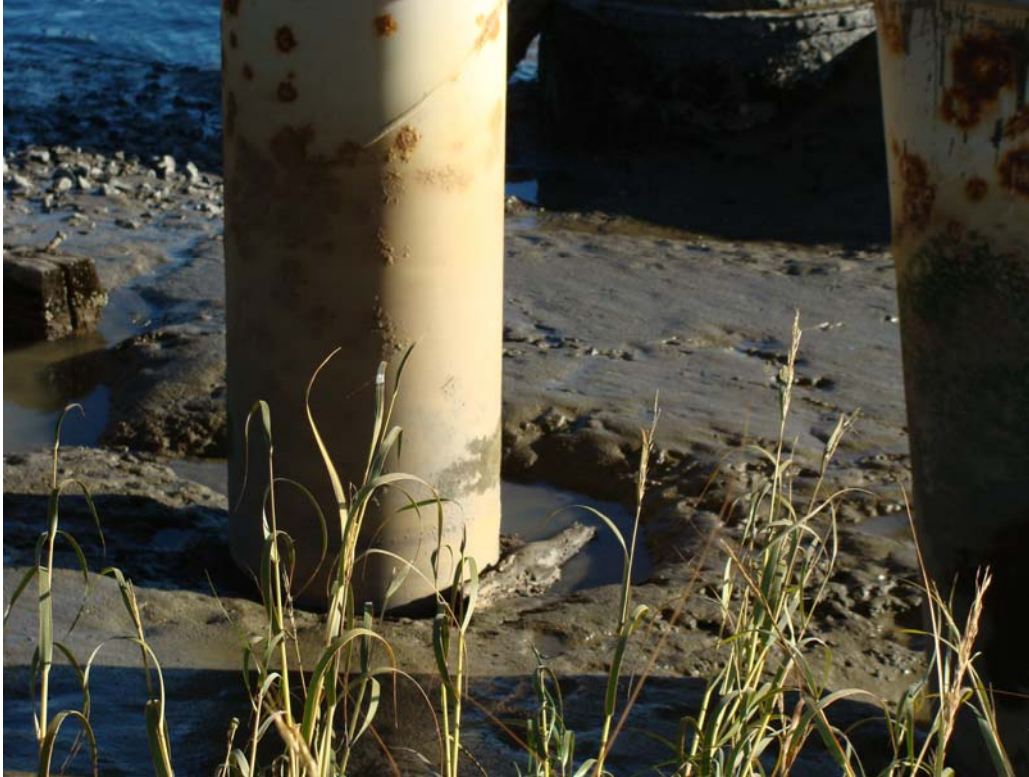
Photo 17. Close-up of pile 1N-B (looking east) – November 21, 2007

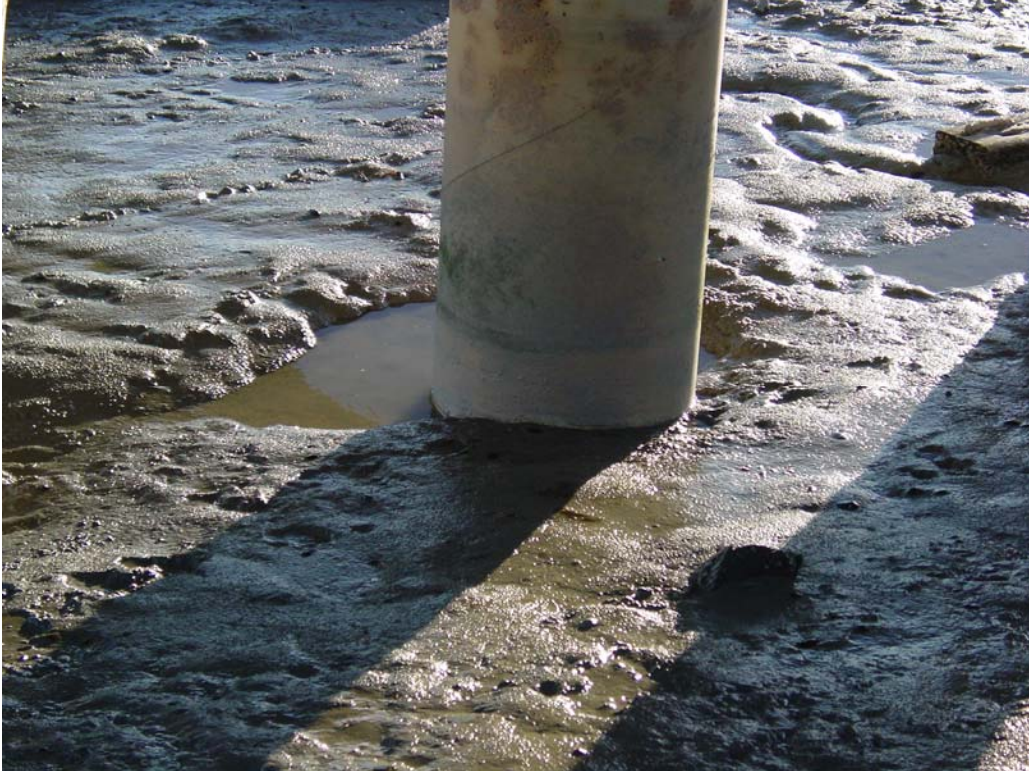
Photo 18. Close-up of pile 1N-B (looking west) – November 29, 2006

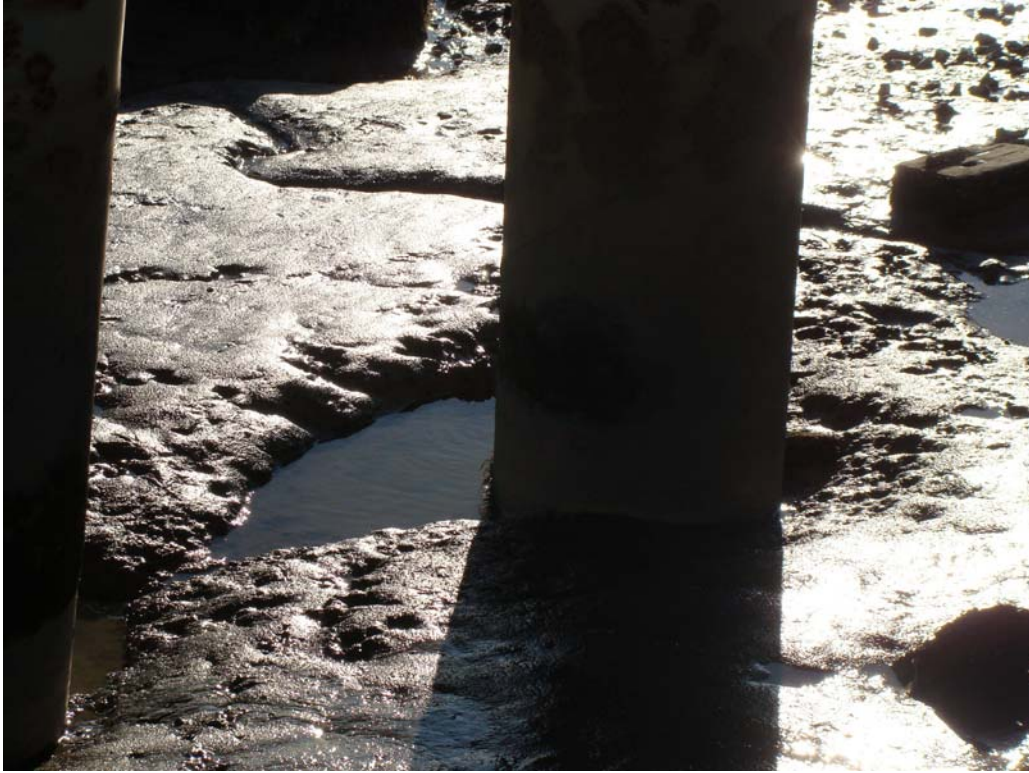
Photo 19. Close-up of pile 1N-B (looking west) – November 21, 2007

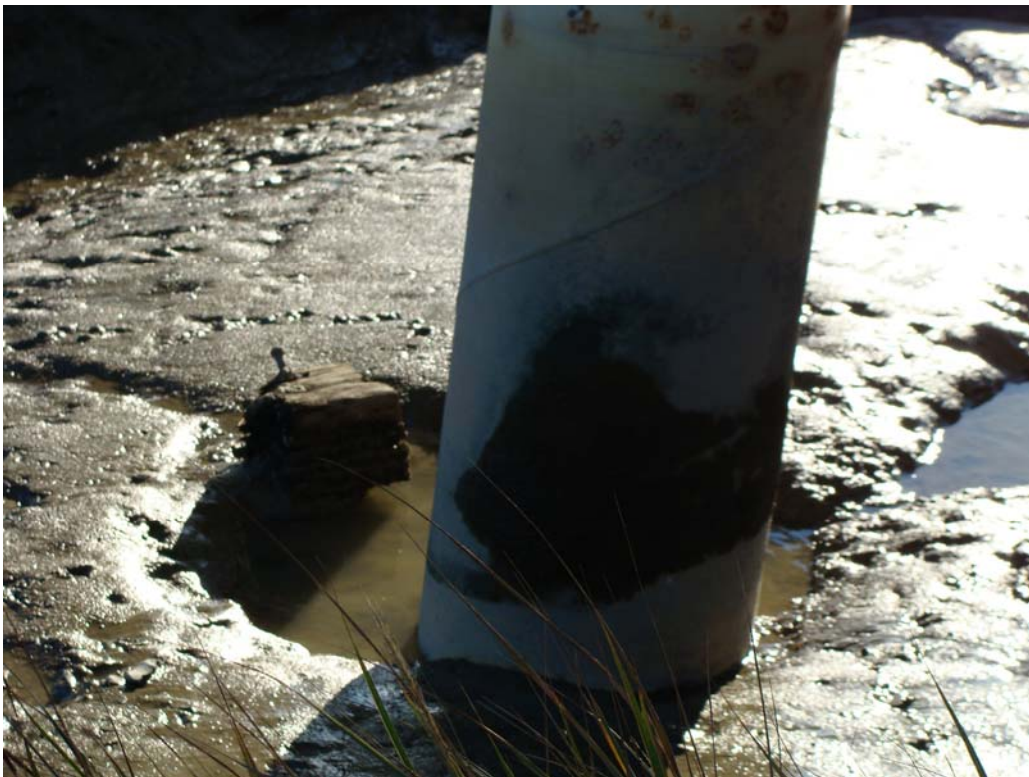
Photo 20. Close-up of pile 1N-C – November 29, 2006

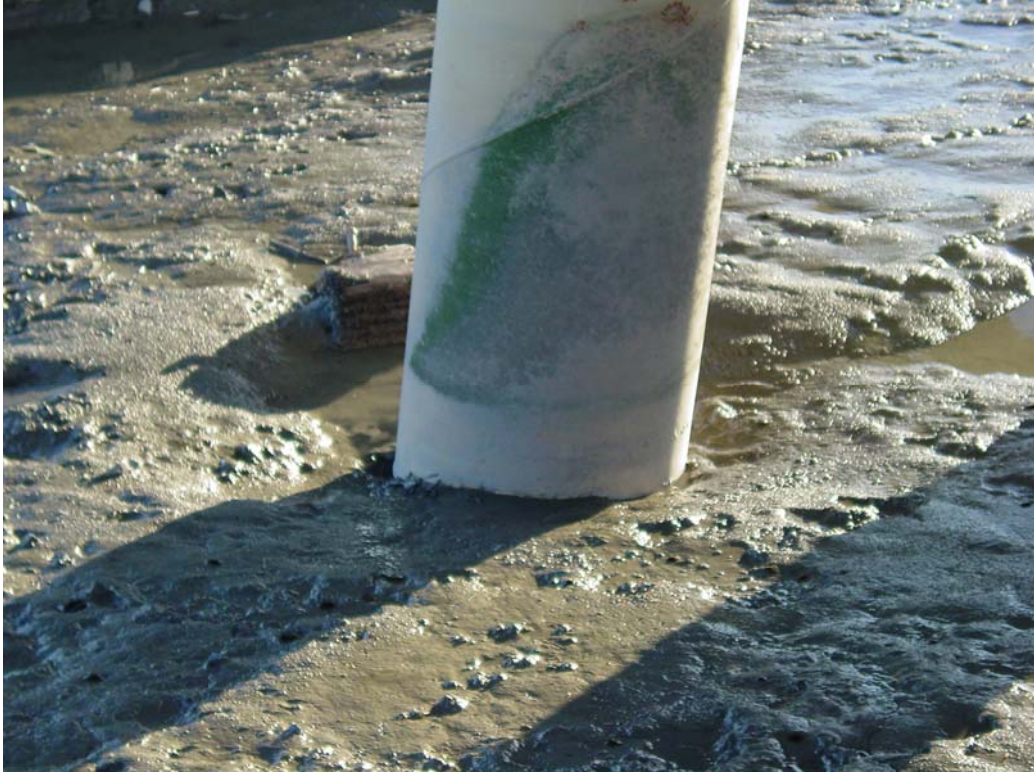
Photo 21. Close-up of pile 1N-C – November 21, 2007

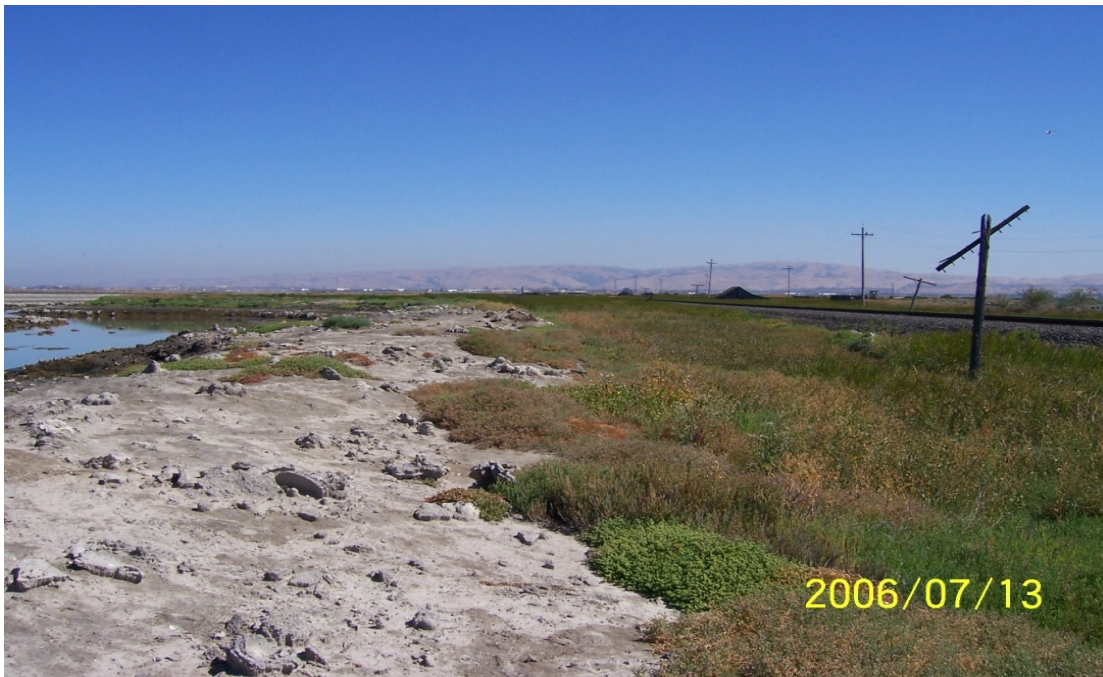
Photo 1. Pond A21 Levee near Rail Levee, view looking north - July 13, 2006.

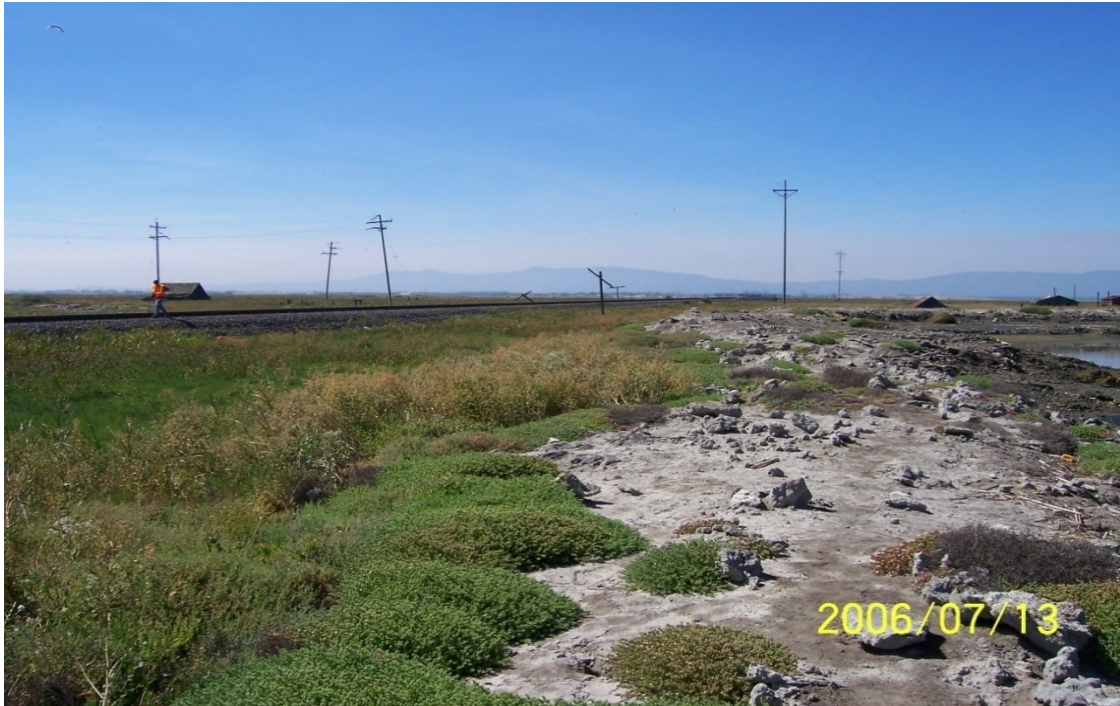
Photo 3. Pond A21 Levee near Rail Levee, view looking south – July 13, 2006.

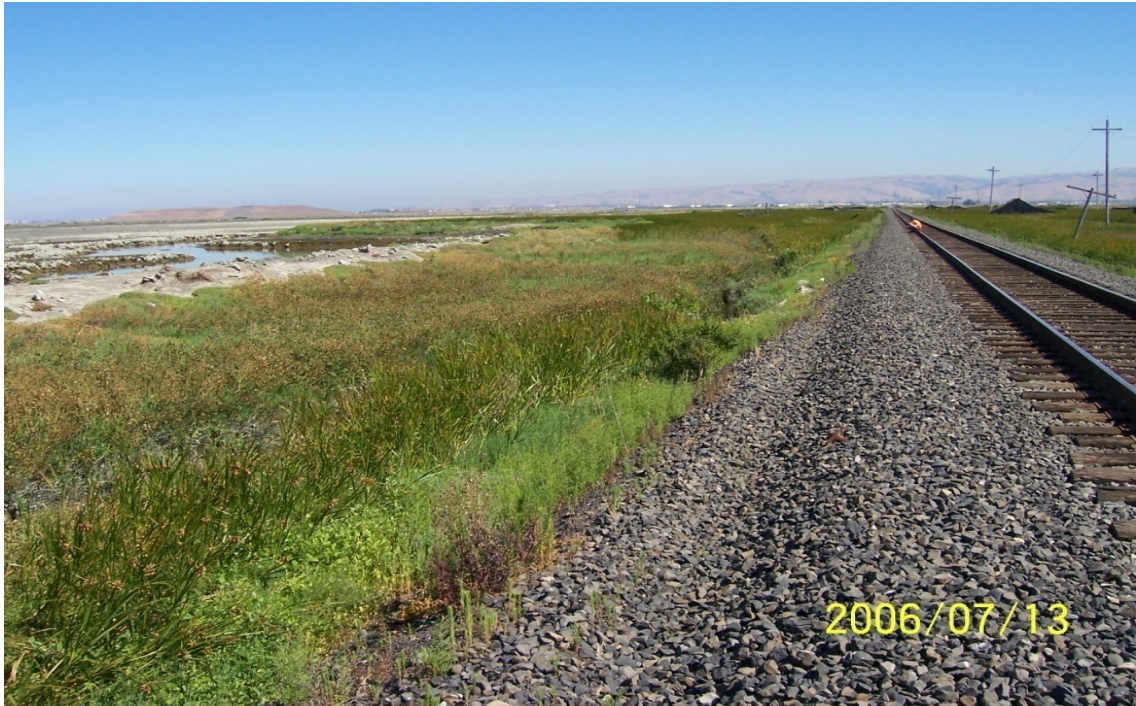
Photo 5. West Rail Levee neat Pond A21, view looking north – July 13, 2006.

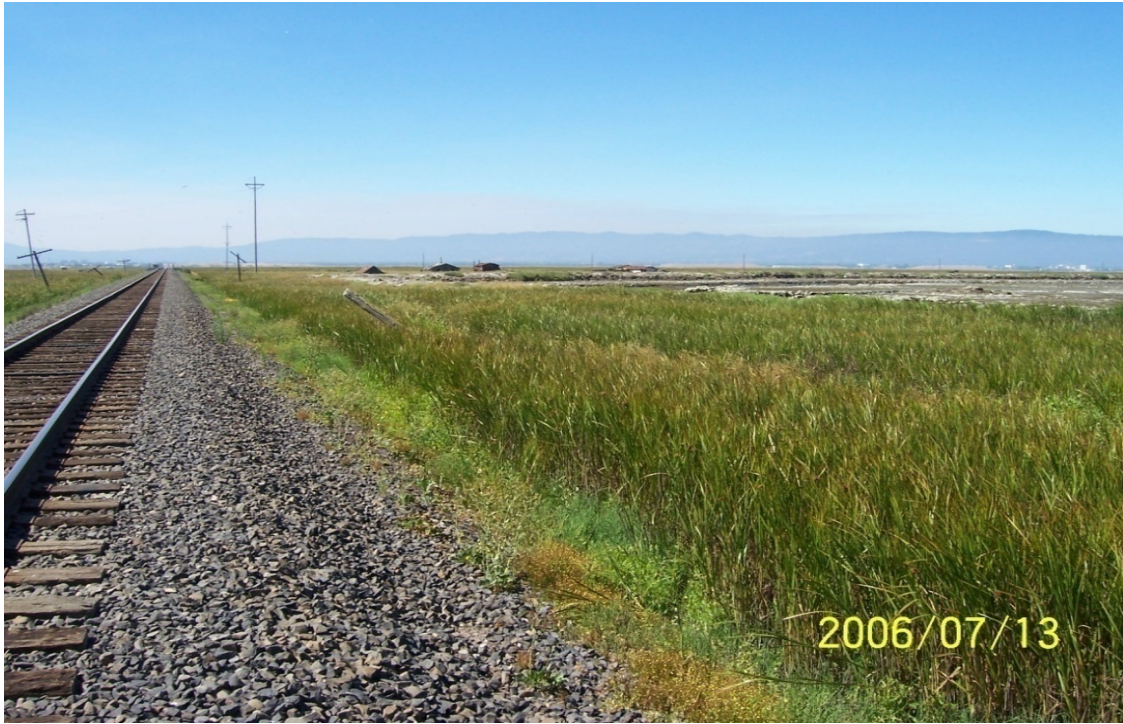
Photo 7. West Rail Levee near Pond A21, view looking south – July 13, 2006.

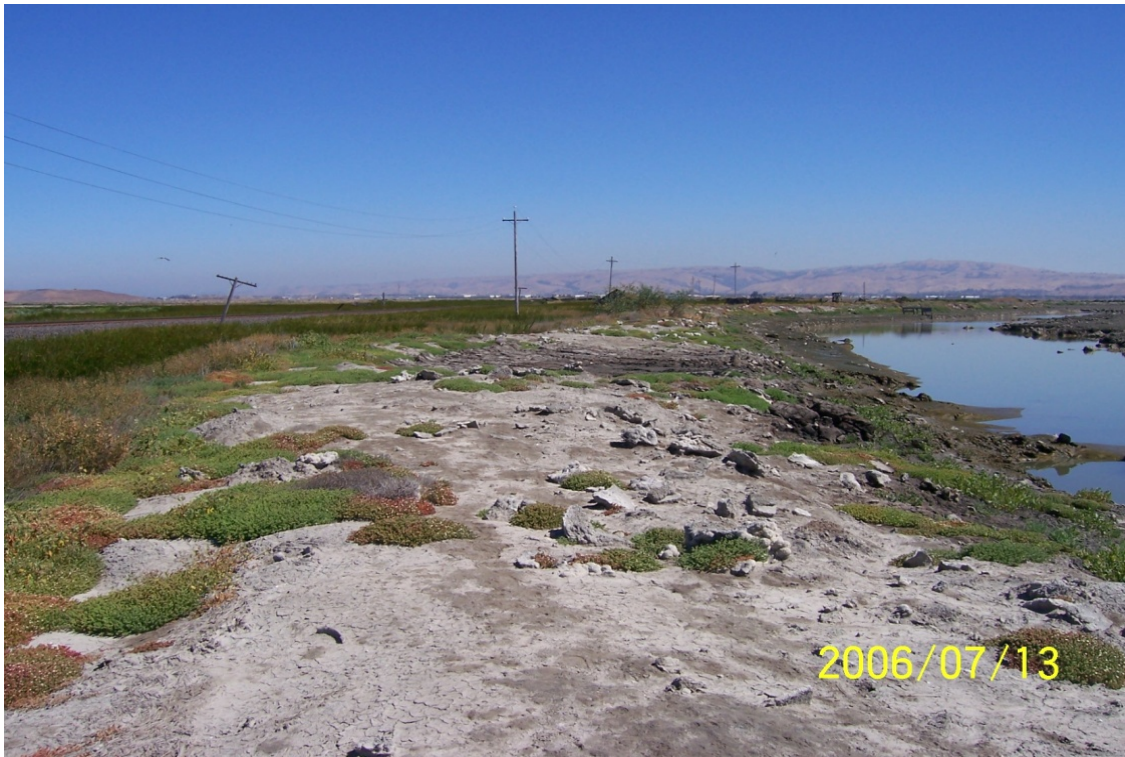
Photo 9. Pond A20 Levee near Rail Levee – July 13, 2007.

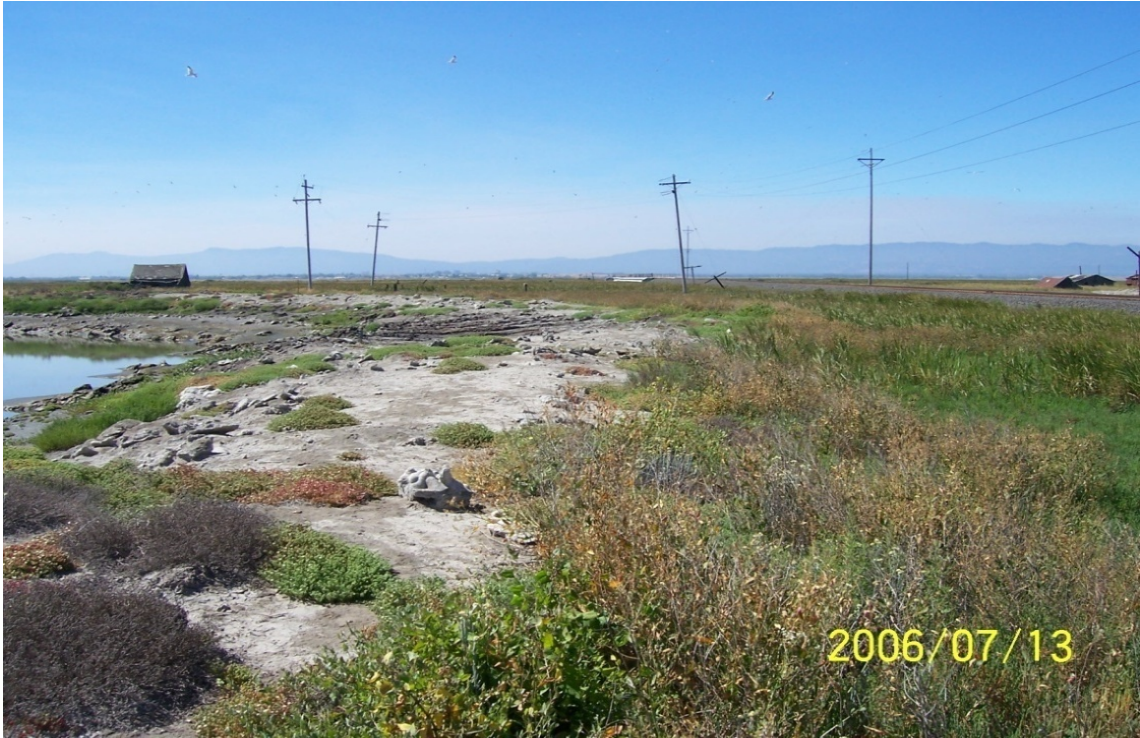
Photo 11. Pond A20 Levee near Rail Levee, view looking south – July 13, 2006.

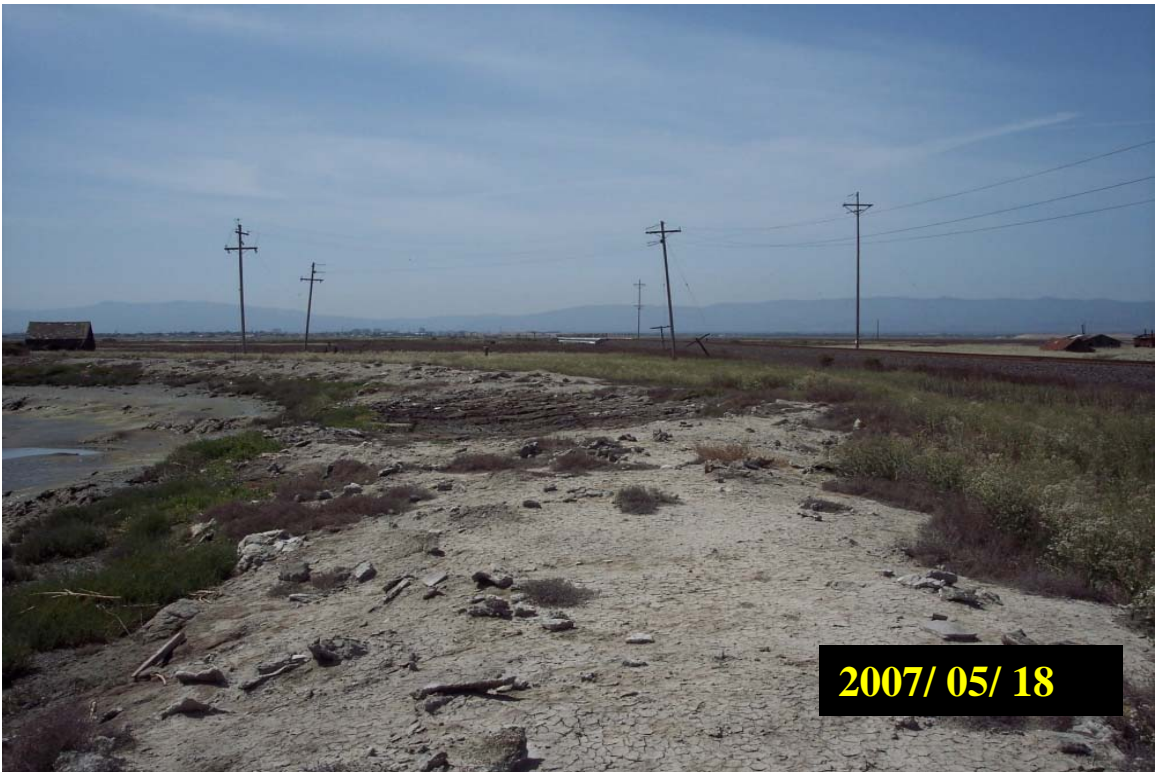
Photo 12. Same location as above – May 18, 2007.

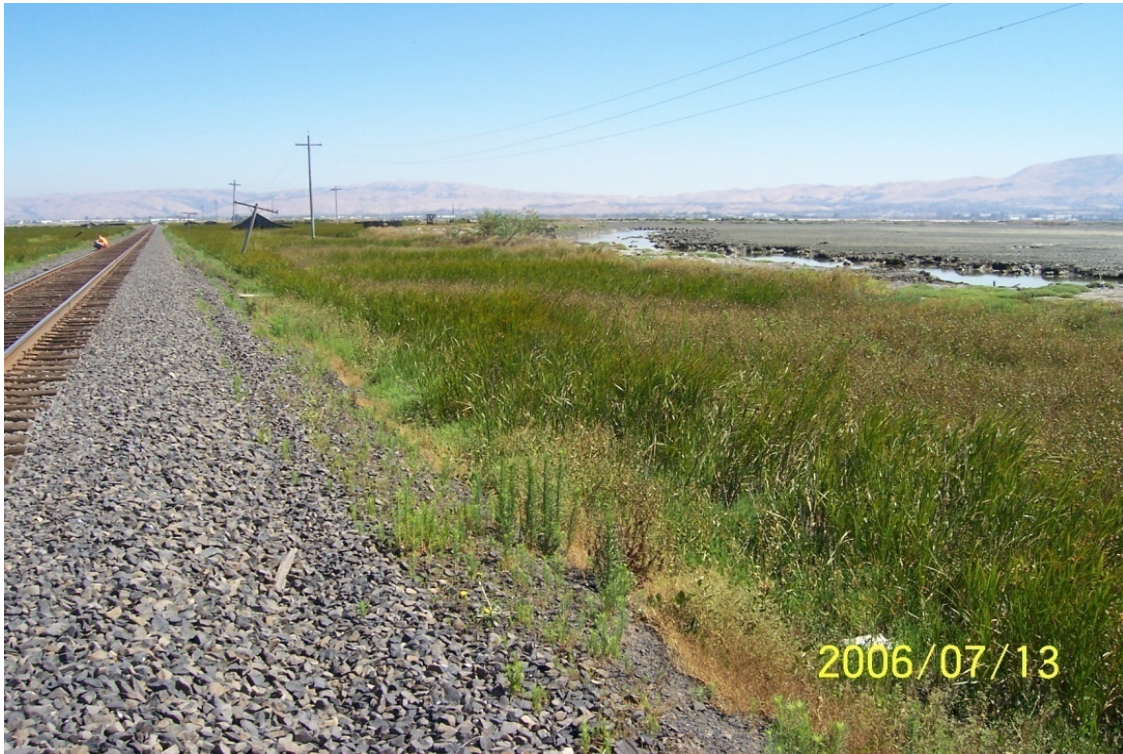
Photo 13. East Rail Levee near Pond A20, view looking north – July 13, 2006.

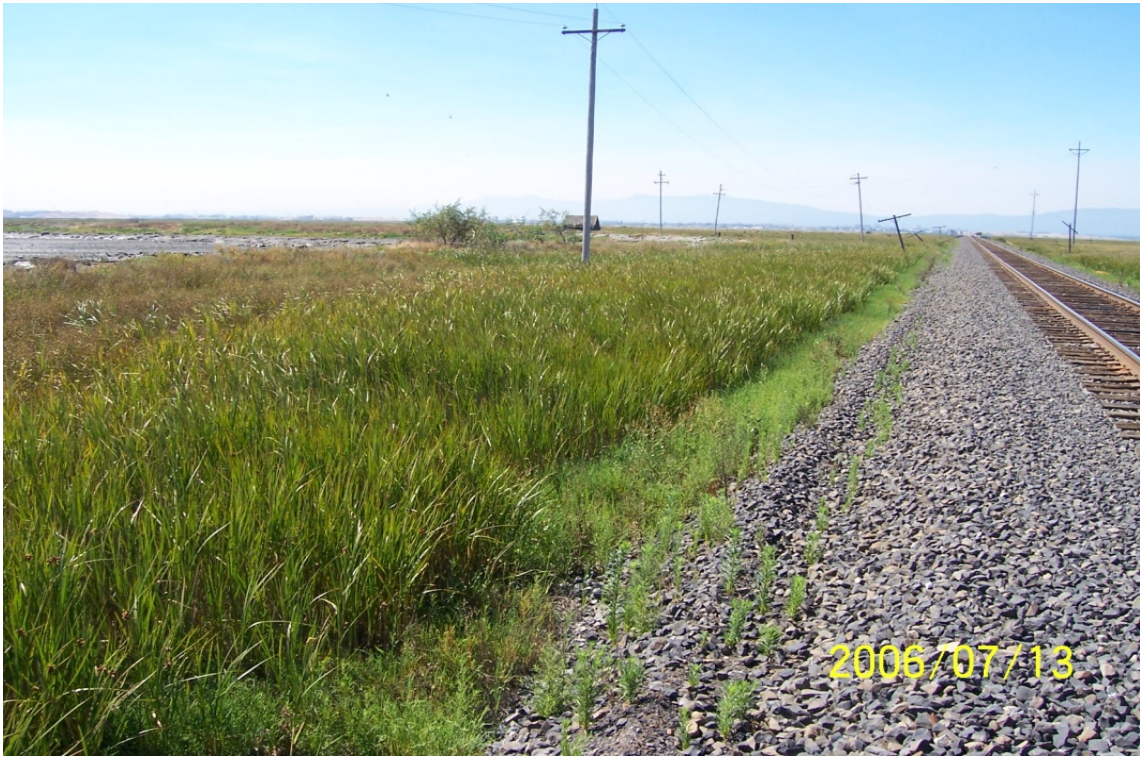
Photo 15. East Rail Levee near Pond A20, view looking south – July 13, 2006.
