South Bay Salt Pond Restoration Project

Levee Assessment

Prepared by:
Geomatrix Consultants

October 2006

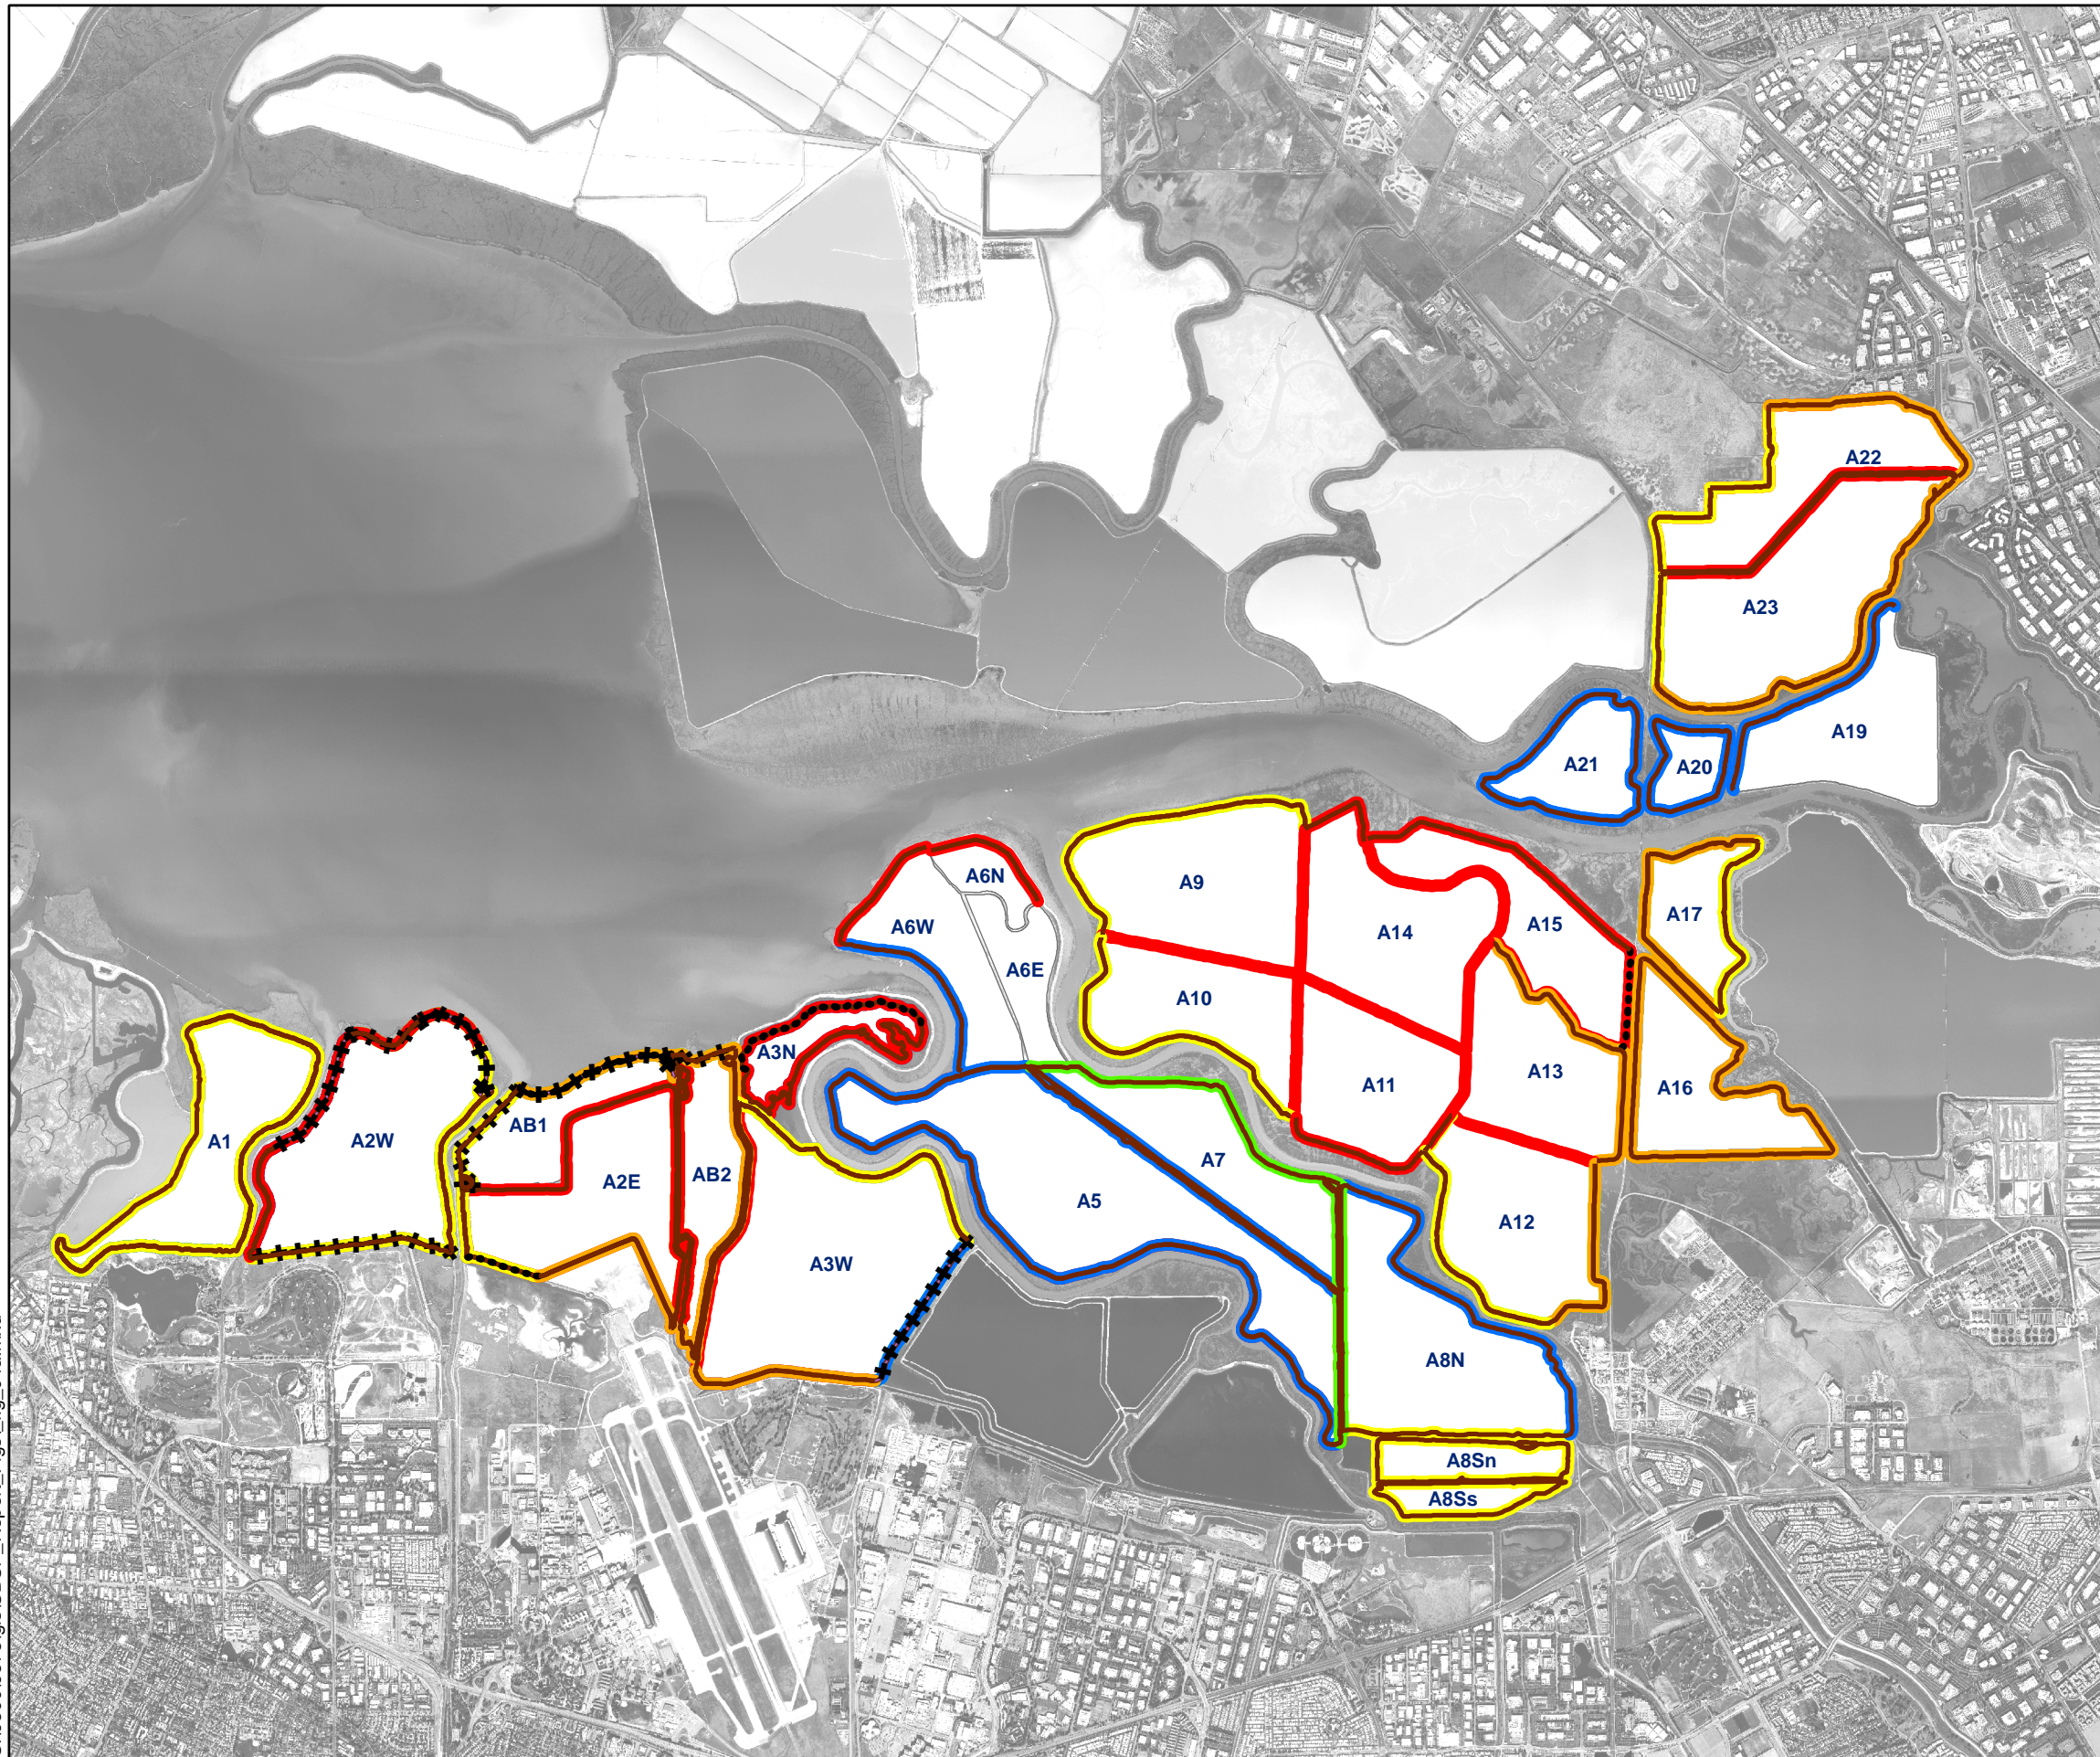
LEVEE PROTECTION TYPE AND CONDITIONS
 ALVISO
 Levee Assessment
 South Bay Salt Ponds Restoration Project
 San Francisco Bay Area, California

Figures 4a, 4e, and 4r are a series of maps for each respective pond complex showing summarized levee protection type and conditions. These figures include data compiled from multiple sources. Where overlapping data exists, that from the most recent source is presented. Slope protection types (broken concrete, riprap, vegetation, other) for each levee are indicated on Figures 4a, 4e, and 4r by symbols. Examples of the various slope protection types are illustrated in photographs 1 through 5 in the Photograph Section of this report. Slope protection conditions in Figures 4a, 4e, and 4r are color coded: good (blue), fair (yellow), and poor (red).

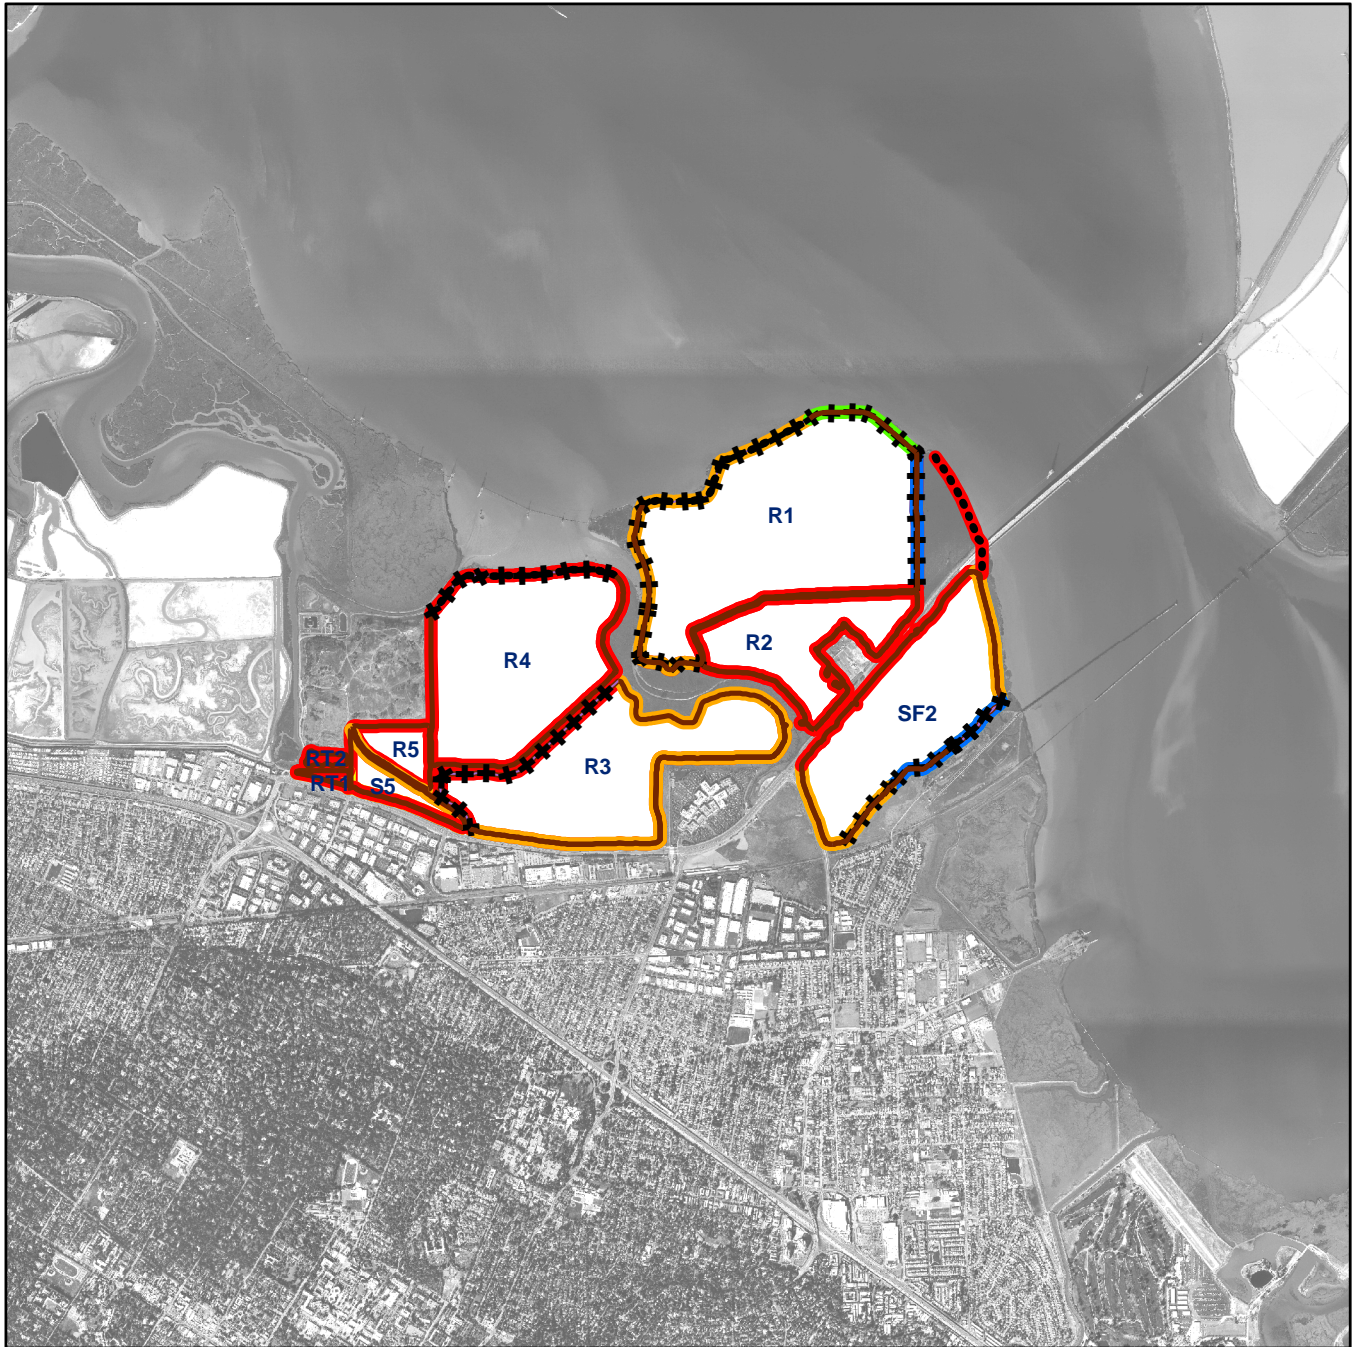
LEVEE PROTECTION TYPE AND CONDITION RAVENSWOOD Levee Assessment South Bay Salt Ponds Restoration Project San Francisco Bay Area, California		
By: SB	Date: 10/25/06	Project No. 9378.003
Geomatrix		Figure 4r

The majority of the embankment slopes along existing outboard pond levees are vegetated. Some are protected with riprap. These slopes are subject to erosion caused by rain and wave action. The type and condition of levee slope protection per pond are summarized in Table 3 and illustrated on Figures 4r, 4e, and 4r.

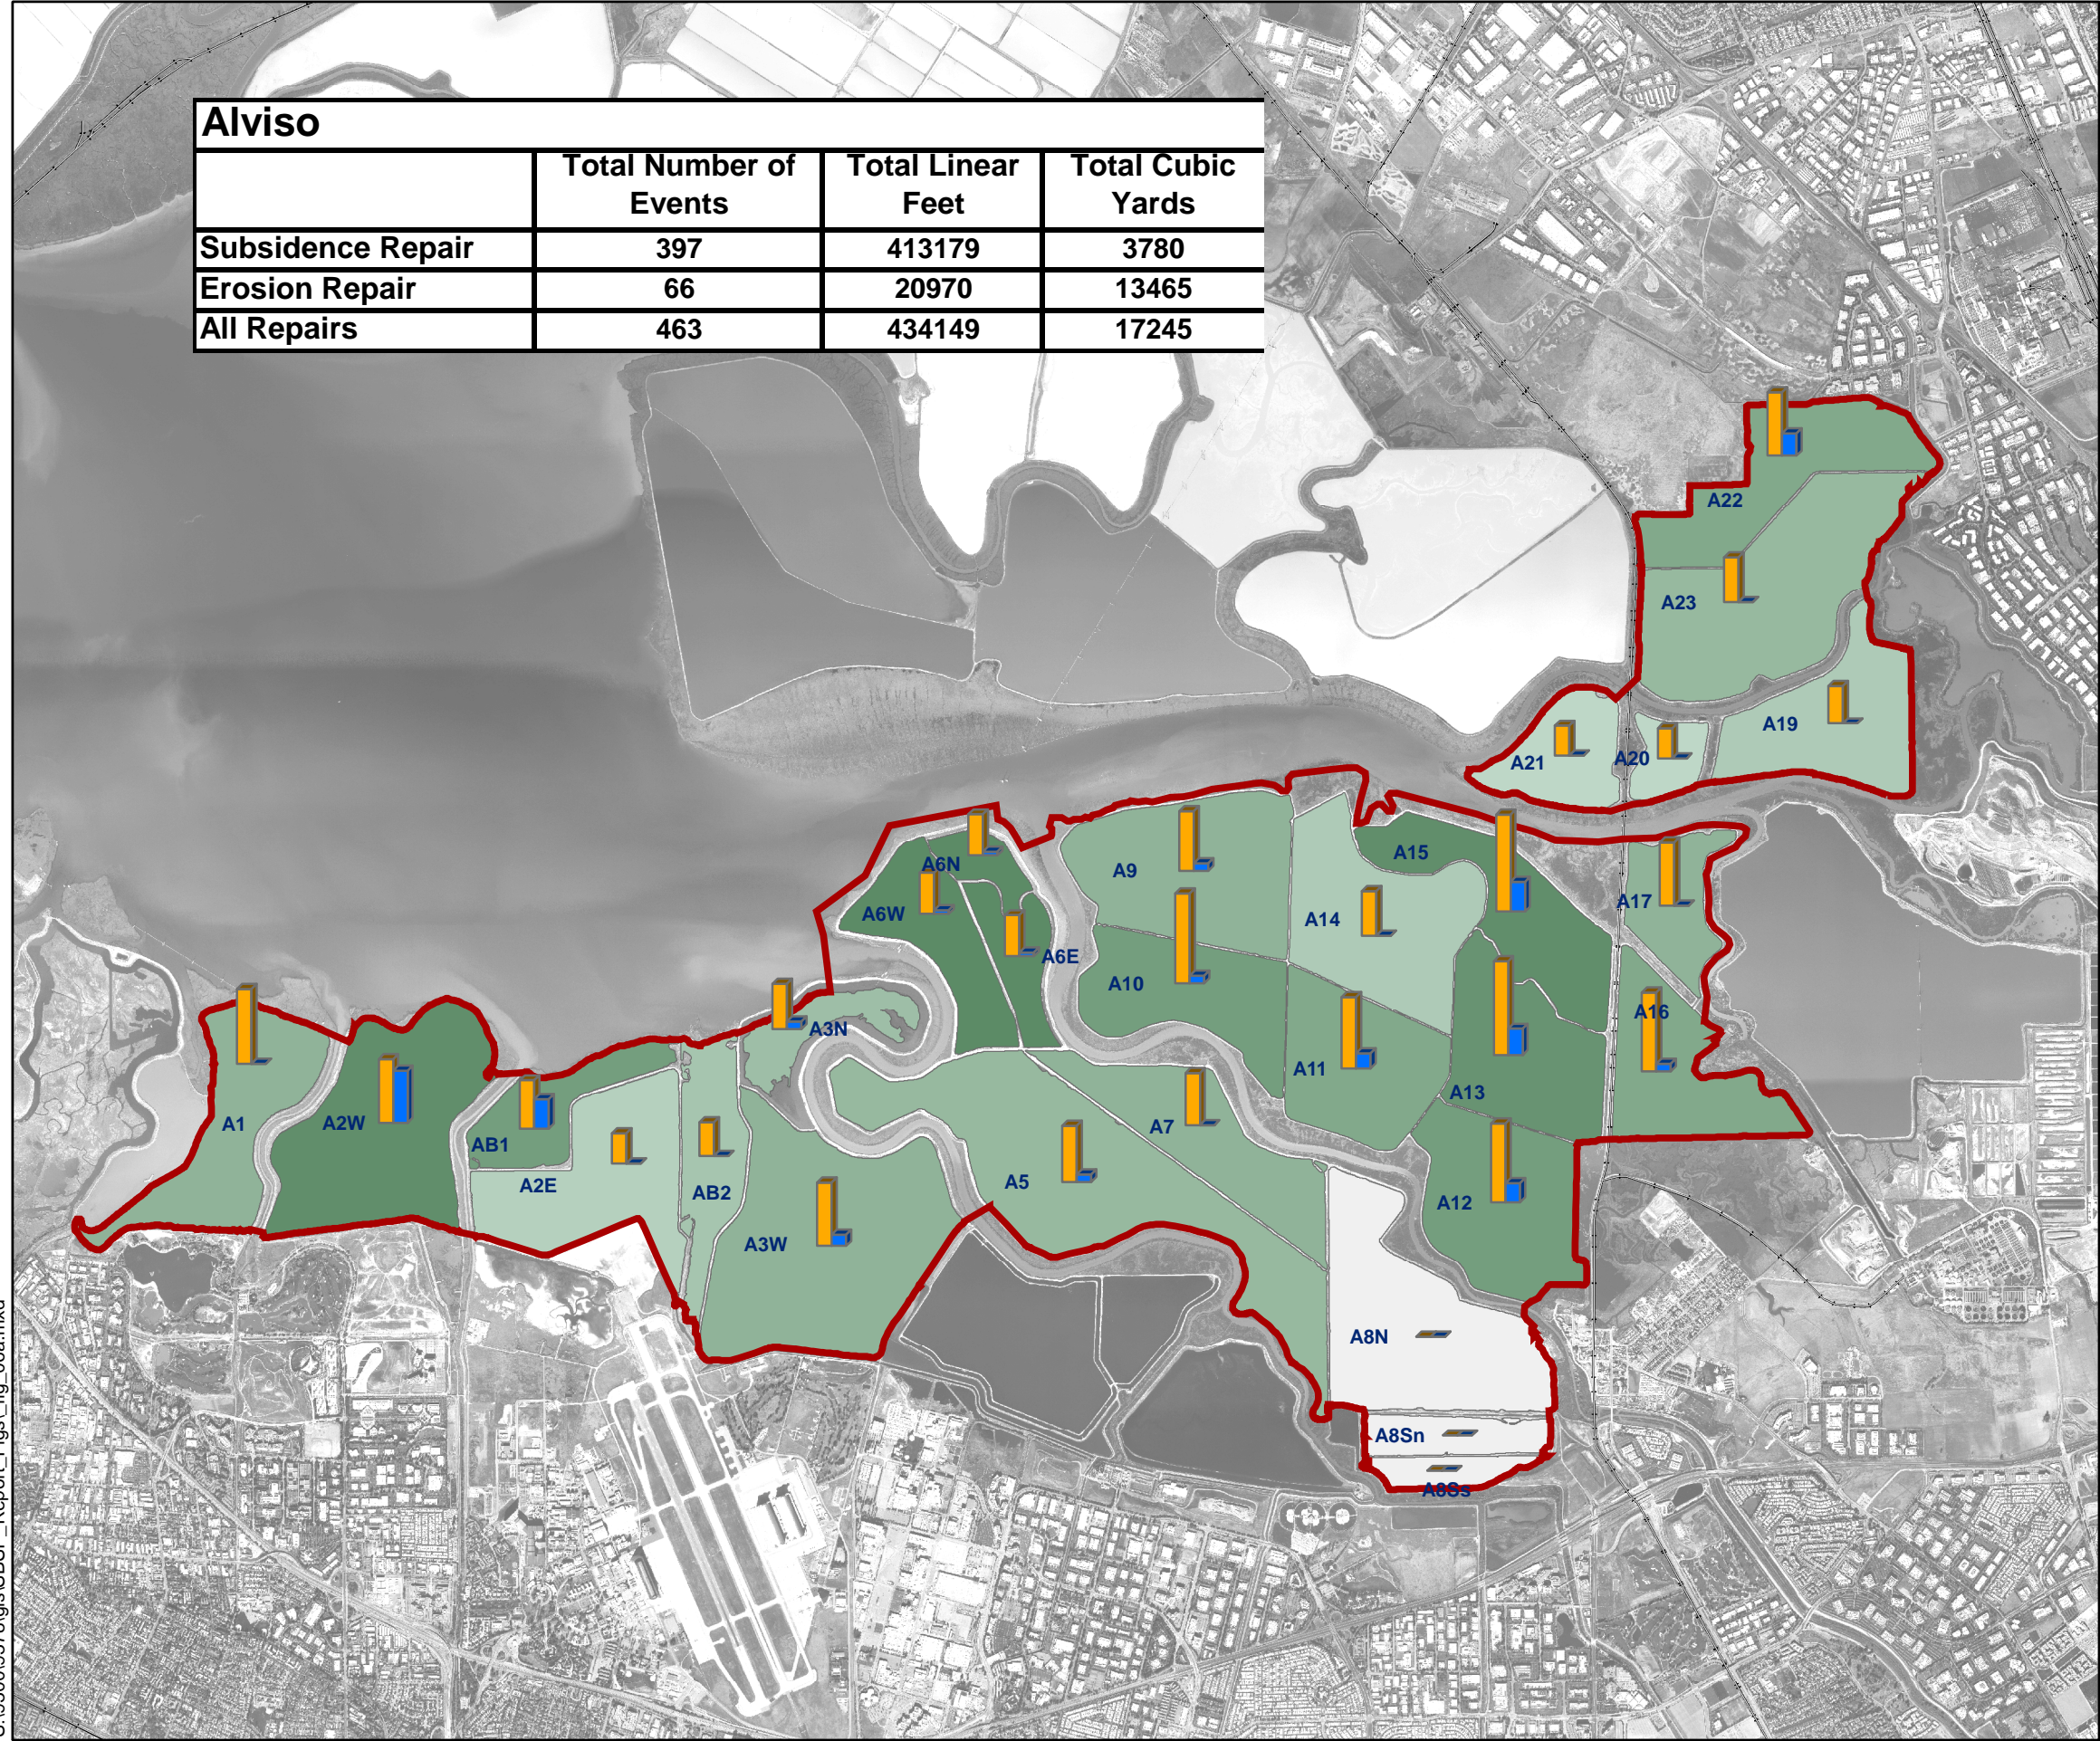
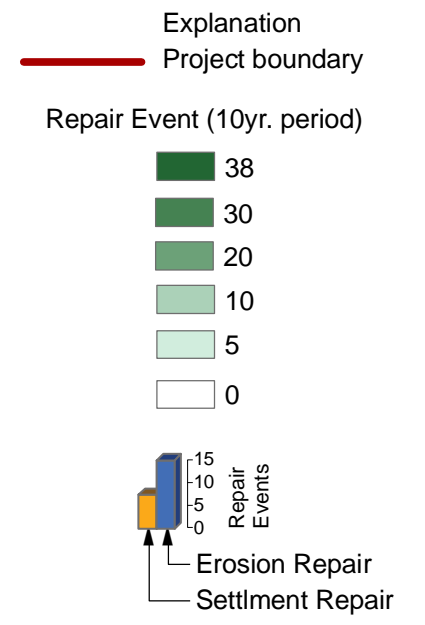
LEVEE MAINTENANCE SUMMARIES
 ALVISO
 Levee Assessment
 South Bay Salt Ponds Restoration Project
 San Francisco Bay Area, California

Total Number of Events	Total Linear Feet	Total Cubic Yards
Subsidence Repair	397	413179	3780
Erosion Repair	66	20970	13465
All Repairs	463	434149	17245

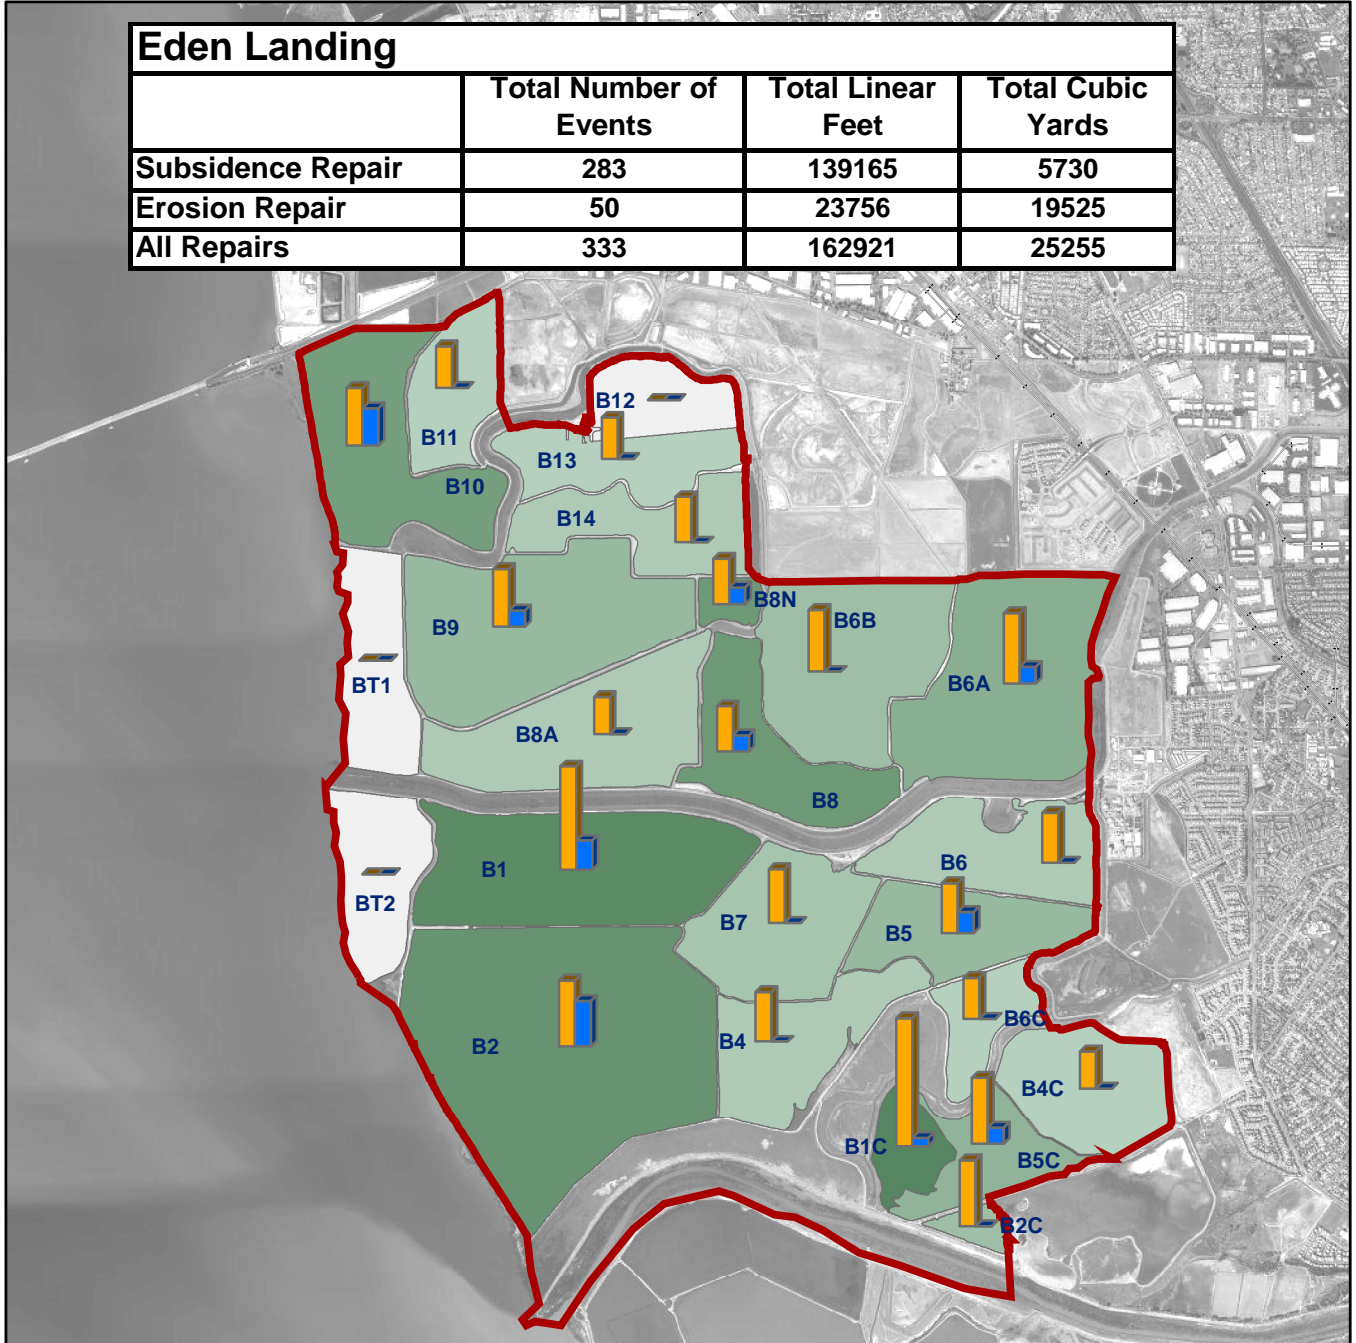
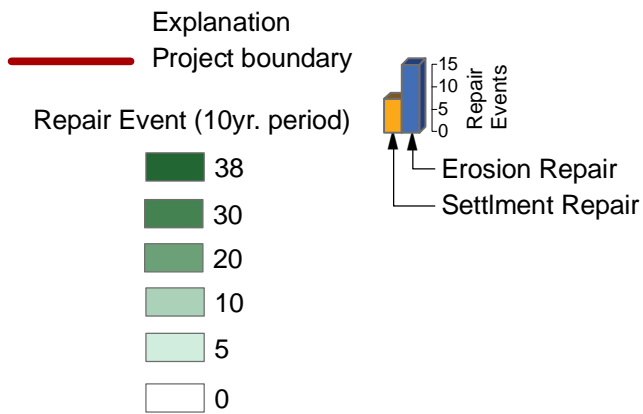
LEVEE MAINTENANCE SUMMARIES
EDEN LANDING
 Levee Assessment
 South Bay Salt Ponds Restoration Project
 San Francisco Bay Area, California

Total Number of Events	Total Linear Feet	Total Cubic Yards
Subsidence Repair	283	139165	5730
Erosion Repair	50	23756	19525
All Repairs	333	162921	25255

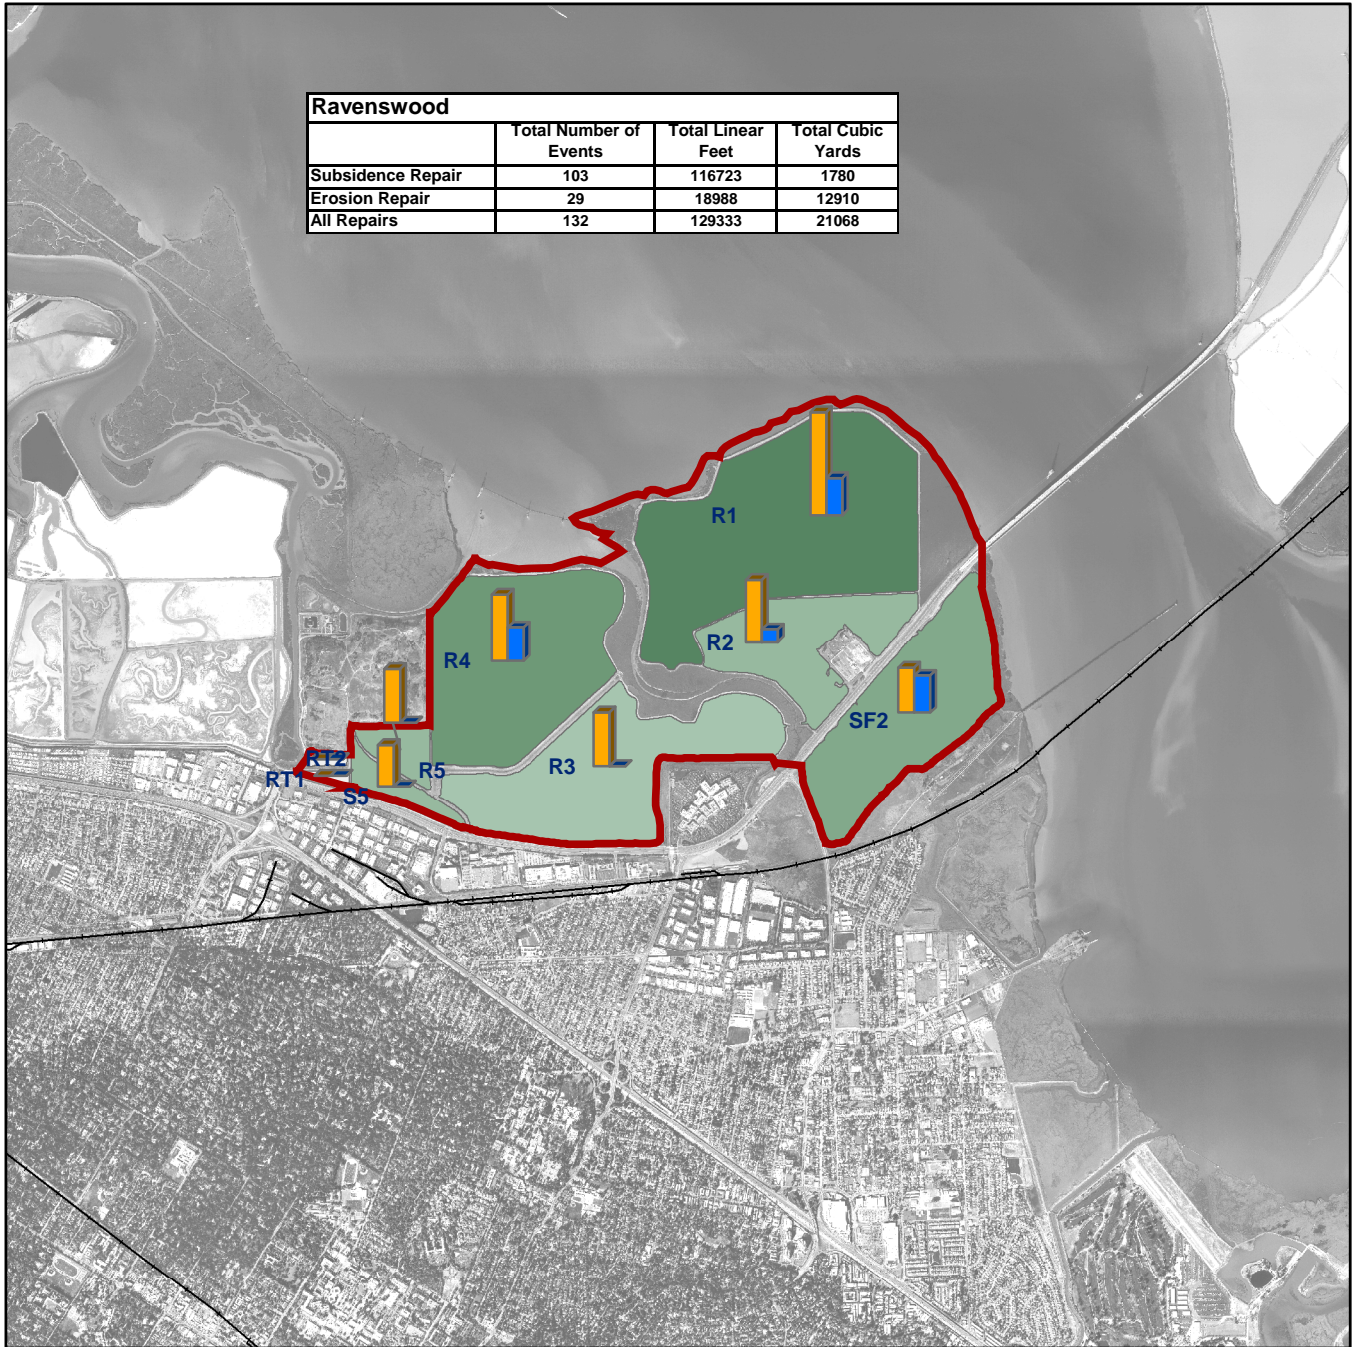
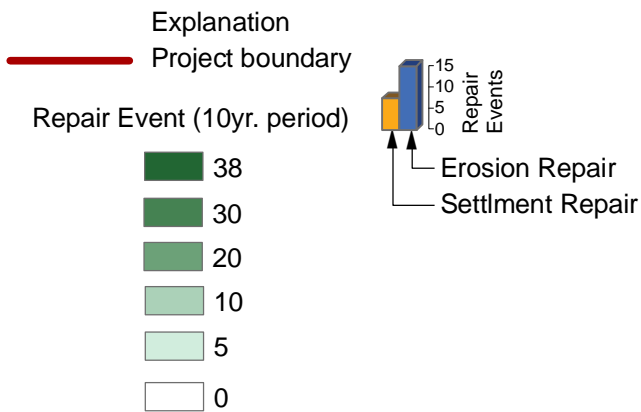
LEVEE MAINTENANCE SUMMARIES
RAVENSWOOD
 Levee Assessment
 South Bay Salt Ponds Restoration Project
 San Francisco Bay Area, California

Ravenswood			
	Total Number of Events	Total Linear Feet	Total Cubic Yards
Subsidence Repair	103	116723	1780
Erosion Repair	29	18988	12910
All Repairs	132	129333	21068
