Existing Hydrologic Conditions Assessment

BAIR ISLAND RESTORATION AND MANAGEMENT PLAN: EXISTING HYDROLOGIC CONDITIONS ASSESSMENT

Philip Williams & Associates, Ltd.

Revised June 30, 2000

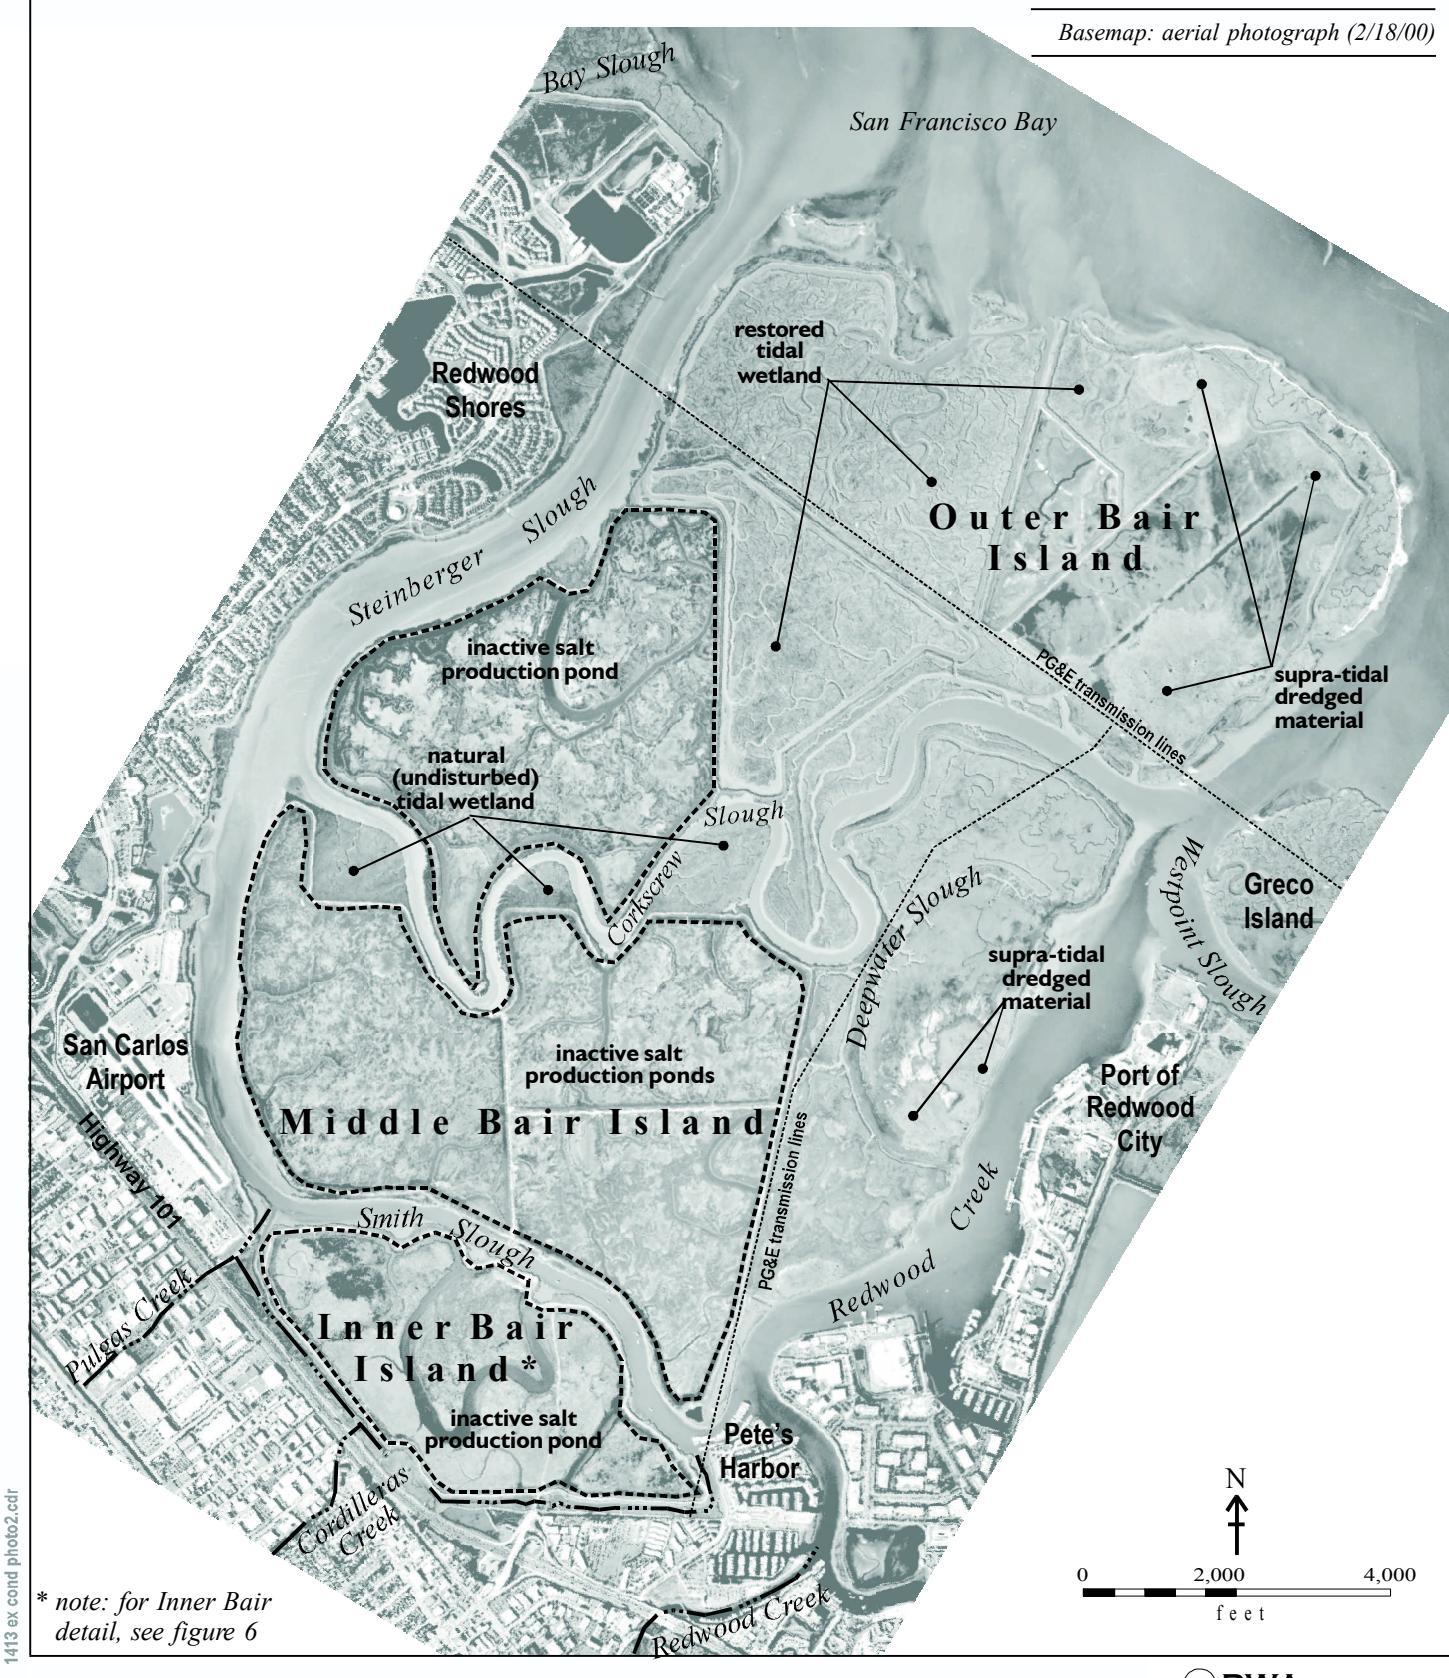
figure 2

Bair Island Existing Conditions

The site consists of leveed inactive salt ponds, restored tidal marsh, supra-tidal dredged material disposal areas, and remnant historical marsh (Figures 2 and 6 and Table 2). Part of Inner Bair (Pond A-12) is owned by the San Carlos Airport and maintained as a safety area for emergency landings (Figure 7).

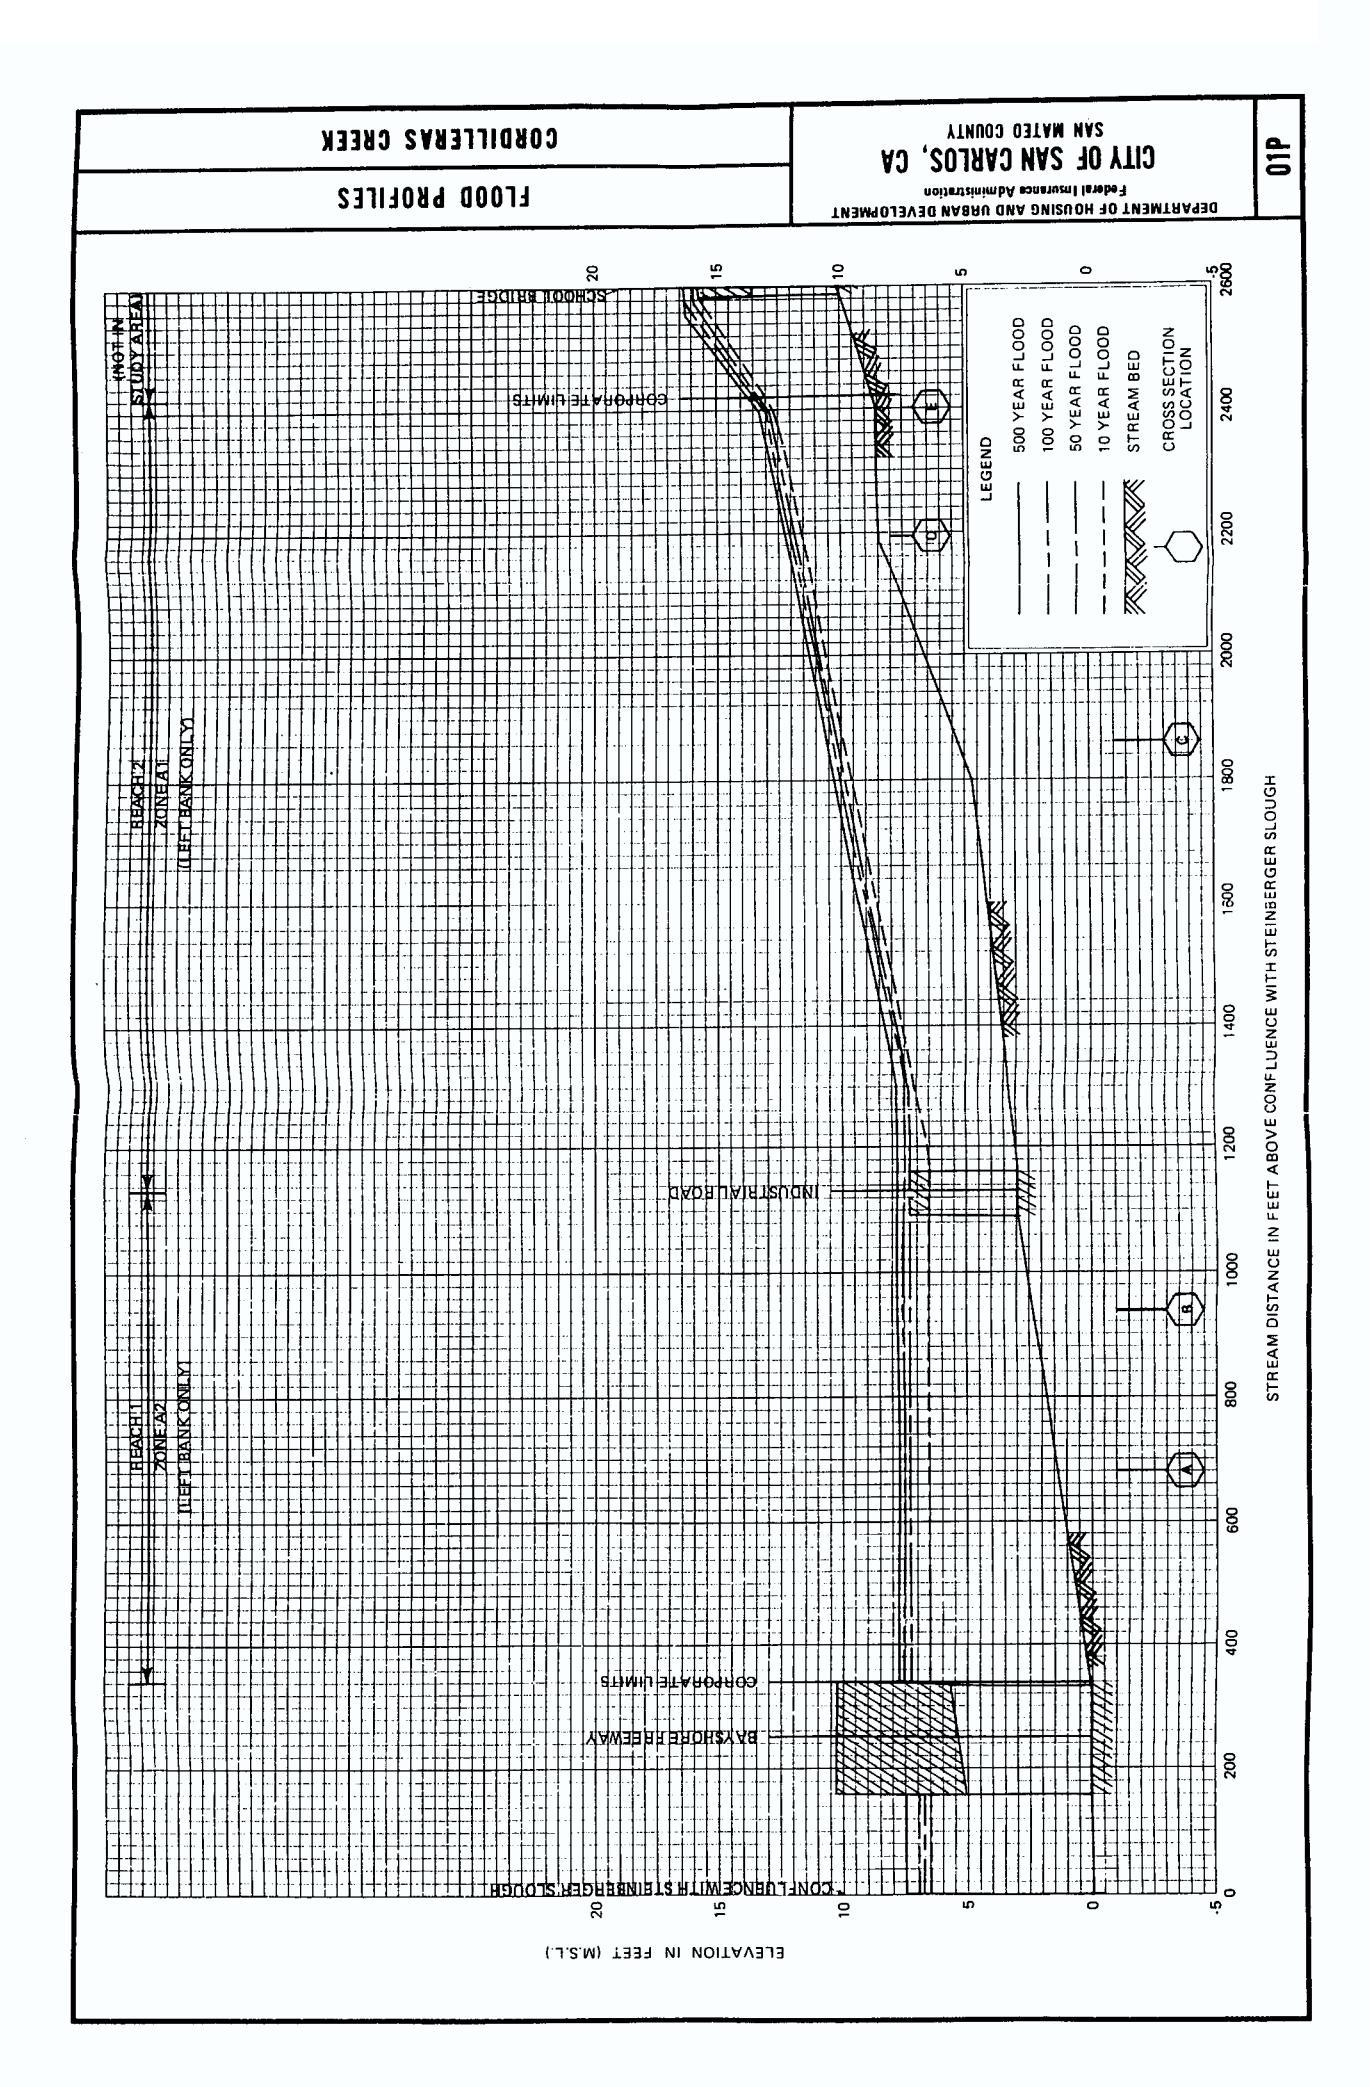
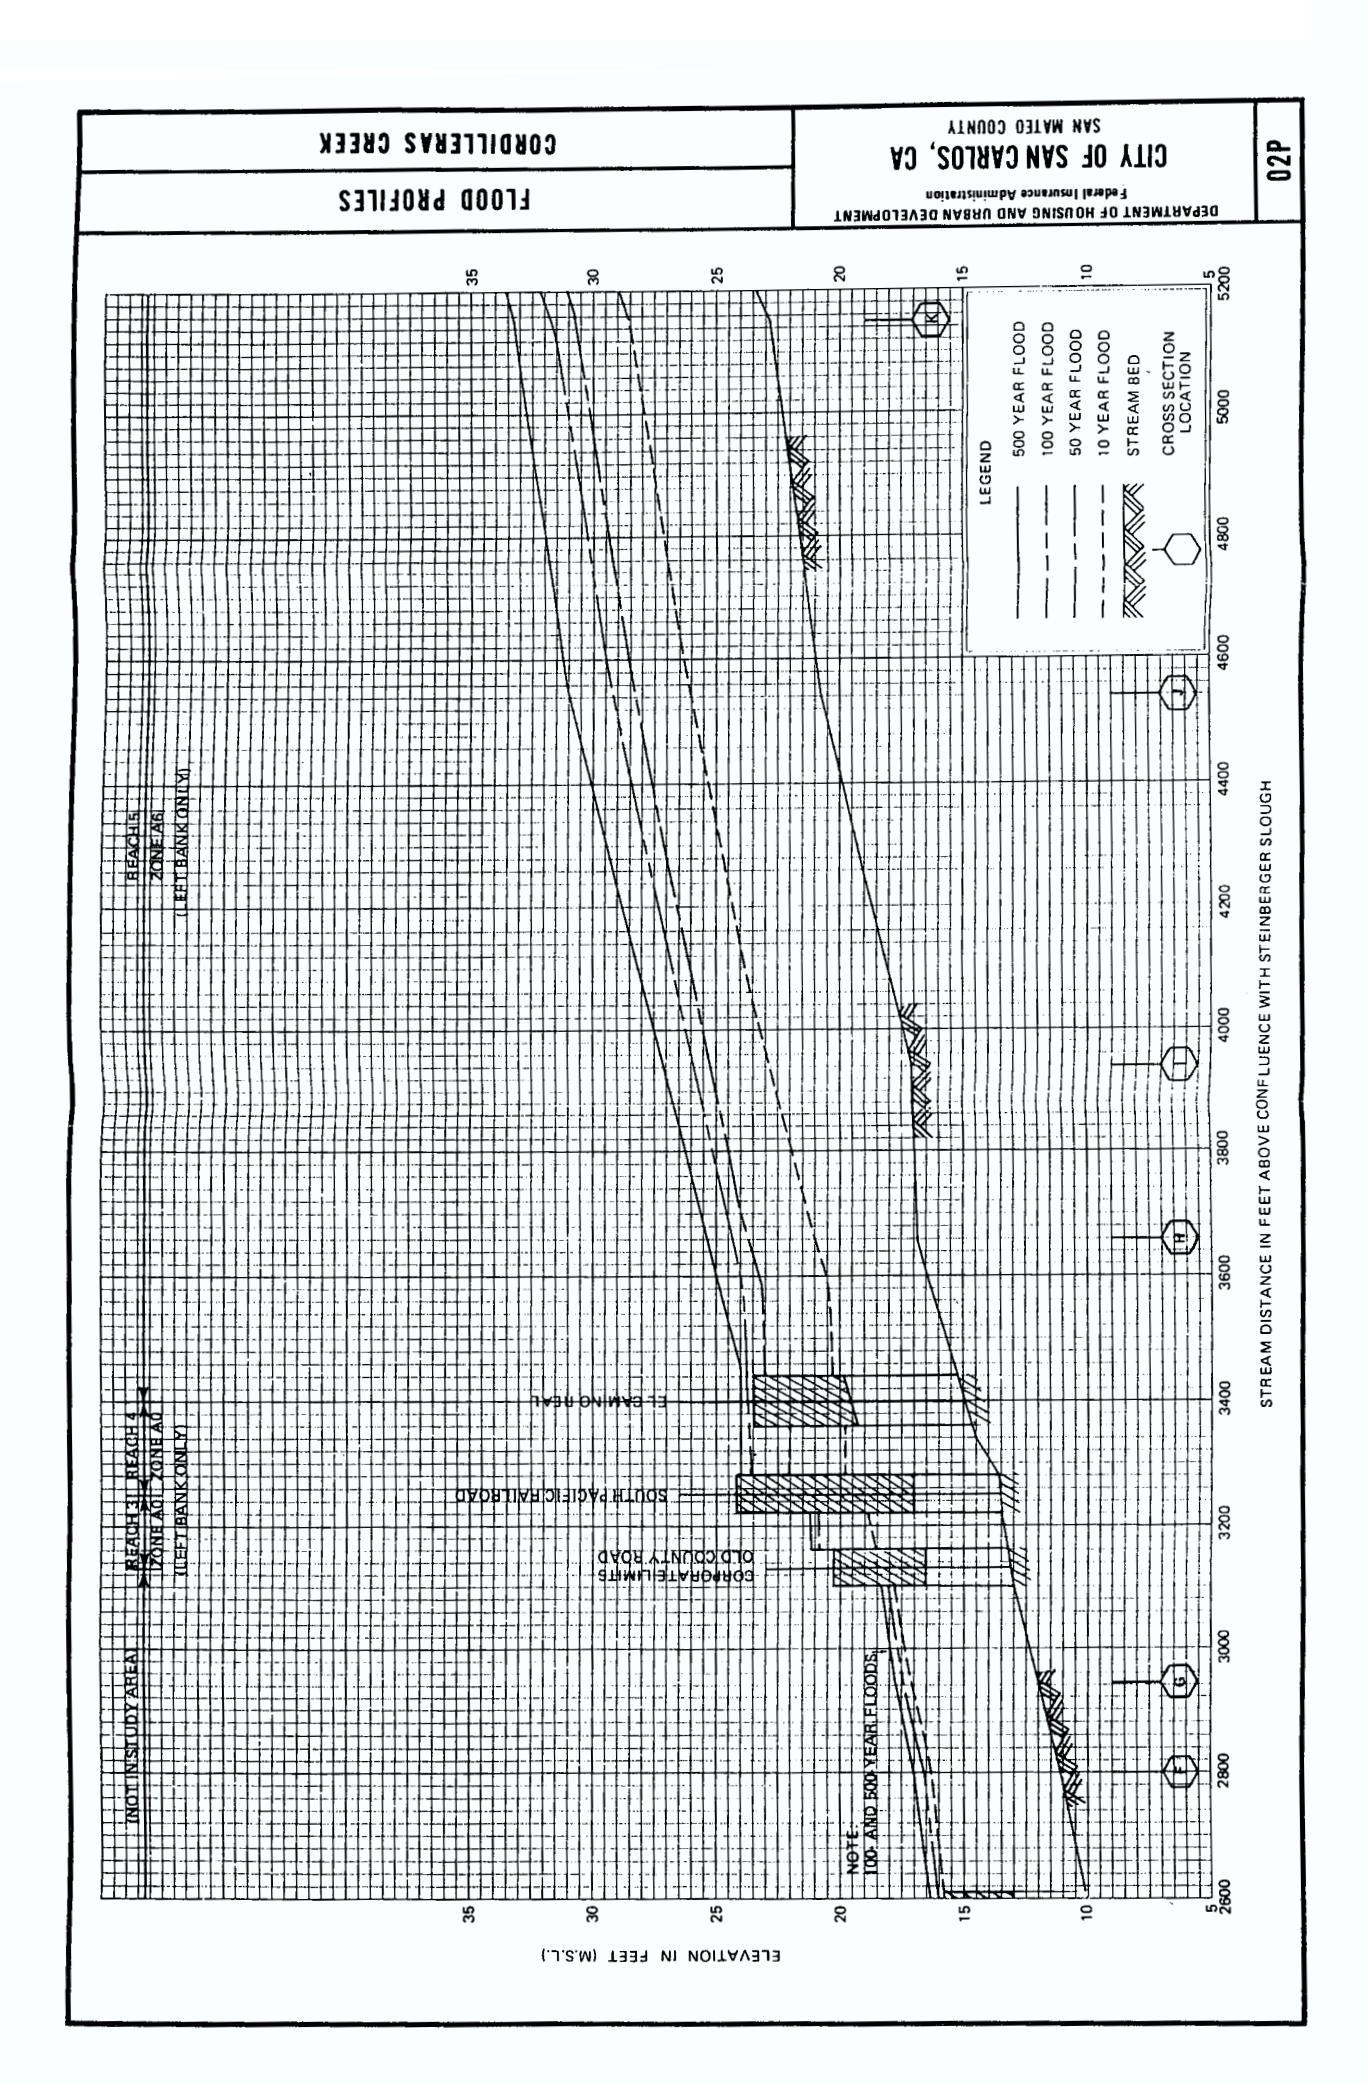
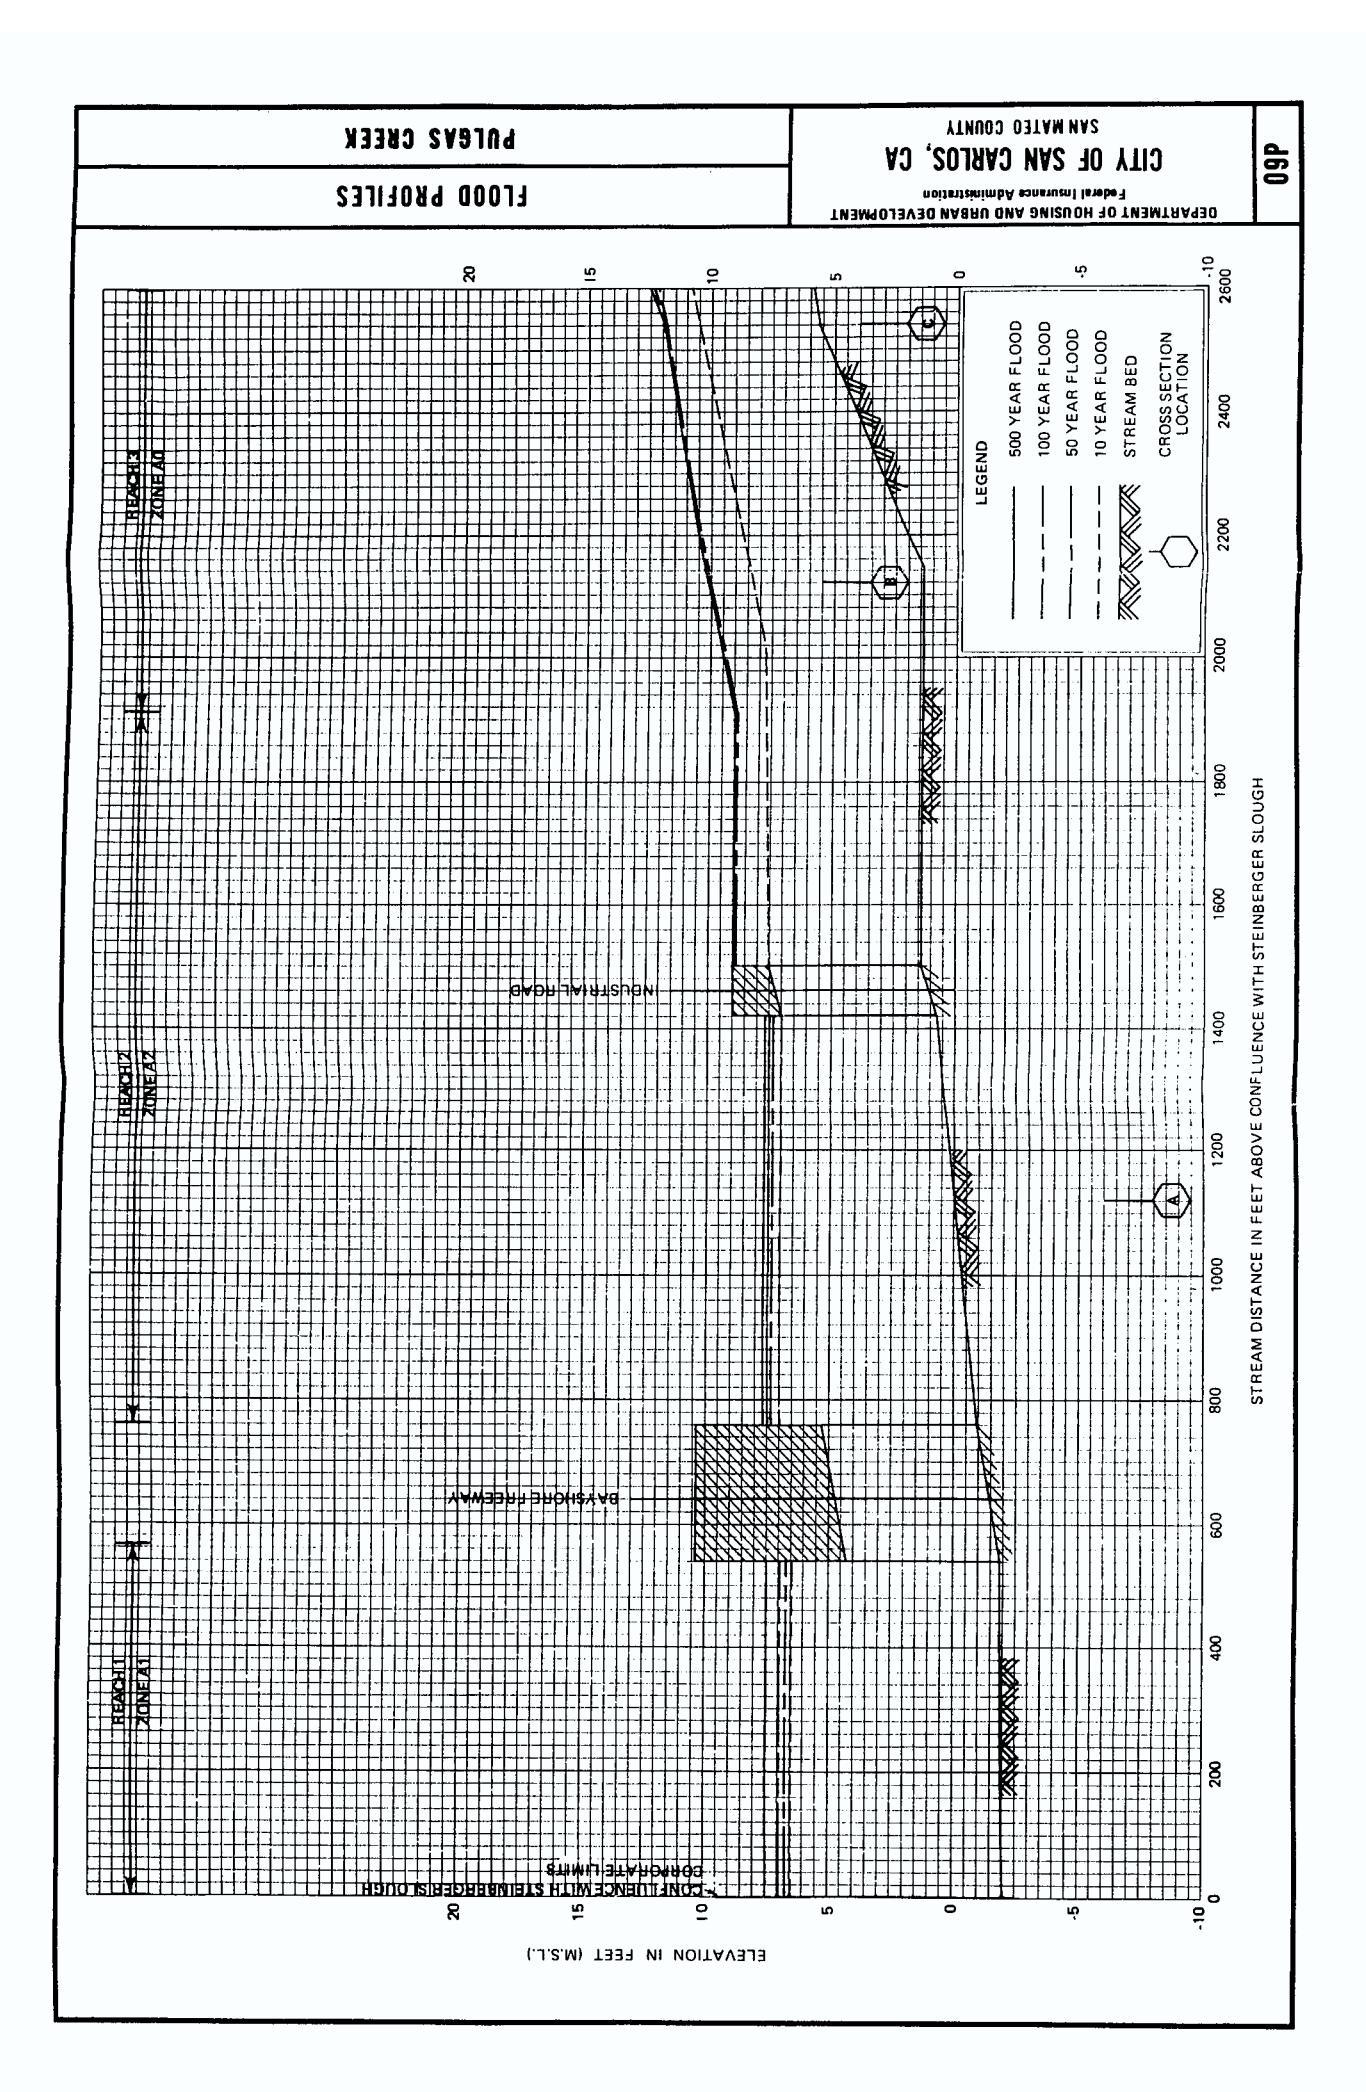
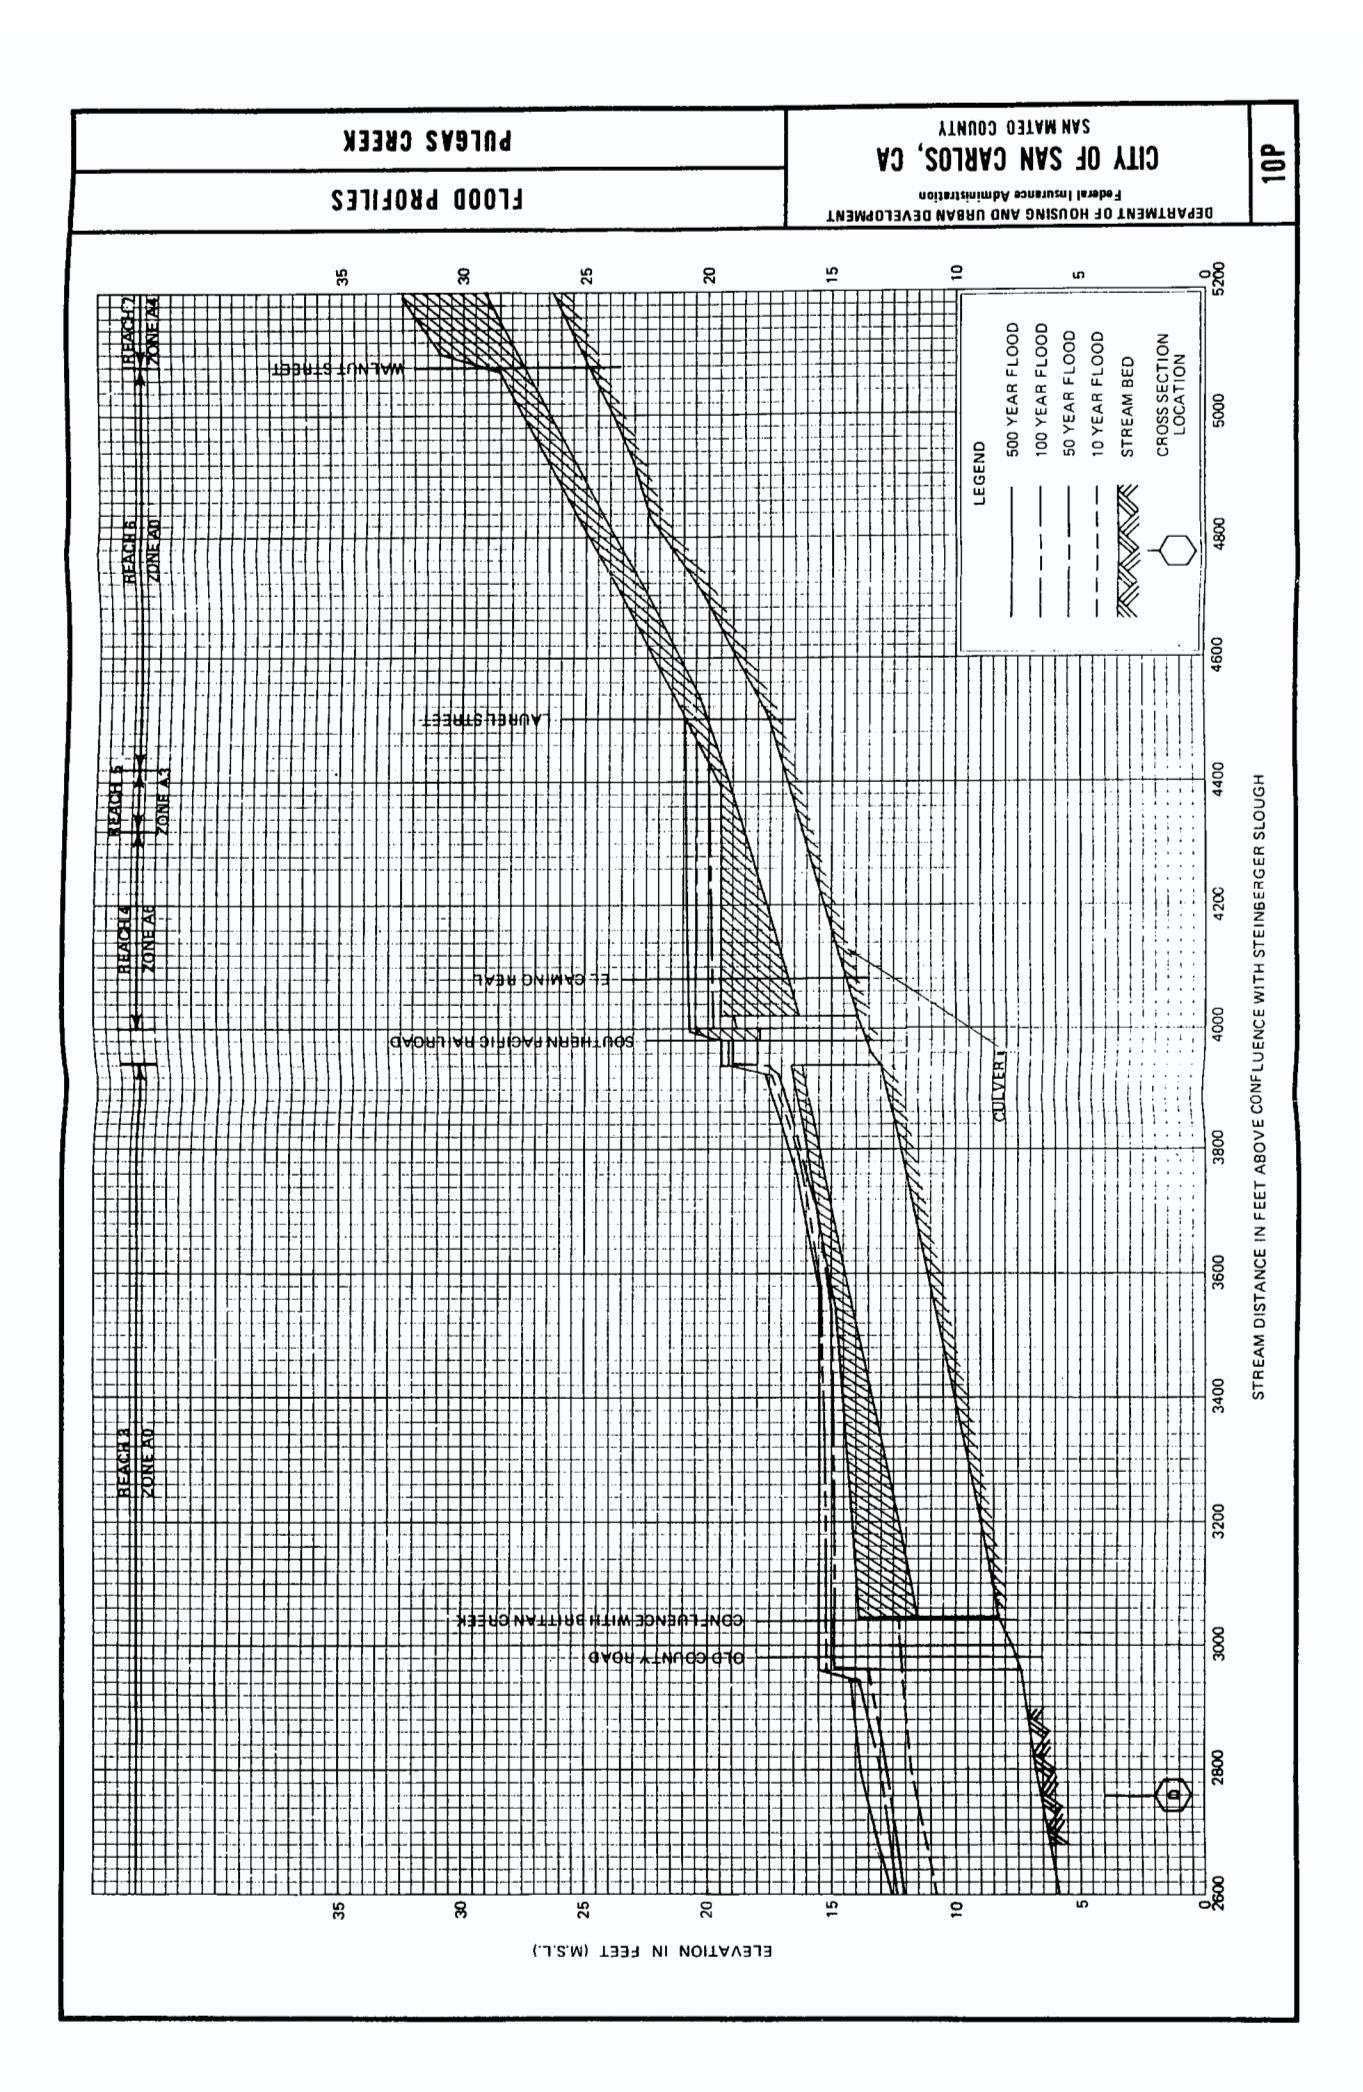
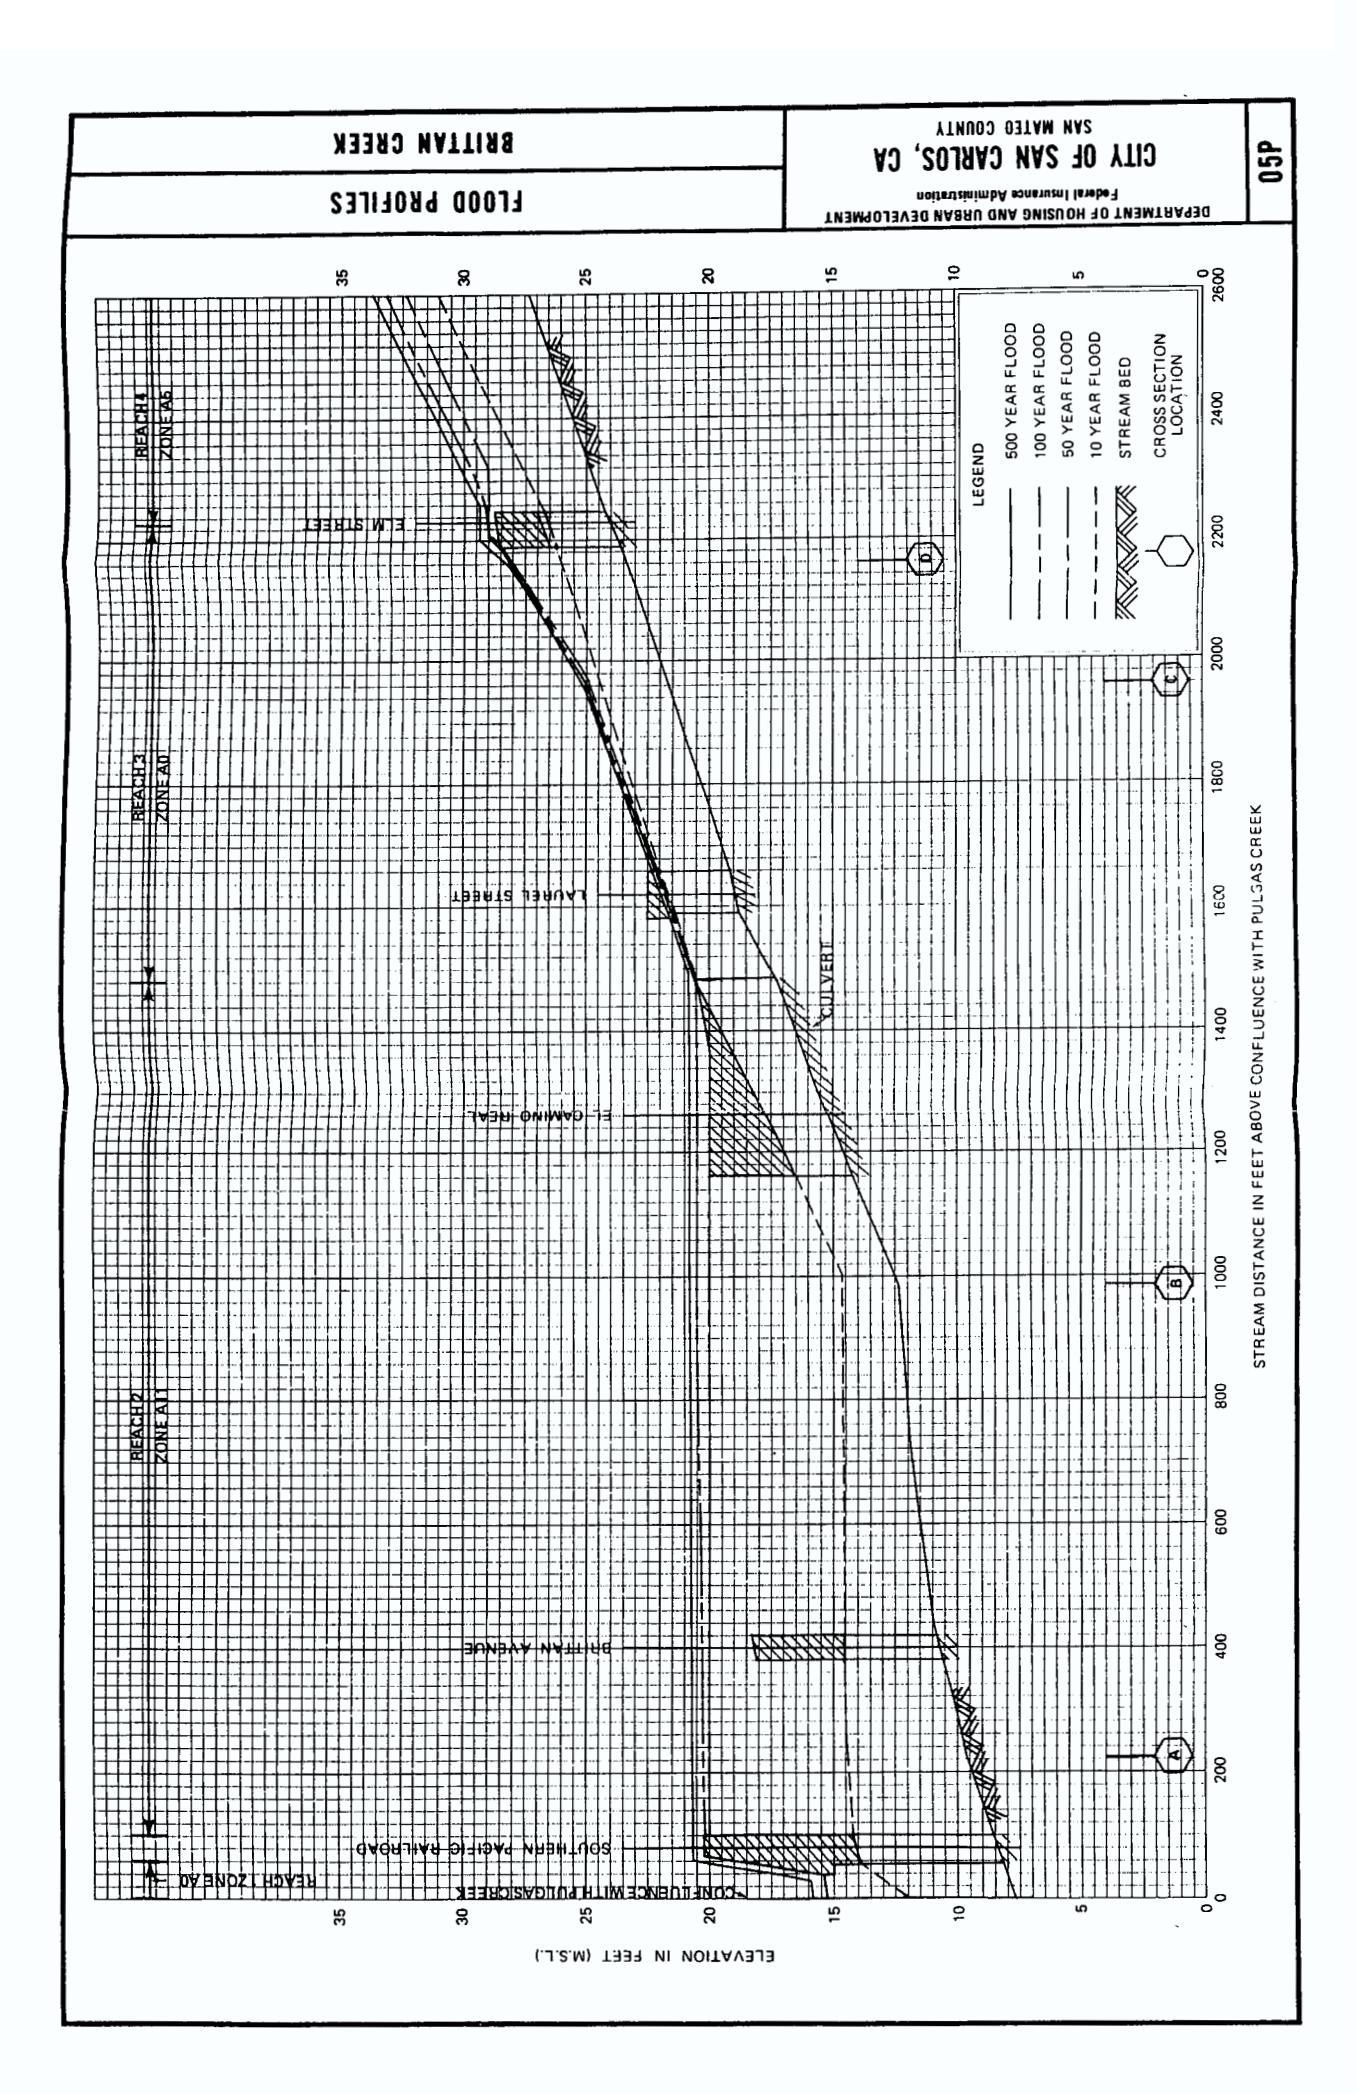
APPENDIX B FEMA 100-YEAR WATER SURFACE ELEVATION PROFILES

- Cordilleras Creek
- Pulgas Creek
