<p><b>OBSERVED LEVELLEE DISTRESS RAVENSWOOD Levee Assessment</b> South Bay Salt Ponds Restoration Project San Francisco Bay Area, California</p>		
By: SB	Date: 10/25/06	Project No. 9378.002
<b>Geomatrix</b>		Figure <b>5r</b>

LEVEE MAINTENANCE SUMMARIES  
ALVISO  
Levee Assessment  
South Bay Salt Ponds Restoration Project  
San Francisco Bay Area, California

LEVEE MAINTENANCE SUMMARIES  
EDEN LANDING  
Levee Assessment  
South Bay Salt Ponds Restoration Project  
San Francisco Bay Area, California

PROPOSED LEVEE ALIGNMENTS  
 Levee Assessment  
 South Bay Salt Ponds Restoration Project  
 San Francisco Bay Area, California

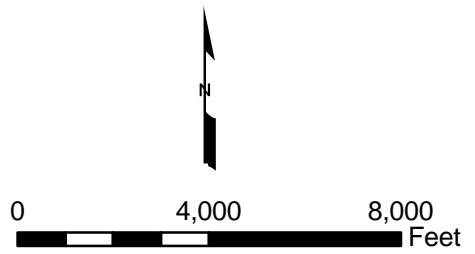
Explanation

| <span style="border: 1px solid black; padding: 2px;">R4</span> | Project ponds | Observed Distress |
| | | <b>SL</b> = Slump |
| | Erosion Potential | <b>ER</b> = Erosion |
| <span style="border-bottom: 2px solid magenta; width: 20px; display: inline-block;"></span> | Severe | <b>UN</b> = Uncutting |
| <span style="border-bottom: 2px solid brown; width: 20px; display: inline-block;"></span> | Intense - Severe | <b>BR</b> = Breach |
| <span style="border-bottom: 2px solid red; width: 20px; display: inline-block;"></span> | Intense | <b>CR</b> = Cracking |
| <span style="border-bottom: 2px solid orange; width: 20px; display: inline-block;"></span> | Moderate - Intense | <b>OV</b> = Overtopping |
| <span style="border-bottom: 2px solid yellow; width: 20px; display: inline-block;"></span> | Moderate | |
| <span style="border-bottom: 2px solid lightgreen; width: 20px; display: inline-block;"></span> | Slight - Moderate | |
| <span style="border-bottom: 2px solid lime; width: 20px; display: inline-block;"></span> | Slight | |

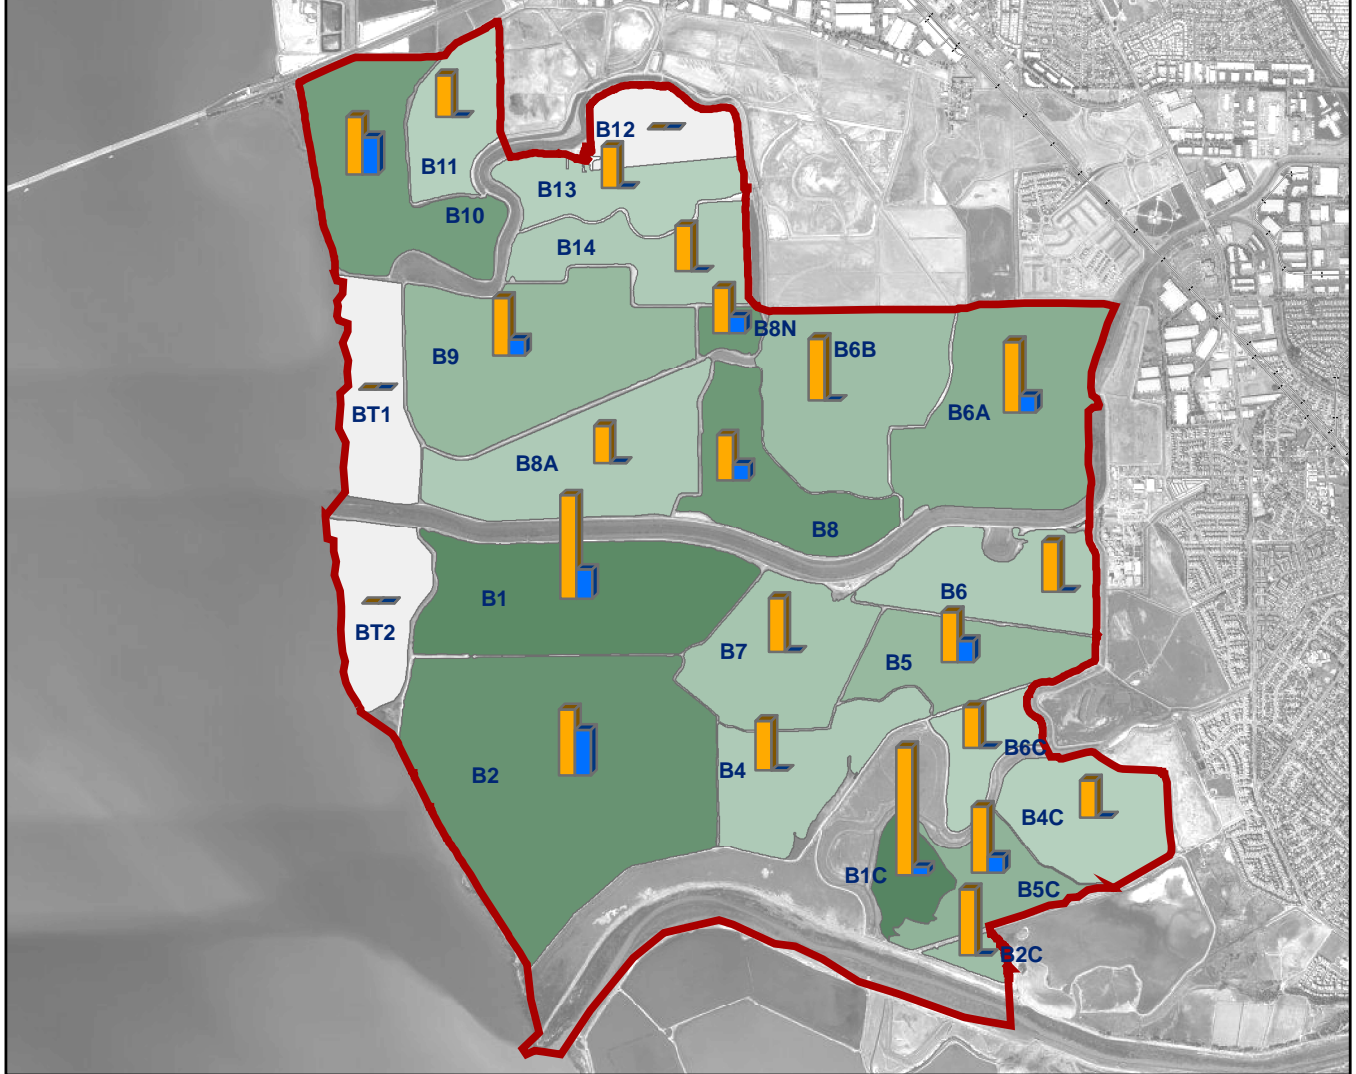
Figure **6e**

Total Number of Events	Total Linear Feet	Total Cubic Yards
Subsidence Repair	283	139165	5730
Erosion Repair	50	23756	19525
All Repairs	333	162921	25255

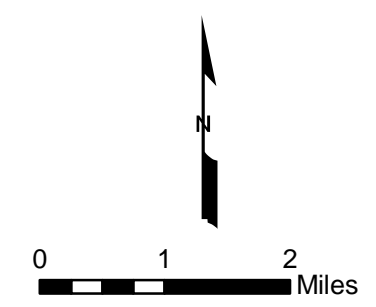
— Proposed Levees
