**ISLAND PONDS MITIGATION MONITORING
AND REPORTING
YEAR 2- 2007**

Santa Clara Valley Water District
U.S. Fish and Wildlife Service - Don Edwards National Wildlife Refuge
H.T. Harvey & Associates
Philip Williams & Associates, Ltd.

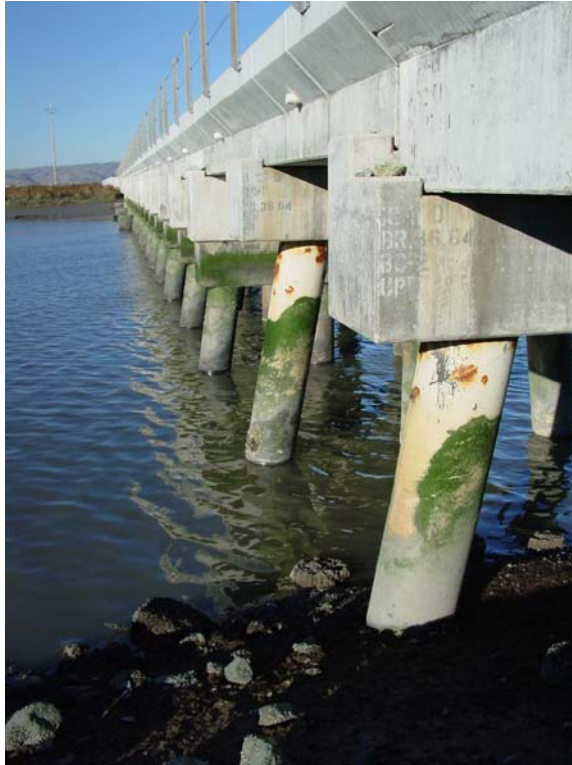
Photo 5. West Side of Bridge Looking North. Pile 1S-A in foreground – November 29, 2006

- The rail bridge scour photographs document only the piles located at the highest intertidal edges of Coyote Creek. Since the largest increase in tidal velocity, due to an increase in upstream tidal prism, would likely take place through the deepest part of the channel, the current method of collecting photographs above the waterline is inadequate to assess the condition of the subtidal piles. Therefore, we recommend that a meeting with railroad staff be scheduled to discuss whether or not there is a need for subtidal data collection. If it is determined that additional data is necessary, a subsequent meeting will be scheduled between the District and Refuge staff to determine appropriate actions and responsibilities.

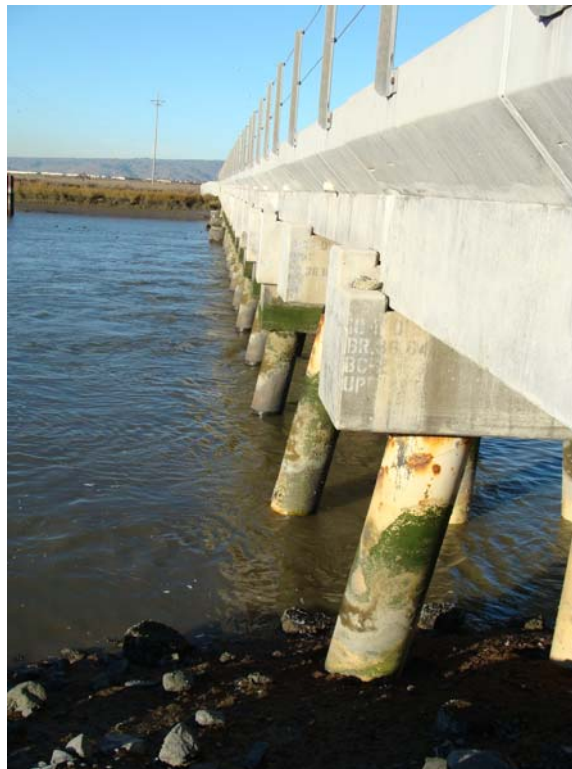
Photo 6. West Side of Bridge Looking North. Pile 1S-A in foreground– November 21, 2007

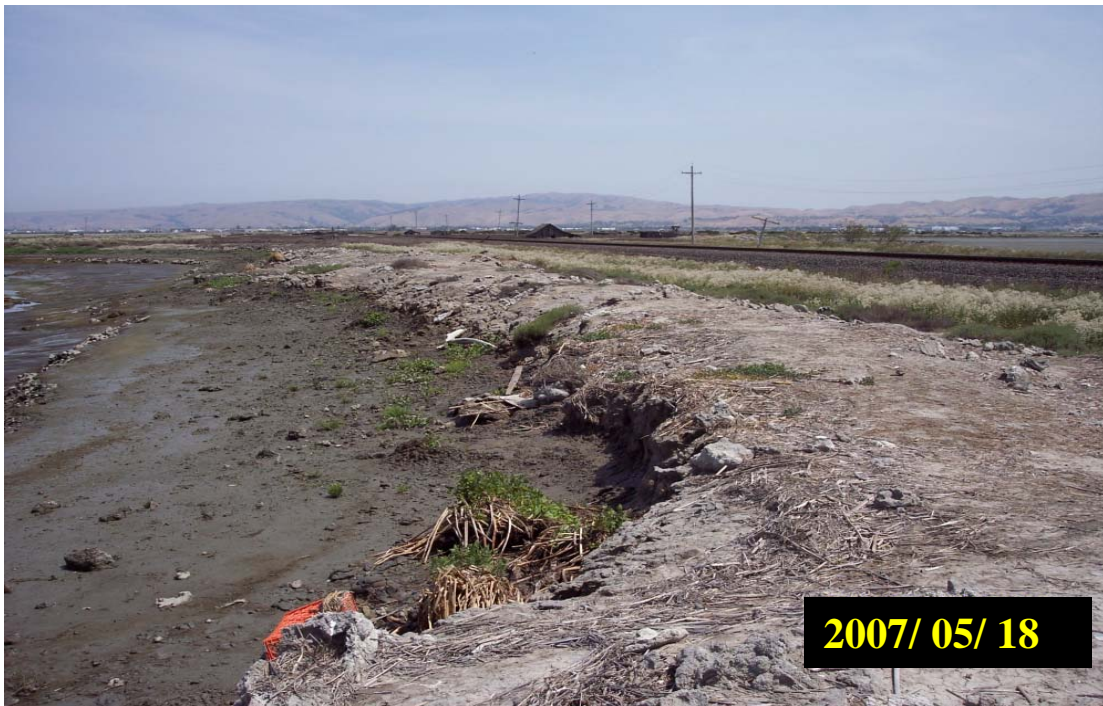
Photo 2. Same location as above – May 18, 2007.

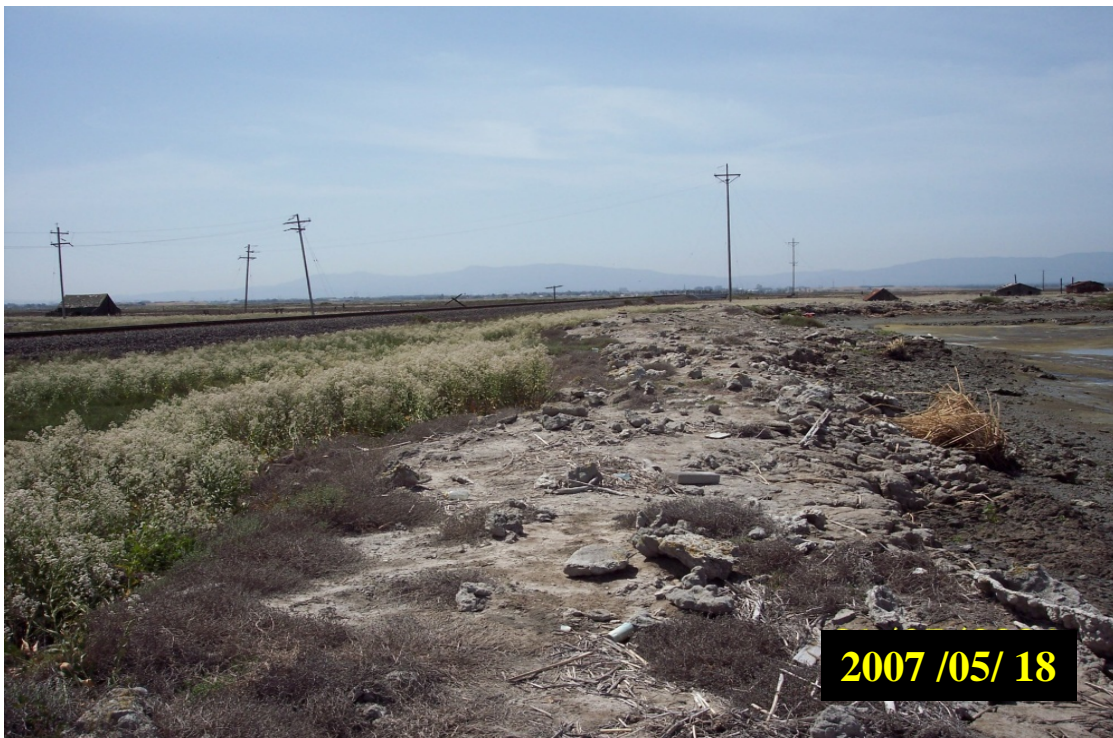
Photo 4. Same location as above – May 18, 2007.

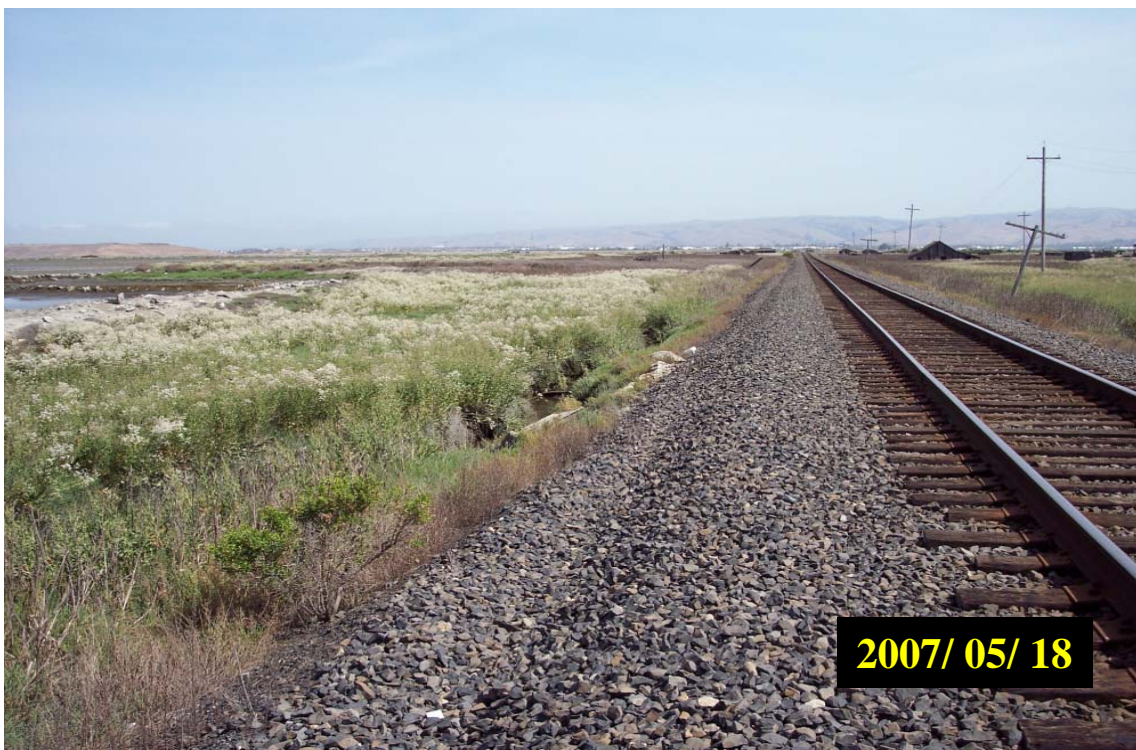
Photo 6. Same location as above – May 18, 2007.

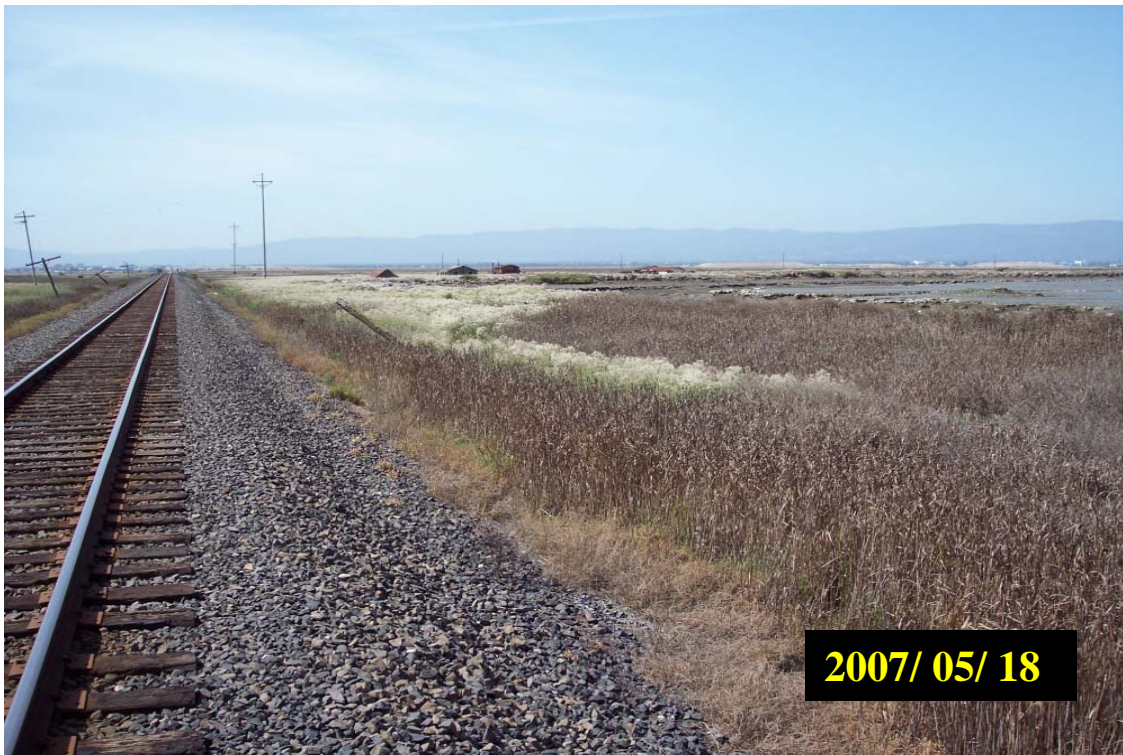
Photo 8. Same location as above – May 18, 2007.

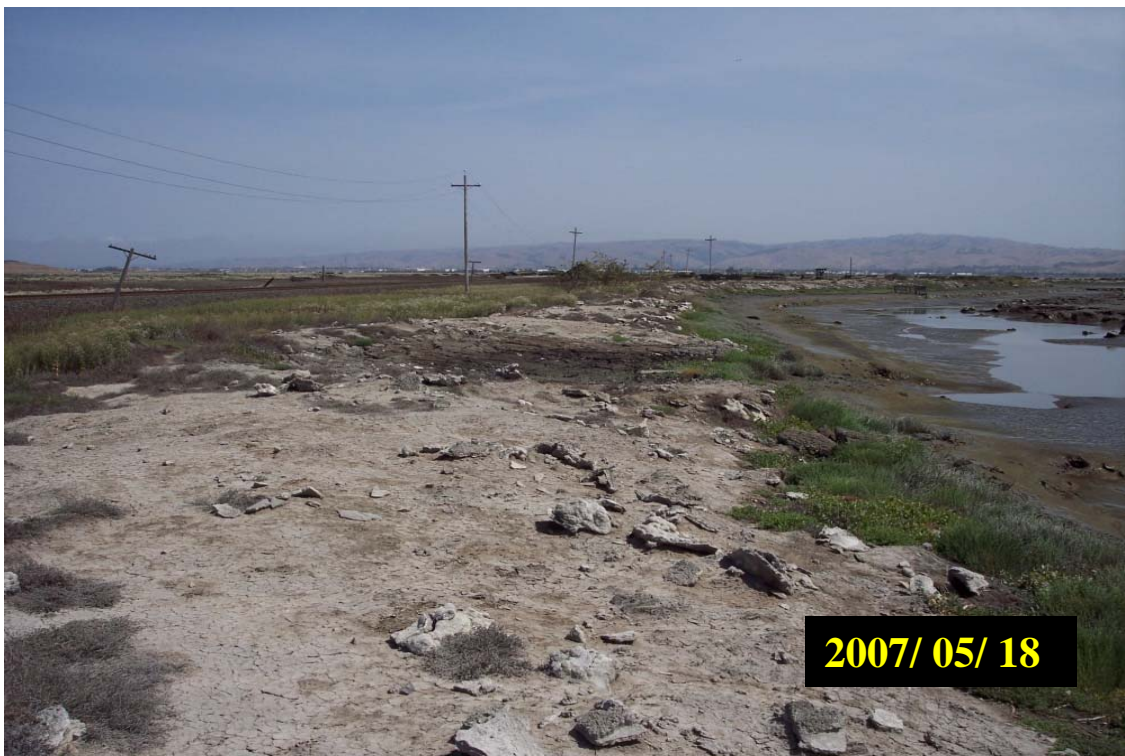
Photo 10. Same location as above – May 18, 2007.

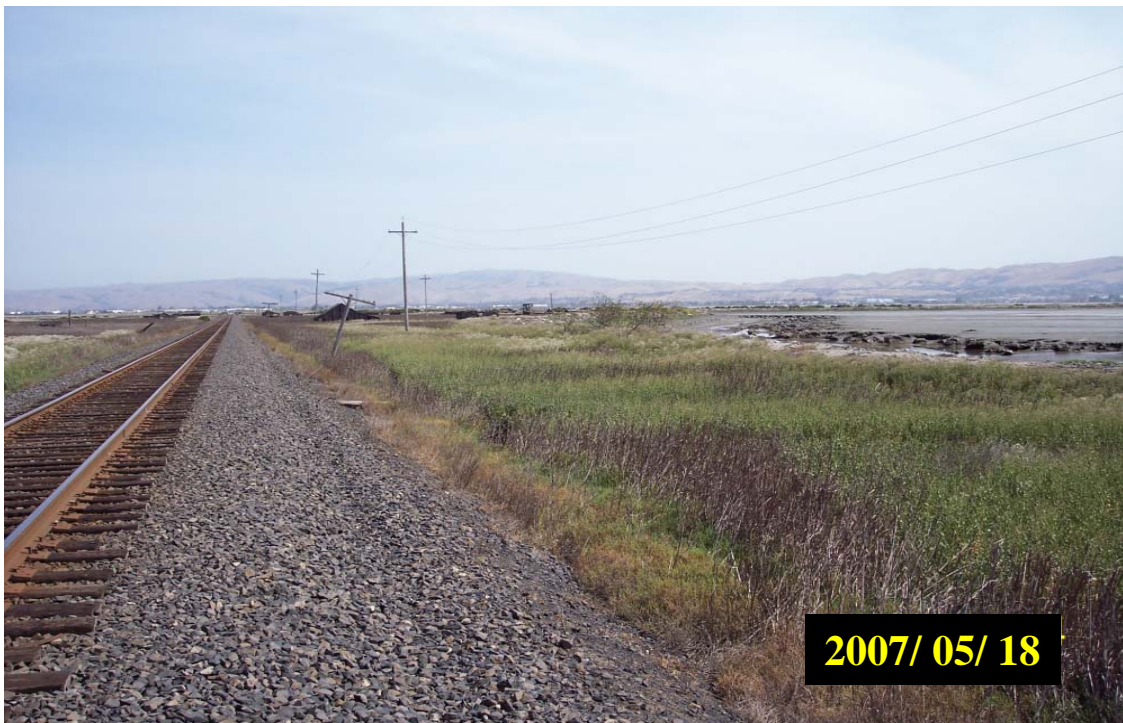
Photo 14. Same location as above – May 18, 2007.

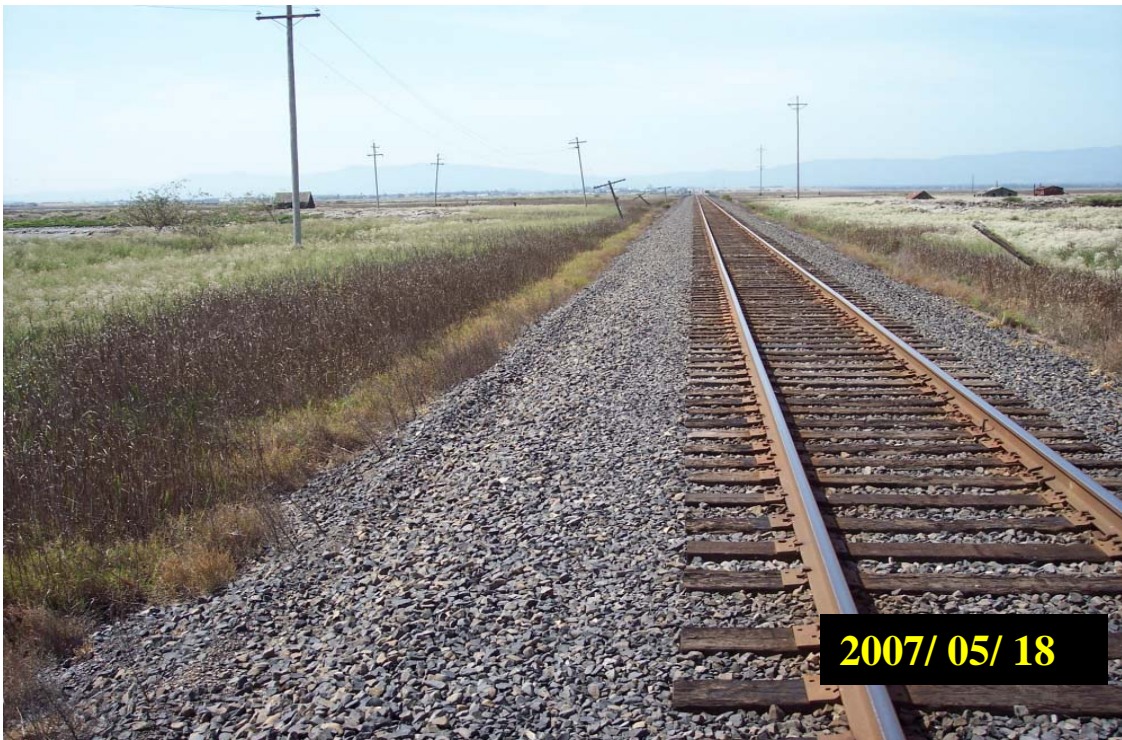
Photo 16. Same location as above – May 18, 2007.
